On conservation issues of contemporary architecture: The technical design development and the ageing process of the Jubilee Church in Rome by Richard Meier

Luciano Cardellicchio

In May 2017, a technical survey was run by the author of this paper fourteen years after the opening day of the church, to measure the ageing process of the church especially with regards to the innovative solutions developed.

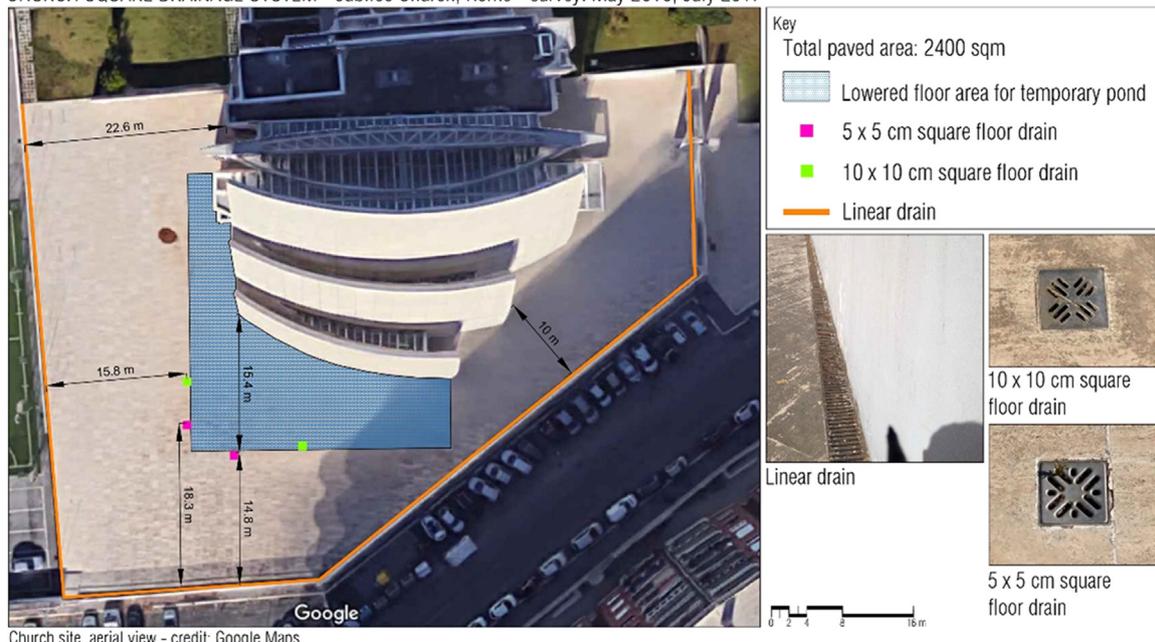
Fig. 6 The drainage system of the church square (drawing and pictures by the author).

The drainage system of the wide church square paved with travertine stones was severely underestimated in the design phase. As has been previously reported, a large pond was designed to surround the shells at the competition stage. Following the change during the Developed Design stage, a much smaller squared area of the external floor bordering the shells and the back of the church was constructed slightly lowered to collect the rain water and create a temporary pond, noticeable only when it rains. In addition

to this solution, very few drains were arranged in the rest of the paved area. The whole area is 2400 m² and the rain water is collected only by linear drains along the perimeter of the plot together with 3 (5 × 5 cm) drains at the edge of the lower area and 2 more (10 × 10 cm) drains in the middle of it (Fig. 6). With the effect of rain-water stagnation and without regular cleaning, the surface is affected by high levels of depositions of sulphur dioxide and oxides of nitrogen (Fig. 7). The level of the deposition rises along the temporary pond at the back of the church where clearly the rain cannot be collected. A long crack is visible on the travertine floor in an area near the small shell suggesting poor execution of the floor together with the supply of shallow travertine tiles not properly sized for both the usage and thermal excursion.

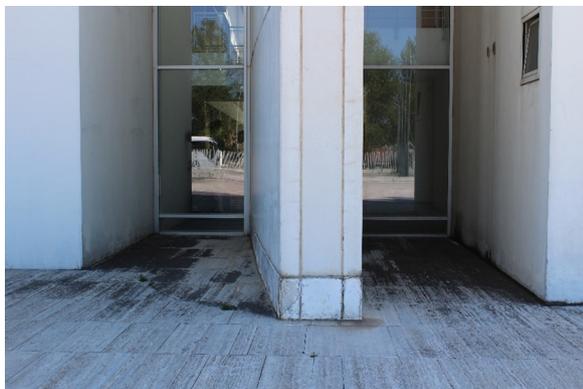
Fig. 7 The area of the external pavement most affected by the acid rain deposits (Picture by the author, taken 22/05/2016).

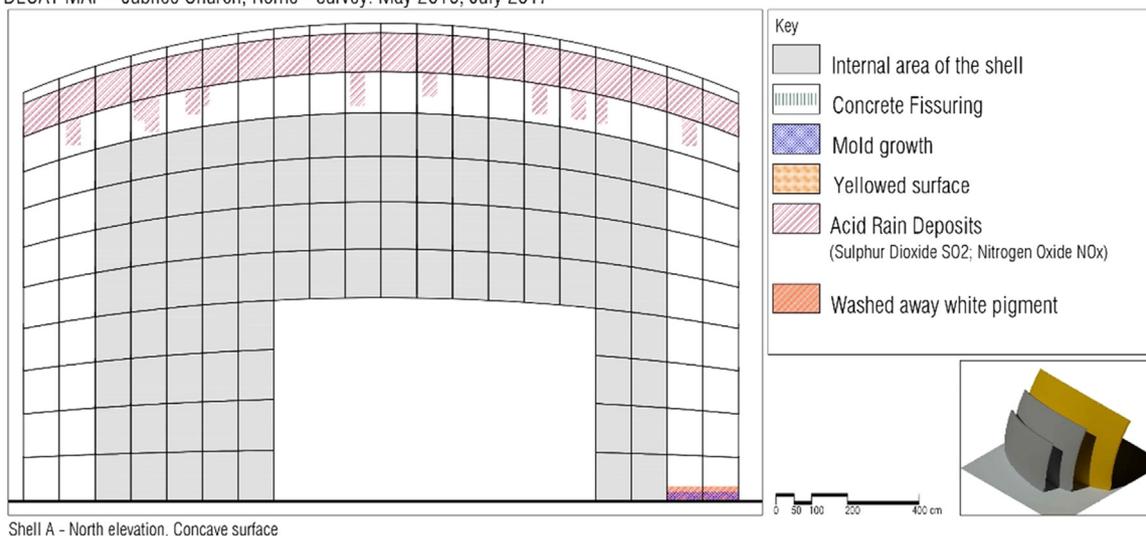
Fig. 8 Decay map of the concave side of the large-size shell (drawing by the author).

shell. In detail, on the first course, concrete fissuring, moulds and washing-off of white pigmentation are visible where the shells meet the ground whilst extensive black stains are visible at the top of the northern side of each shell. The black deposition on the shells is more visible on the surfaces which constantly shaded, where the surface remains wet for longer and the sun cannot start the catalysing process with the dioxide of titanium contained in the TX Millennium concrete. This happens mostly at the back of the church, where the shells are closer to each other, or on the surfaces exposed to the north (Figs. 8, 10, 12).

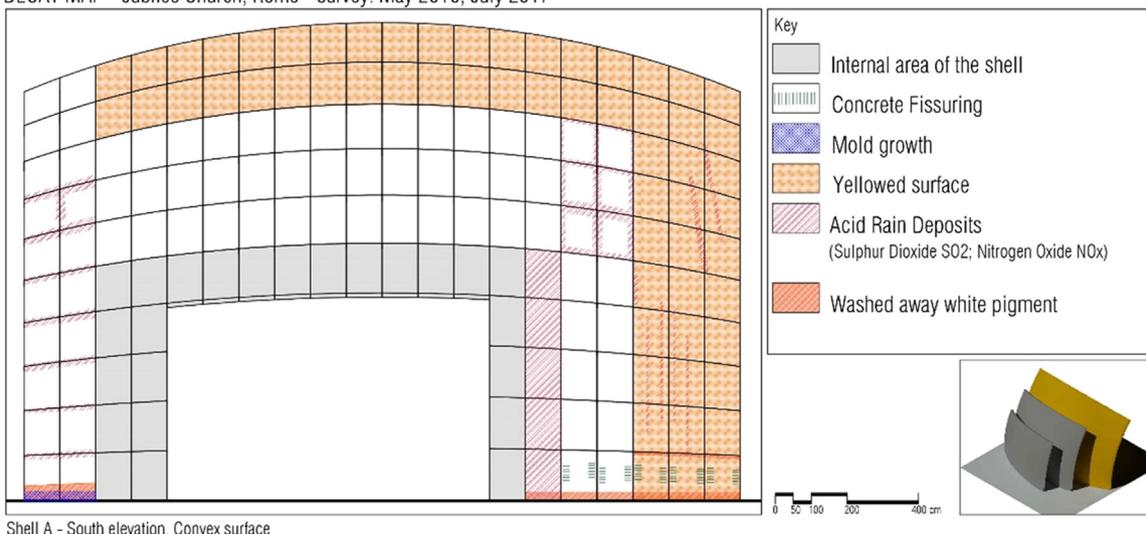
Fig. 9 Decay map of the convex side of the large-size shell (drawing by the author).

whilst blackening and fissuring along the edges. This is why the rain stagnates on the wider joints between the concrete blocks, blackening them extensively (Figs. 9, 11, 13). As this was the first time this cement mix was used it is not possible to compare this data with other case studies or measure the ageing process against the expectations of the Italcementi Group (Fig. 14).

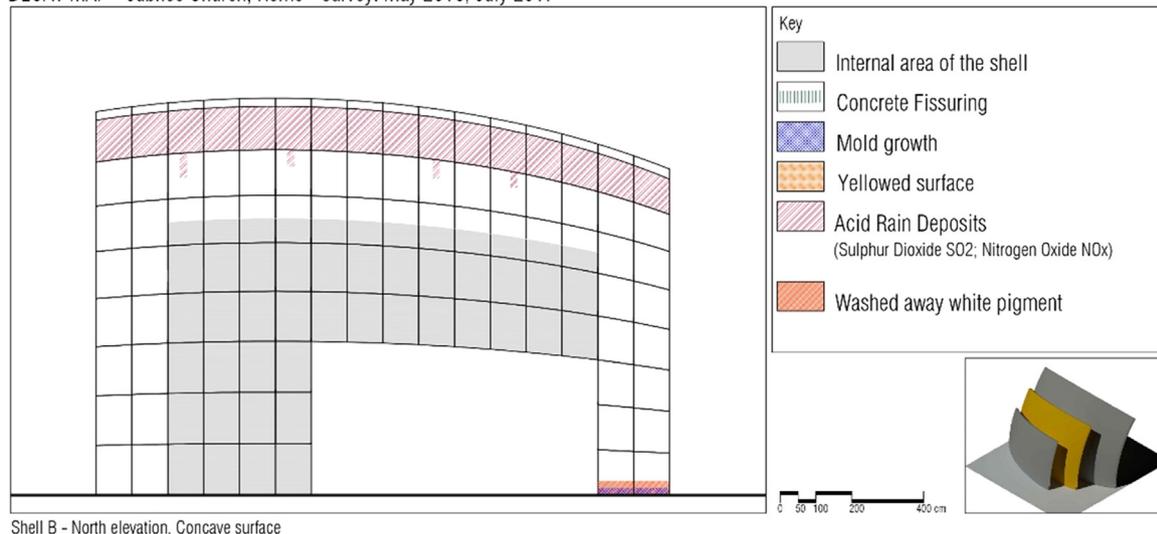
Shell B - North elevation, Concave surface

Fig. 10 Decay map of the concave side of the medium-size shell (drawing by the author).

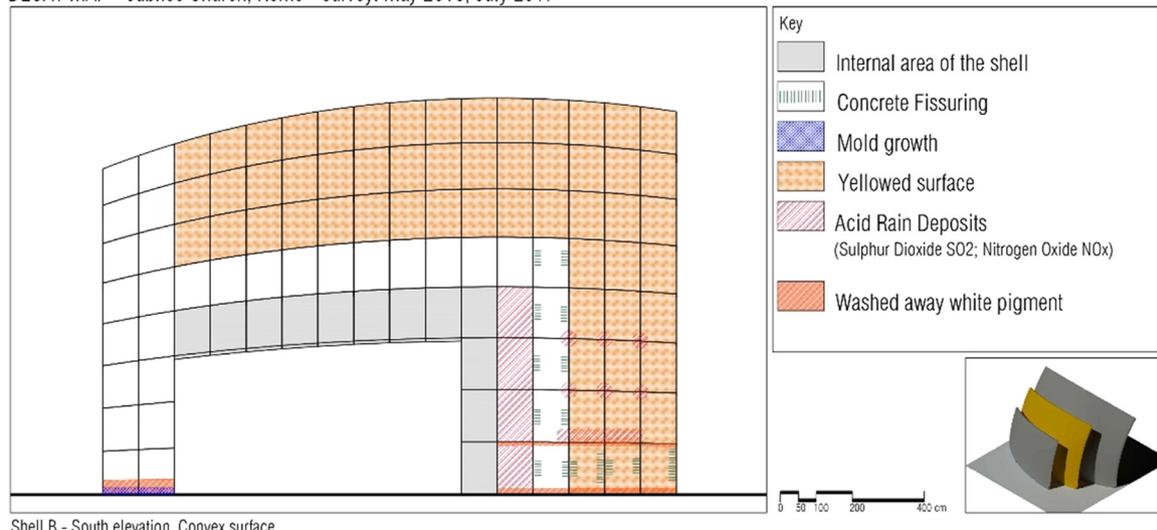
Shell B - South elevation, Convex surface

Fig. 11 Decay map of the convex side of the medium-size shell (drawing by the author).

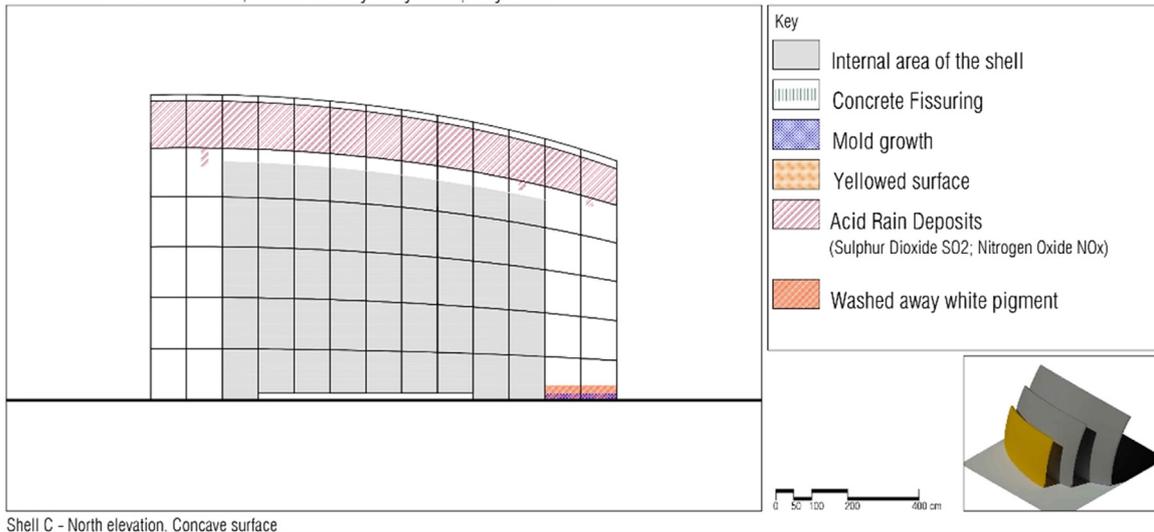
Fig. 12 Decay map of the concave side of the small-size shell (drawing by the author).

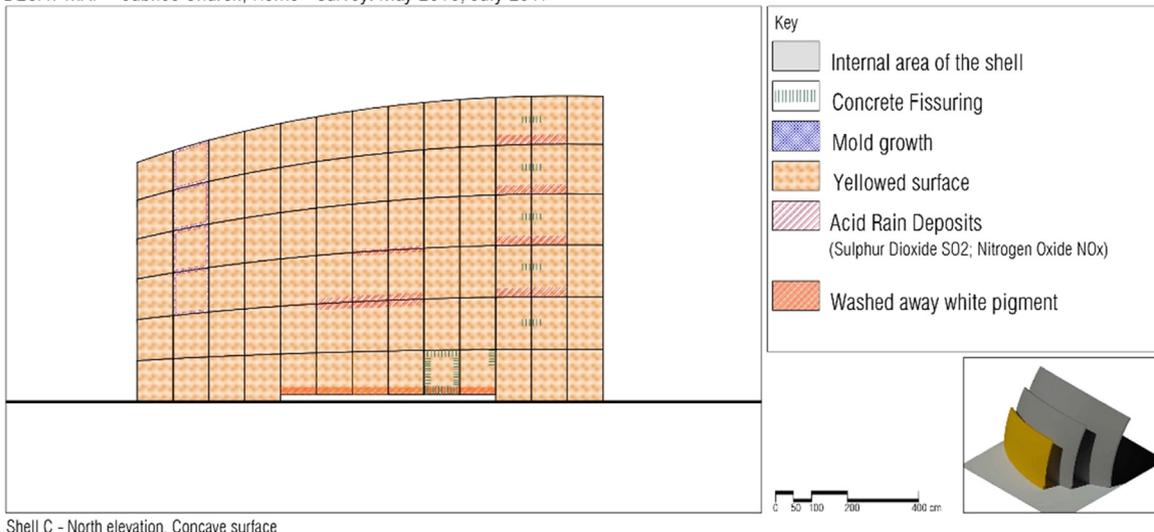
Fig. 13 Decay map of the convex side of the small-size shell (drawing by the author).

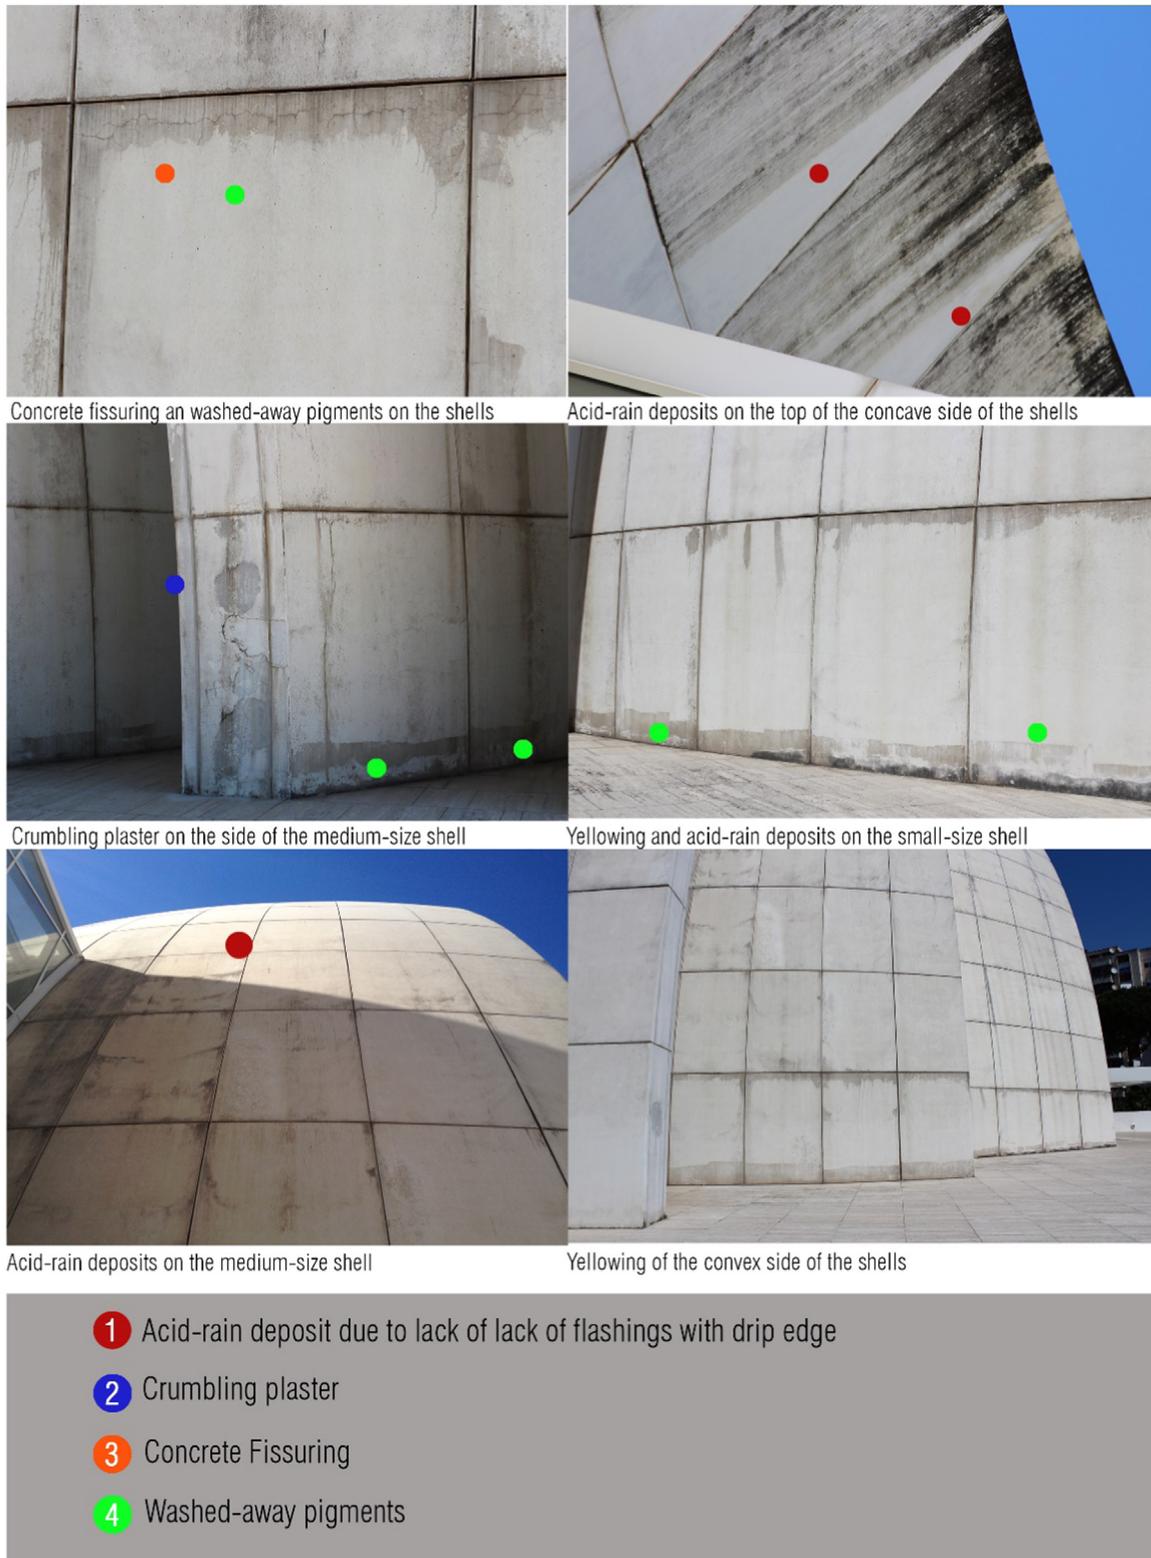
Regarding the whitening properties of the cement, after fourteen years the TX Millennium exposed concrete has yellowed extensively. Every block is yellowing in the middle

Fig. 14 State of decay of the shells (Pictures by the author, taken 22/05/2016 and 28/07/2017).

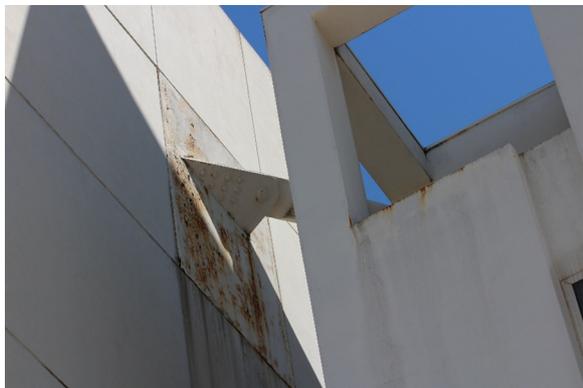
Fig. 15 Presence of rust on the pinned joint of the roof beam (Picture by the author, taken 22/05/2016).

The pinned joints connecting this wall with the curved beam and some of the pendula are visibly rusted, suggesting a poor level of galvanisation prior to their construction (Fig. 15).

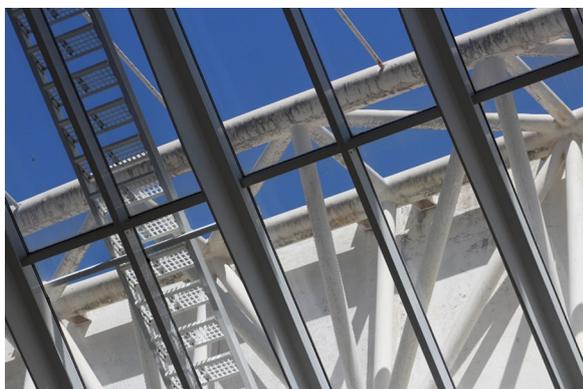
Fig. 16 Presence of acid rain deposits on the roof beam and on the roof truss. Some rusted roof pendula are visible as well as the crumbling plaster behind the steel truss (Picture by the author, taken 22/05/2016).

On the intrados of the curved beam and inside the cross bracing of the truss, large depositions of sulphur dioxide and oxides of nitrogen are visible from the inside of the church hall. Plaster detachment is visible on the wall against the steel truss (Fig. 16).

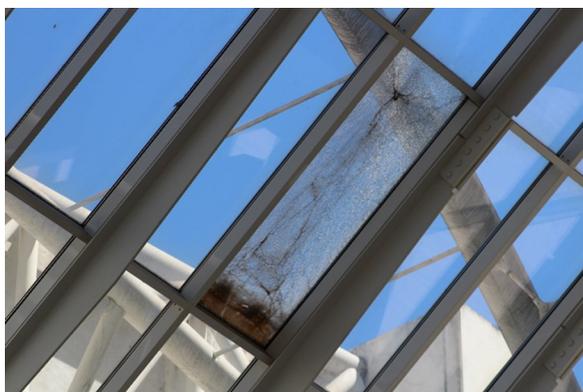
Fig. 17 A broken glass panel of the roof truss (Picture by the author, taken 22/05/2016).

In April 2012, a seagull flying over the church dropped an object from its beak onto the glazed roof. The impact broke a glass panel which has not been replaced yet due to the high cost, unaffordable for a small parish on the outskirts of Rome (Fig. 17). The rest of the glass panels and their mullions and transoms are in good-shape.

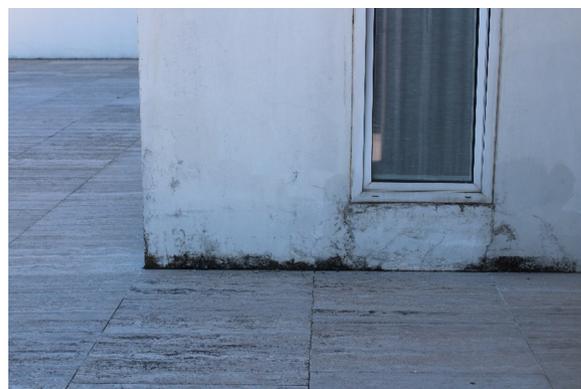
The sacristy and the altar are designed into a plastered block which encloses the space of the hall on the west side of the church. The volume is located half inside and half outside the church. The part protruding on the outside is bordered by the lowered floor acting as a temporary pond when it rains. In the construction detail, no waterproofing membrane, nor a stone skirting board, nor a linear drain were designed where the block meets the travertine floor. Therefore, the stagnation of the water has caused diffuse crumbling plaster and visible mould at the bottom of the block (Fig. 18).

Fig. 18 Mould growth at the bottom of the block of the altar.

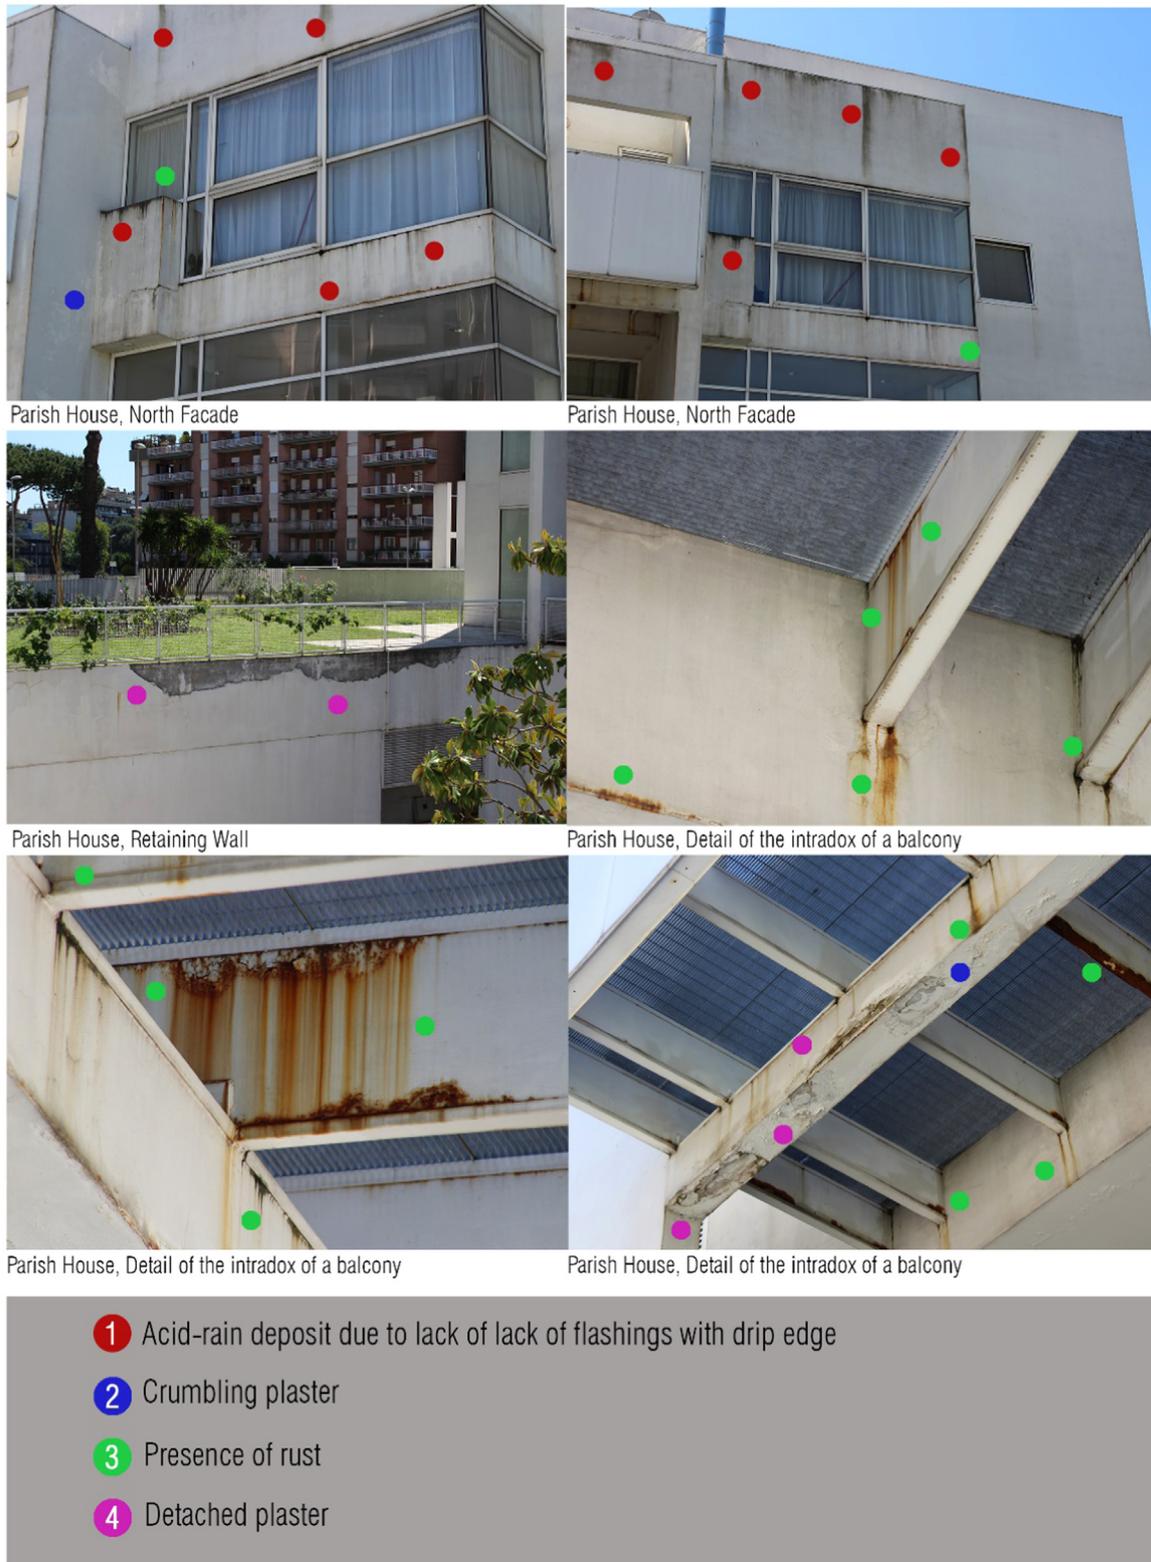
Fig. 19 State of decay of the northern façade of the parish house truss (Picture by the author, taken 22/05/2016).

On the northern façade of the parish house several damages have occurred. The balconies are built with a system of exposed steel girders supported by a reinforced concrete beam, plastered with stucco. Due to a poor level of galvanisation, all of the girders are visibly rusted while the concrete beams have experienced severe crumbling and detachment of the plaster. As the floor of the balconies is built in metal grill, rain water falls directly on these structural members which have not been built with proper waterproofing elements.

The northern façade of the parish house is severely damaged by the lack of flashing with drip edges. The windows are aligned with the plastered wall and they are not protected either by being set back or by canopies. In addition, the flashing topping that there is on the façade does not protrude enough to protect the walls from acid rain. The result is the presence of diffuse stains from black particles all along the façade and around the frames of the windows. On top of the east side of the retaining wall bordering the lowered courtyard, designed to naturally light up the basement of the parish house, extensive portions of detached plaster are visible. Again, this is due to a poorly designed drainage system and poor execution (Fig. 19).
