# On conservation issues of contemporary architecture: the technical design development and the ageing process of the Jubilee Church in Rome by Richard Meier

Dr Luciano Cardellicchio, University of Kent

DECAY MAP - Jubilee Church, Rome - survey: May 2016, July 2017

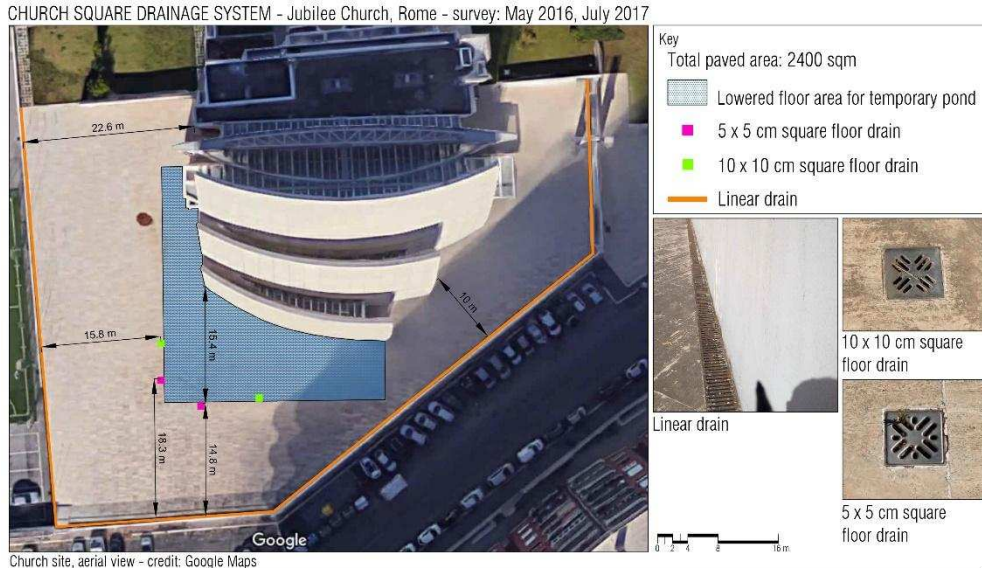
The drainage system of the wide church square paved with travertine stones was severely underestimated in the design phase. As has been previously reported, a large pond was designed to surround the shells at the competition stage. Following the change during the Developed Design stage, a much smaller squared area of the external floor bordering the shells and the back of the church was constructed slightly lowered to collect the rain water and create a temporary pond, noticeable only when it rains. In addition to this solution, very few drains were arranged in the rest of the paved area. The whole area is 2400 square meters and the rain water is collected only by linear drains along the perimeter of the plot together with 3 (5 x 5 cm) drains at the edge of the lower area and 2 more (10 x 10 cm) drains in the middle of it (fig.6). With the effect of rain-water stagnation and without regular cleaning, the surface is affected by high levels of depositions of sulphur dioxide and oxides of nitrogen (fig.7). The level of the deposition rises along the temporary pond at the back of the church where clearly the rain cannot be collected. A long crack is visible on the travertine floor in an area near the small shell suggesting poor execution of the floor together with the supply of shallow travertine tiles not properly sized for both the usage and thermal excursion.

Figure 6. The drainage system of the church square (drawing and pictures by the author).

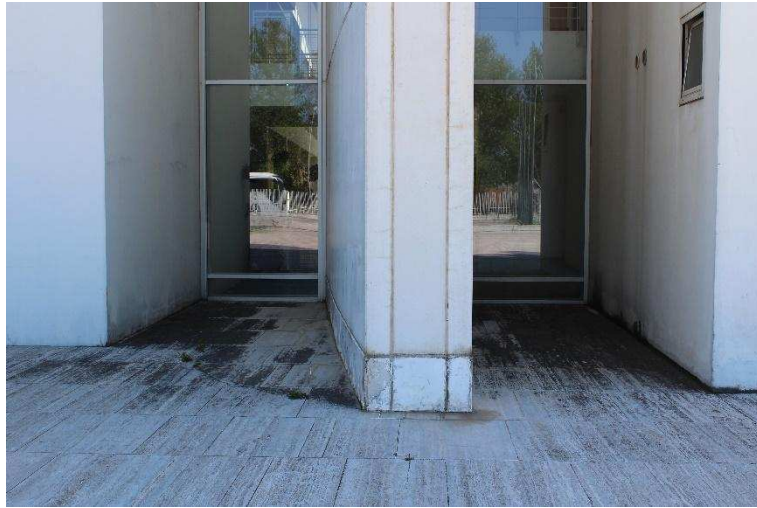
Figure 7. The area of the external pavement most affected by the acid rain deposits (Picture by the author, taken 22/05/2016).

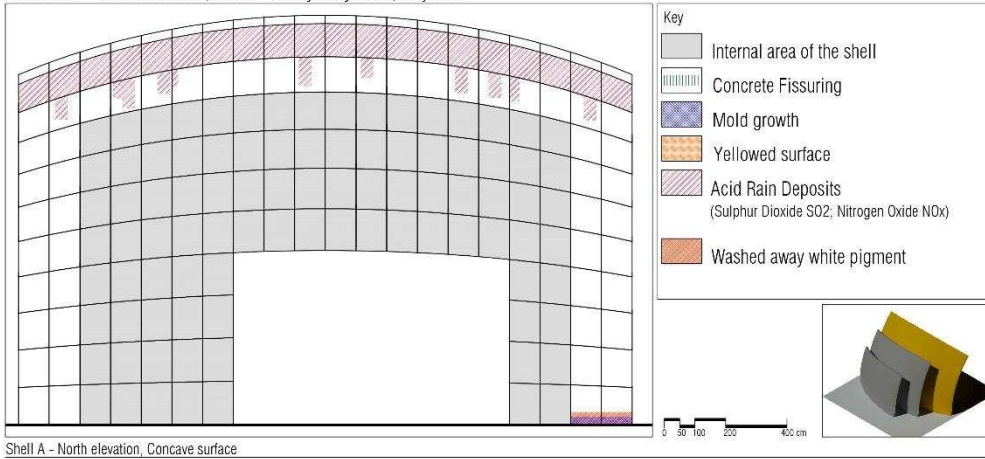
The stagnation of rain-water on the external floor due to the lack of drains near the building and the impact of acid rain on the concrete surface has caused visible damage to the shells. Due to the spherical geometry, the rain washes the shell in two ways: on the convex side, the rain washes the whole surface from top to bottom, therefore the first course of blocks is the one washed the most from the rain water; on the concave side, without a flashing at the top of the shells, the rain washes the surface of the top course until the first joint acts as a drip edge, deflecting the water from the shell's surface. This is noticeable by the deposition of particles along only the highest course of blocks and on the top course of each shell. In detail, on the first course, concrete fissuring, moulds and washing-off of white pigmentation are visible where the shells meet the ground whilst extensive black stains are visible at the top of the northern side of each shell. The black deposition on the shells is more visible on the surfaces which constantly shaded, where the surface remains wet for longer and the sun cannot start the catalysing process with the dioxide of titanium contained in the TX Millennium concrete. This happens mostly at the back of the church, where the shells are closer to each other, or on the surfaces exposed to the north (fig. 8, 10, 12).

Figure 8. Decay map of the concave side of the large-size shell (drawing by the author).

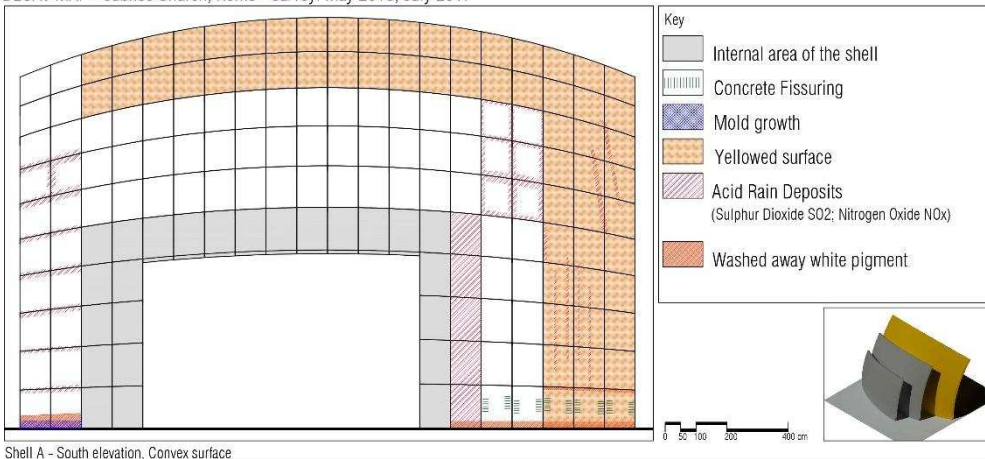
Figure 9. Decay map of the convex side of the large-size shell (drawing by the author).

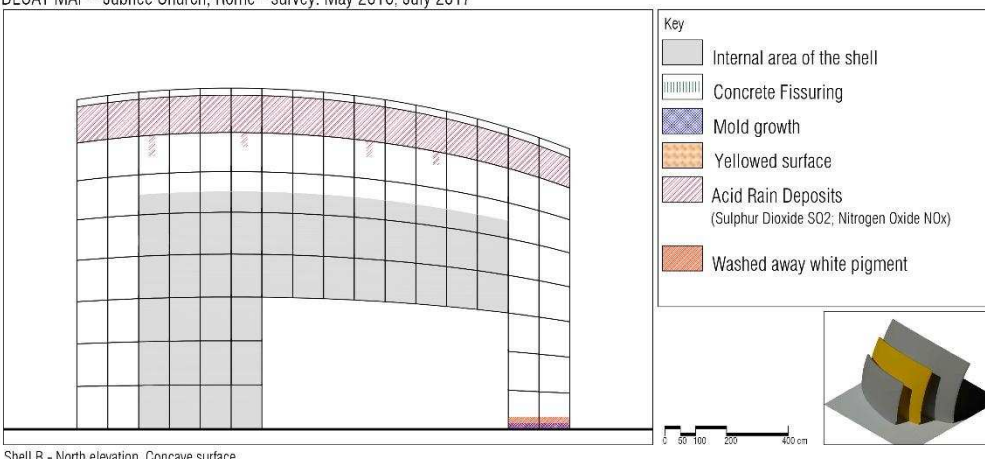
Figure 10. Decay map of the concave side of the medium-size shell (drawing by the author).

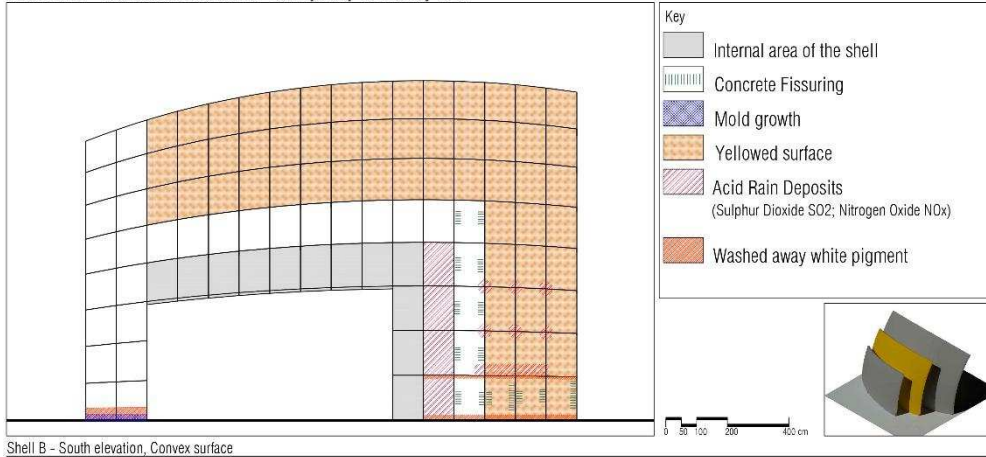
Figure 11. Decay map of the convex side of the medium-size shell (drawing by the author).

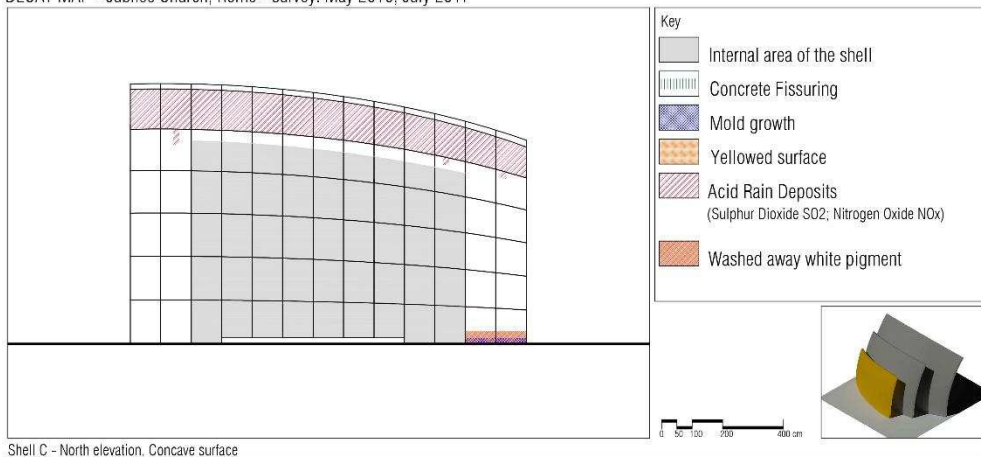
Figure 12. Decay map of the concave side of the small-size shell (drawing by the author).

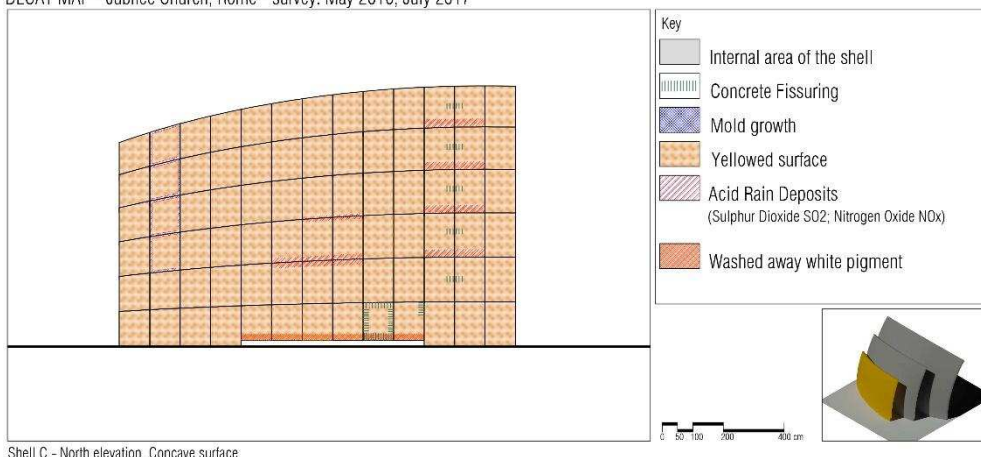
Figure 13. Decay map of the convex side of the small-size shell (drawing by the author).

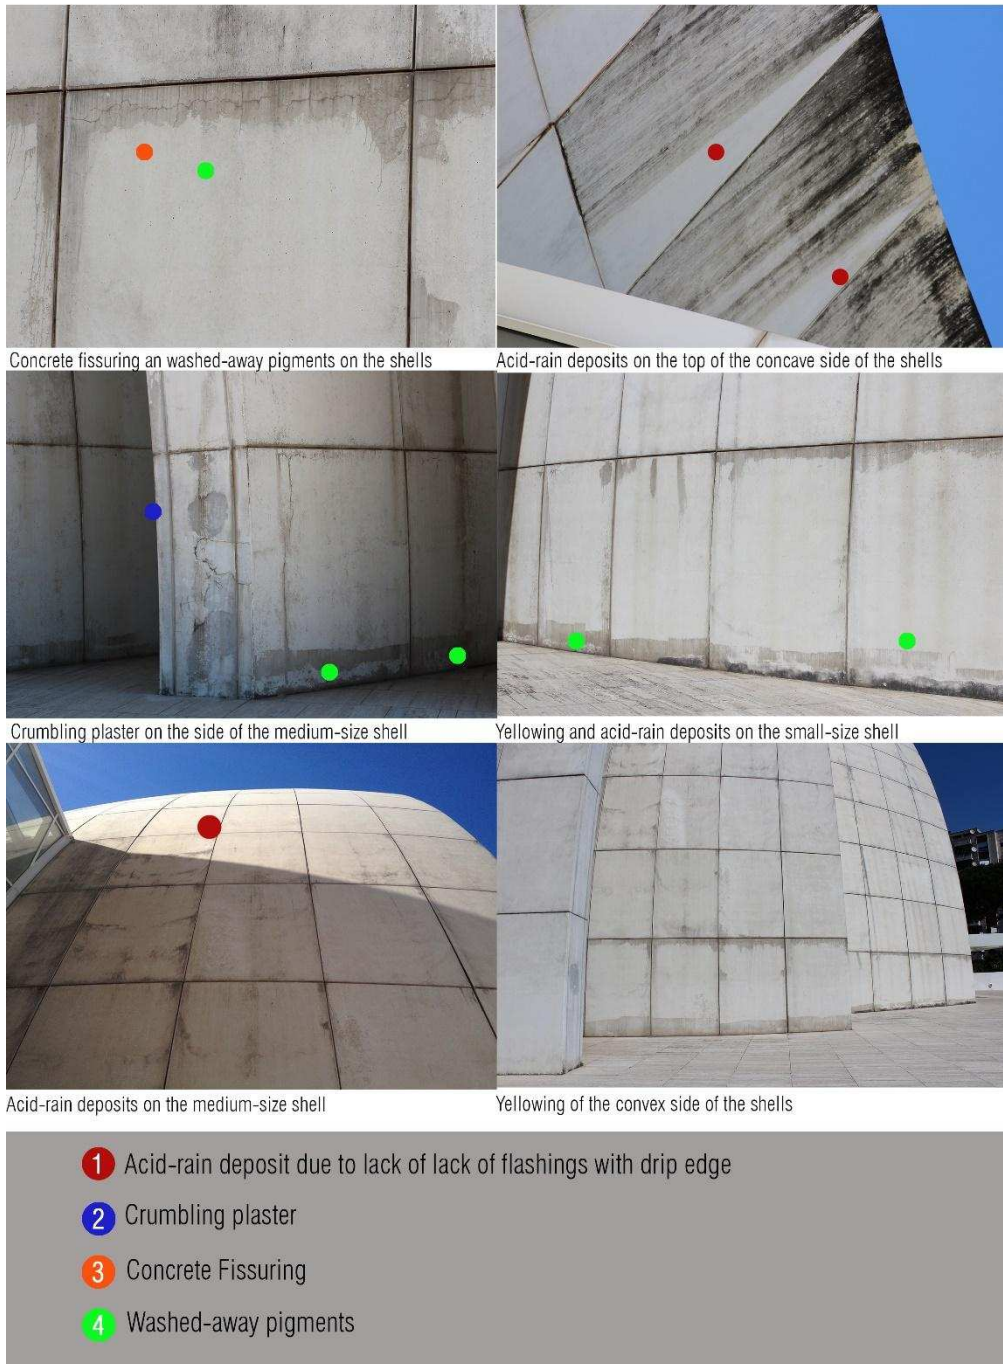
Regarding the whitening properties of the cement, after fourteen years the TX Millennium exposed concrete has yellowed extensively. Every block is yellowing in the middle whilst blackening and fissuring along the edges. This is why the rain stagnates on the wider joints between the concrete blocks, blackening them extensively (fig. 9, 11, 13). As this was the first time this cement mix was used it is not possible to compare this data with other case studies or measure the ageing process against the expectations of the Italcementi Group (fig. 14).

Figure 14. State of decay of the shells (Pictures by the author, taken 22/05/2016 and 28/07/2017).

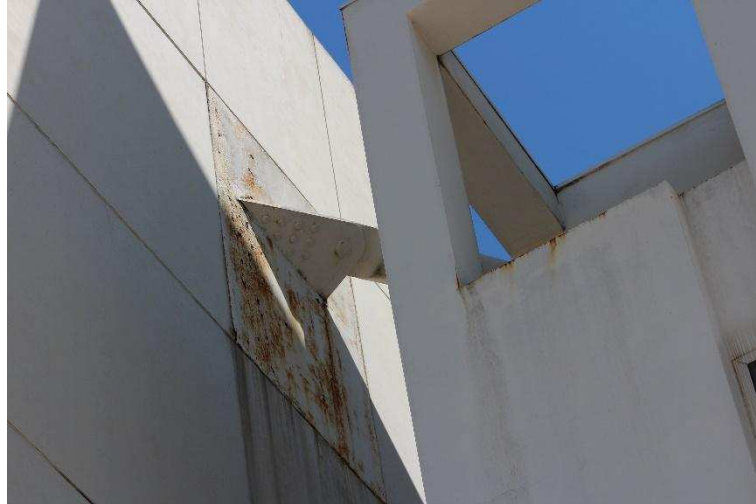
The pinned joints connecting this wall with the curved beam and some of the pendula are visibly rusted, suggesting a poor level of galvanisation prior to their construction (fig. 15).

5  
6  
7  
8  
9  
10  
11  
12  
13  
14  
15  
16  
17  
18  
19  
20  
21  
22  
23 *Figure 15. Presence of rust on the pinned joint of the roof beam (Picture by the author, taken 22/05/2016).*

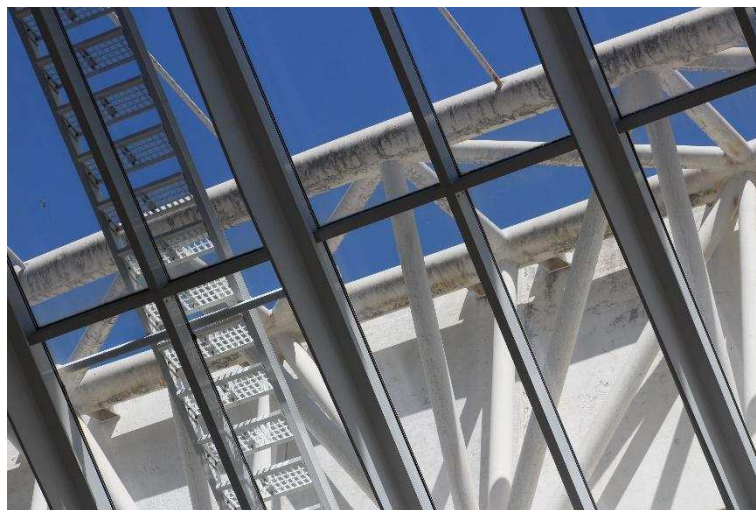
1 On the intrados of the curved beam and inside the cross bracing of the truss, large  
2 depositions of sulphur dioxide and oxides of nitrogen are visible from the inside of  
3 the church hall. Plaster detachment is visible on the wall against the steel truss (fig.  
4 16).

24  
25  
26  
27  
28  
29  
30  
31  
32  
33  
34  
35  
36  
37  
38  
39  
40  
41  
42  
43 *Figure 16. Presence of acid rain deposits on the roof beam and on the roof truss. Some rusted roof pendula are  
44 visible as well as the crumbling plaster behind the steel truss (Picture by the author, taken 22/05/2016).*

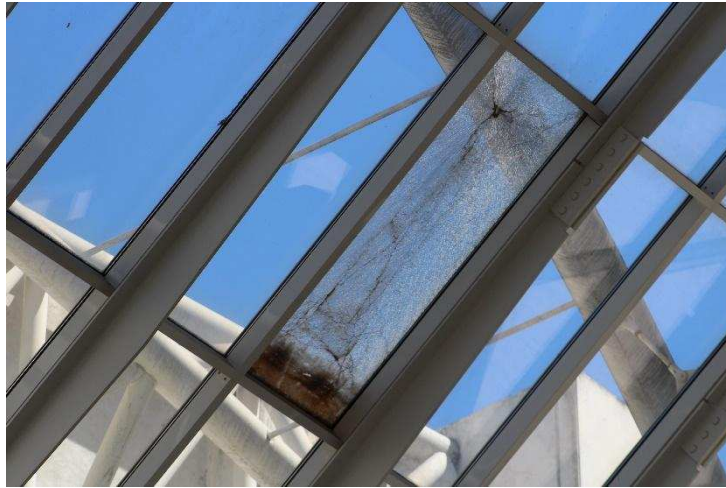
48 In April 2012, a seagull flying over the church dropped an object from its beak onto  
49 the glazed roof. The impact broke a glass panel which has not been replaced yet due  
50 to the high cost, unaffordable for a small parish on the outskirts of Rome (fig.17).  
51 The rest of the glass panels and their mullions and transoms are in good-shape.  
52  
53  
54  
55  
56  
57  
58  
59  
60  
61  
62  
63  
64  
65

Figure 17. A broken glass panel of the roof. truss (Picture by the author, taken 22/05/2016).

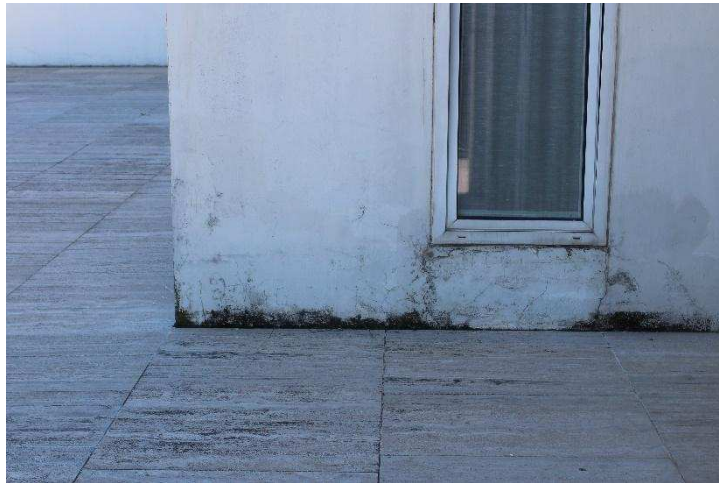
The sacristy and the altar are designed into a plastered block which encloses the space of the hall on the west side of the church. The volume is located half inside and half outside the church. The part protruding on the outside is bordered by the lowered floor acting as a temporary pond when it rains. In the construction detail, no waterproofing membrane, nor a stone skirting board, nor a linear drain were designed where the block meets the travertine floor. Therefore, the stagnation of the water has caused diffuse crumbling plaster and visible mould at the bottom of the block (fig.18).

Figure 18. Mold growth at the bottom of the block of the altar.

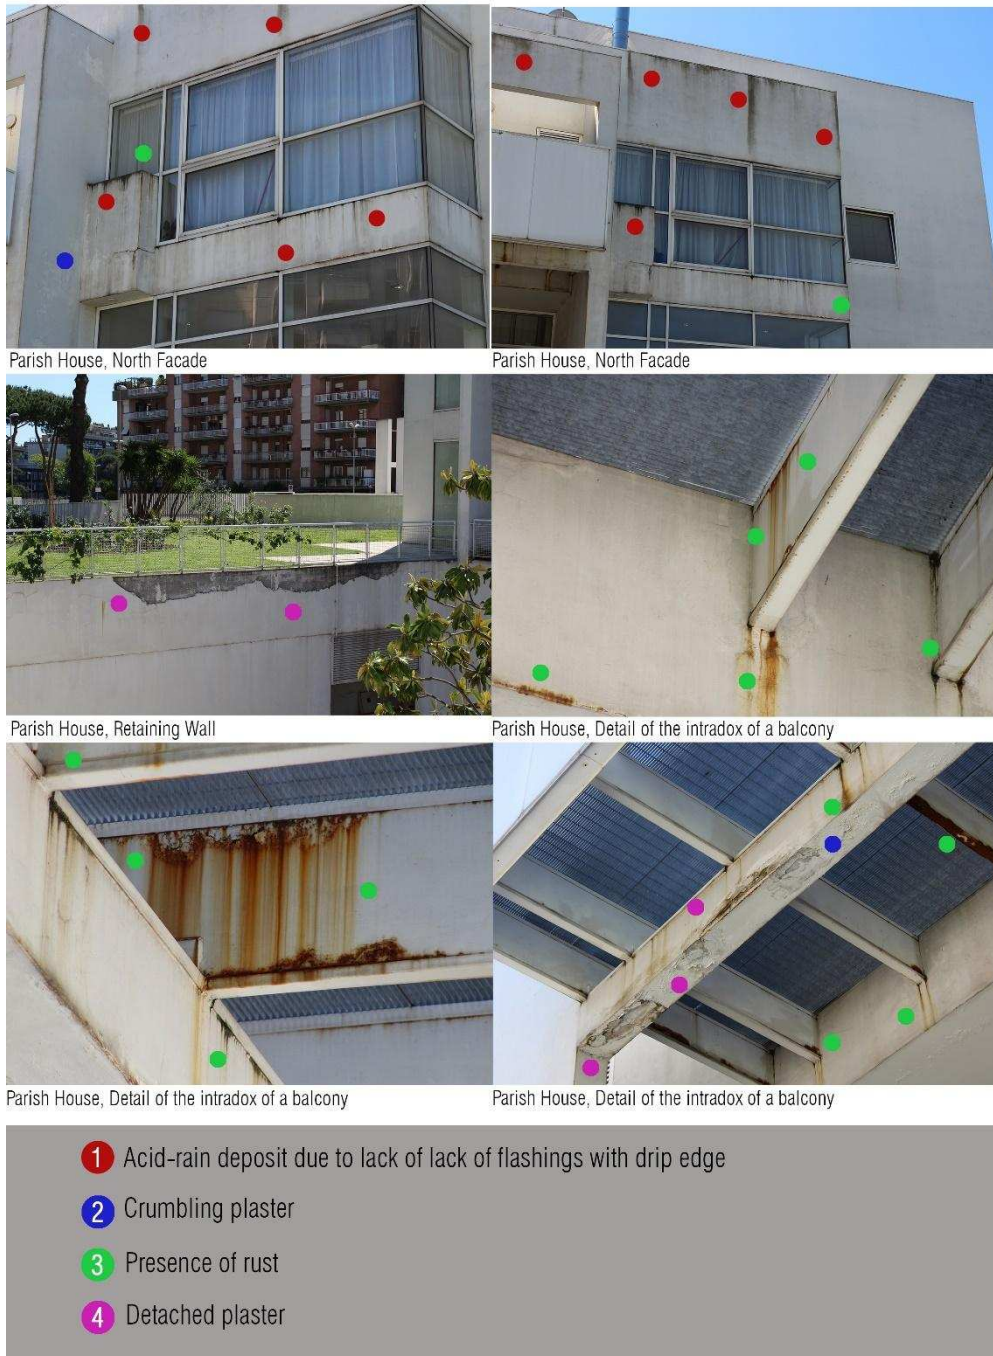
1 On the northern façade of the parish house several damages have occurred. The  
2 balconies are built with a system of exposed steel girders supported by a reinforced  
3 concrete beam, plastered with stucco. Due to a poor level of galvanisation, all of the  
4 girders are visibly rusted while the concrete beams have experienced severe  
5 crumbling and detachment of the plaster. As the floor of the balconies is built in  
6 metal grill, rain water falls directly on these structural members which have not been  
7 built with proper waterproofing elements.  
8

9  
10 The northern façade of the parish house is severely damaged by the lack of flashing  
11 with drip edges. The windows are aligned with the plastered wall and they are not  
12 protected either by being set back or by canopies. In addition, the flashing topping  
13 that there is on the façade does not protrude enough to protect the walls from acid  
14 rain. The result is the presence of diffuse stains from black particles all along the  
15 façade and around the frames of the windows. On top of the east side of the retaining  
16 wall bordering the lowered courtyard, designed to naturally light up the basement of  
17 the parish house, extensive portions of detached plaster are visible. Again, this is due  
18 to a poorly designed drainage system and poor execution (fig 19).  
19  
20  
21  
22  
23  
24  
25  
26  
27  
28  
29  
30  
31  
32  
33  
34  
35  
36  
37  
38  
39  
40  
41  
42  
43  
44  
45  
46  
47

Figure 19. State of decay of the northern façade of the parish house truss (Picture by the author, taken 22/05/2016).
