THE INVESTIGATION OF
THE CAUSE AND
SEVERITY OF
CORROSION AT THE
PORT OF DOVER

Thesis Submitted For The Degree Of Research Masters In
Chemistry At The University Of Kent

Abstract

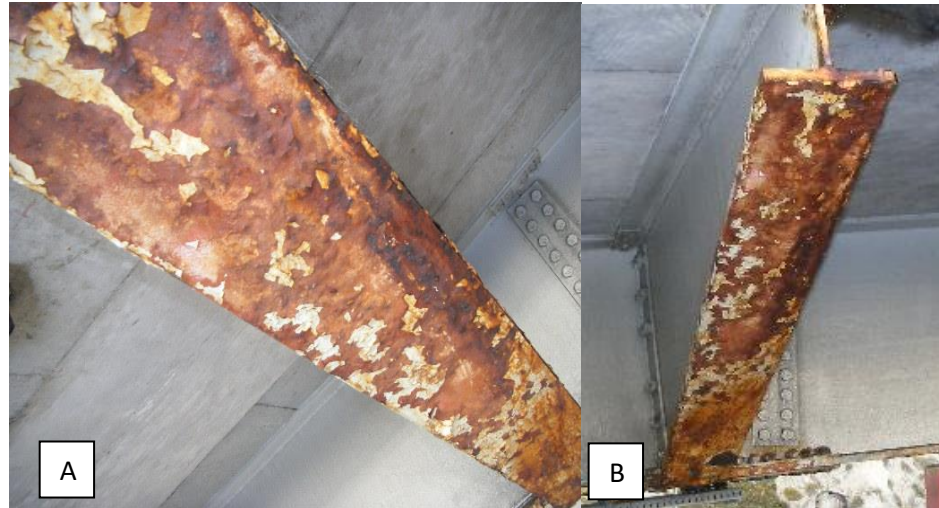
Figure 15. Sample site 1, A is before sampling and B is after sampling.

The initial visual inspection of sample site one shows a very clear discolouration of the paint layer, with raise lumps underneath the paint. After sampling heavy discolouring was observed under the metal. **Figure 15** below shows before and after sampling.

The extent of corrosion is not graded as severe but, it is obvious that corrosion has taken place. At this site the paint layer is still visible. Hence corrosion appears to have taken place beneath the coating itself. This type of corrosion is referred to as, under-rusting, when the corrosion takes place between the paint and the metal.

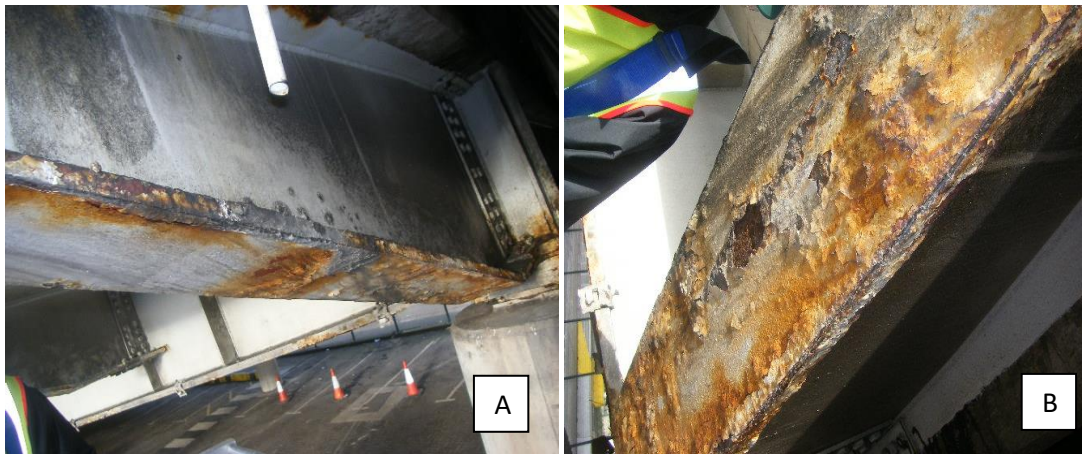
Figure 18. Before(A) and after(B) sampling of sample site 2.

The corrosion here is not very severe (in **Figure 18**) but there is visible corrosion, which has occurred beneath the coating. In both **Figure 18A** and **B** the paint is peeling away from the steel. The types of corrosion visually observed are filiform, due to the raised lumps, uniform corrosion underneath the coating of the steel and exfoliation, which occurs parallel to the surface and along grain boundaries. Exfoliation forces the metal away from the metal in thin sheets.

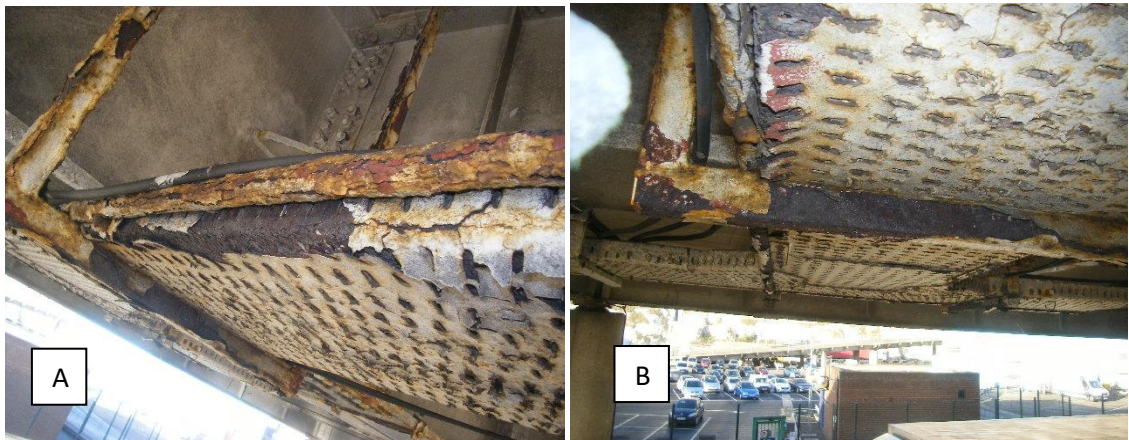
Figure 45. Before(A) and after(B) sampling of sample site 11.

Sample site 11 has more corrosion than sample site 10 but is next to it as seen in **Figure 14**.
