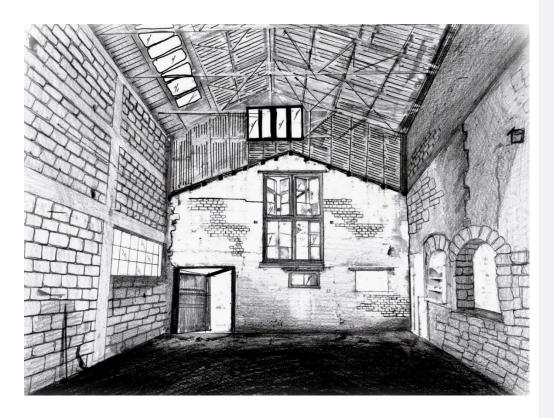
Fig. 8. Preliminary hand sketches showing the 'patch-work' of construction styles.

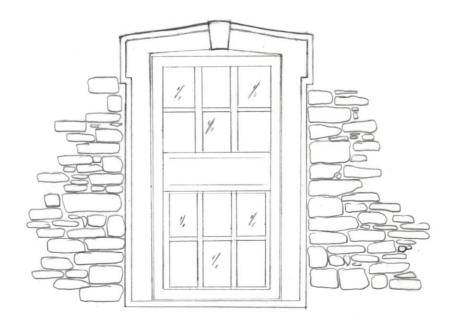
Fig. 9. Preliminary hand sketches showing construction details.

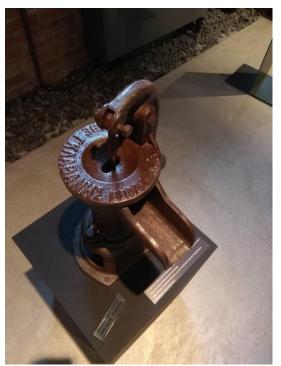
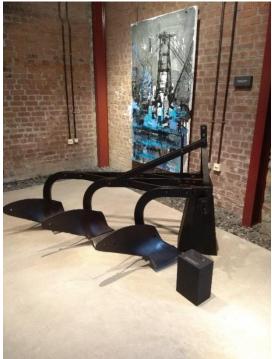
Fig. 10. Farming Plough and Water Pump (final products) constructed by Glavanis Ironworks. Thought to date to the 1920s.

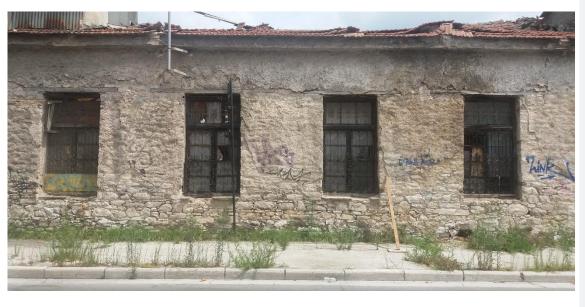
Fig. 12. The Machine
Shop, view from
Papadiamantis Street.
Note the load bearing
structure of the Machine
Shop which belongs to
one of the earliest
surviving assets on site.

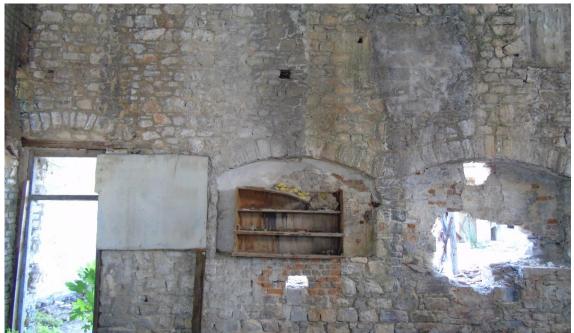
Fig. 13. Foundry Workshop, view from the interior.

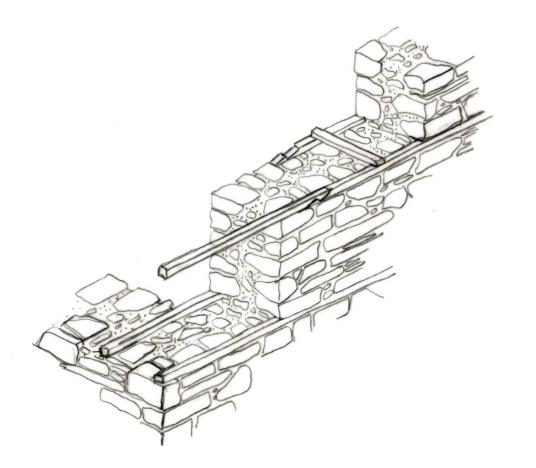
Fig. 14. Sketch showing the masonry construction: randomly placed stones set in earth mortar bound at intervals by horizontal or vertical timber tying grids (with an infill of brick).

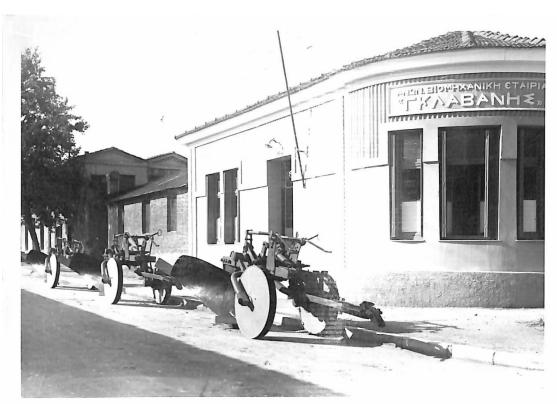
Fig. 15. (left) Photograph taken in 1960 for promotional and advertising use, illustrating both the industrial premises and the products.

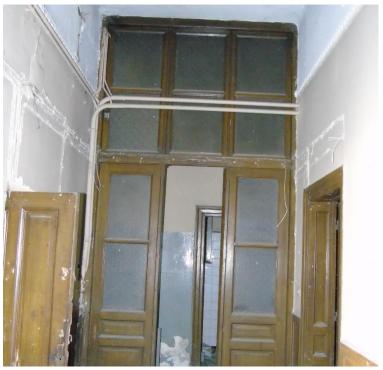
Fig. 17. Intact interior decoration including woodcarvings on the doors, shutters, and partitions.

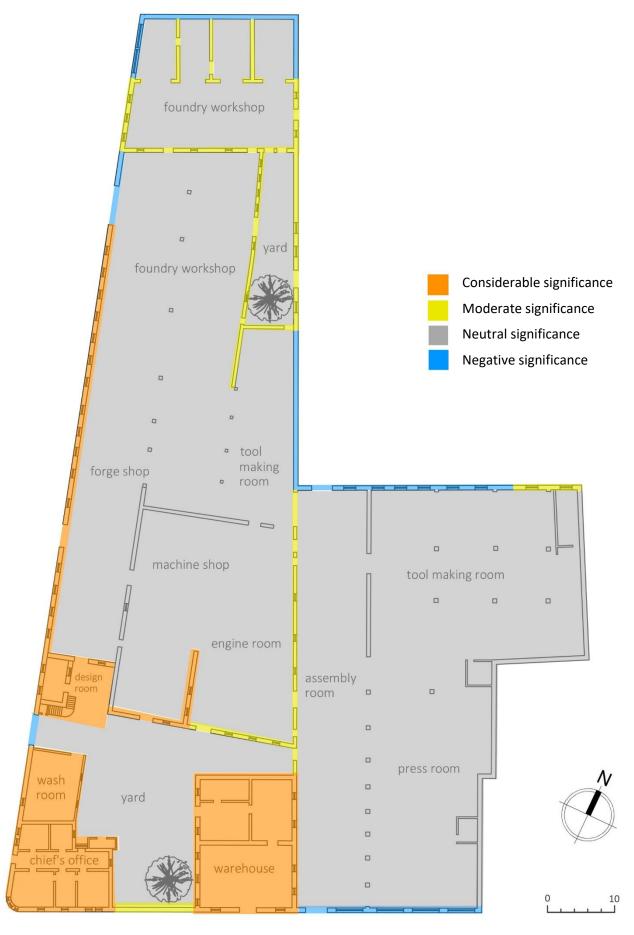
Fig. 33. Mapping the level of significance Source: M. Dimitriou 2019

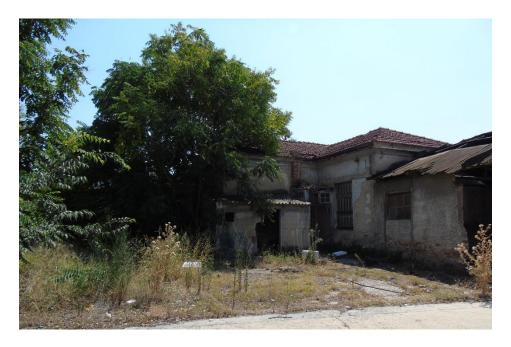
Fig. 34. Vegetation growing on the plot and out of the historic fabric could also lead to further structural deterioration.

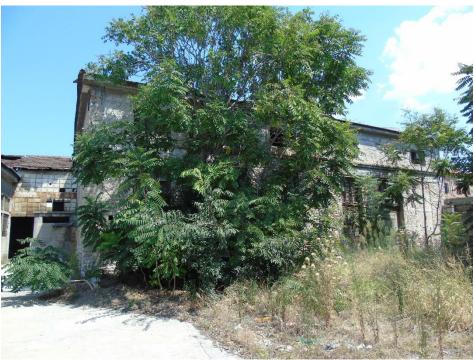
Fig. 35. The walls are generally sound, but vegetation may cause further degradation.

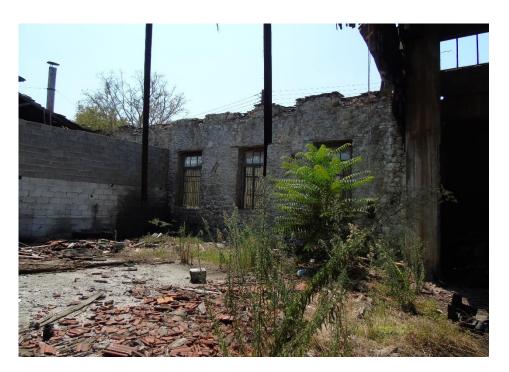
Fig. 36. Many of the current buildings have no roof or covering, which makes them vulnerable to the weather conditions.

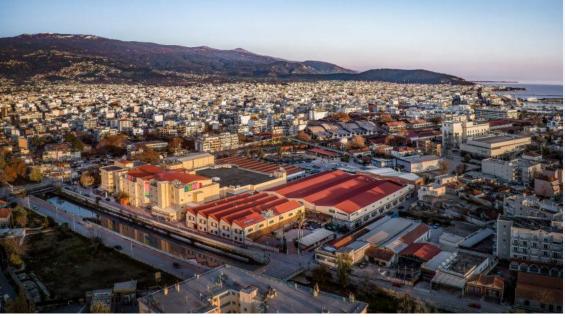
Fig. 47. Papageorgiou
Textile Factory - Loulis
mill converted into an
entertainment centre
'Village Centre' – after.
Following reconstruction,
the saw-tooth roof has
been maintained and is
among the very few
features that could
remind us of the historic
site.

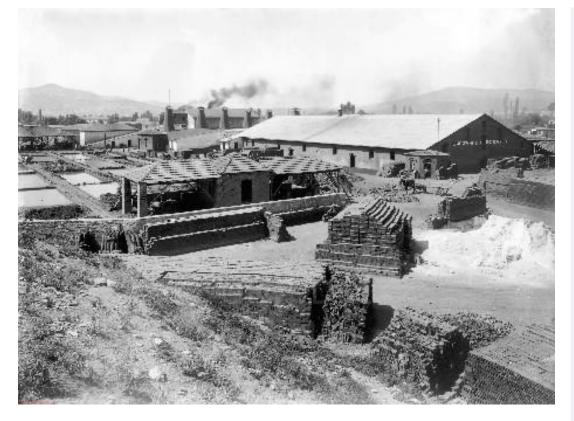
Fig. 48. The Tsalapatas Rooftile and Brickworks Factory – before.

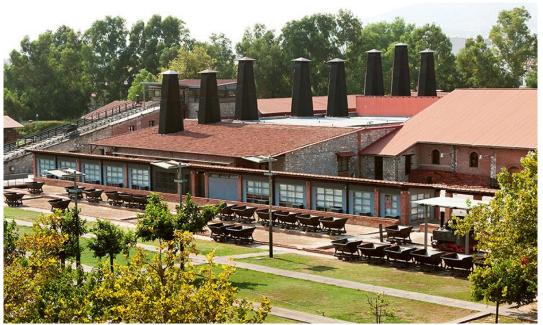
Fig. 49. The Tsalapatas Rooftile and Brickworks Factory transformed into an industrial museum and cultural centre – after.

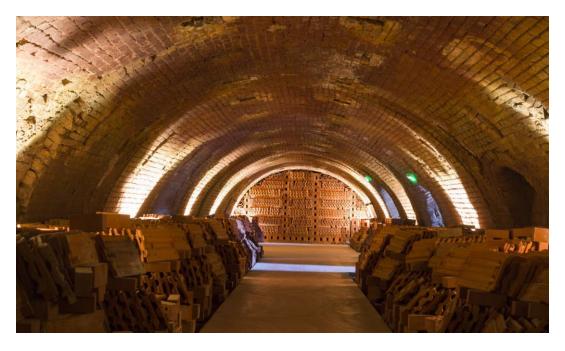
Fig. 50. The imposing Hoffmann kiln remains a factory installation and is among the best-preserved features.

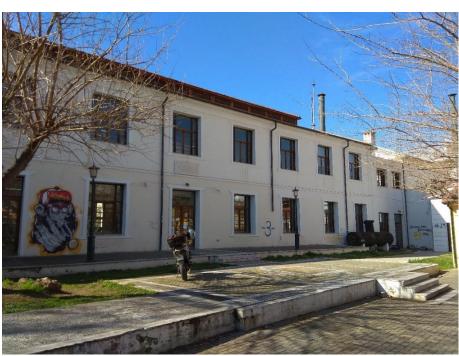
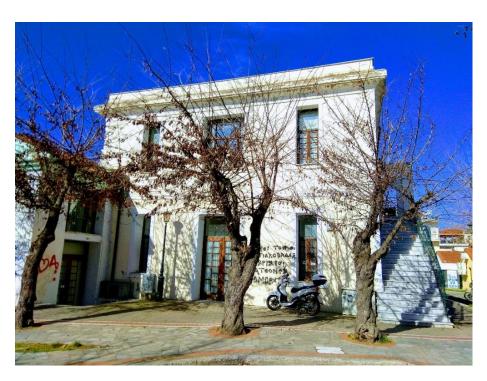
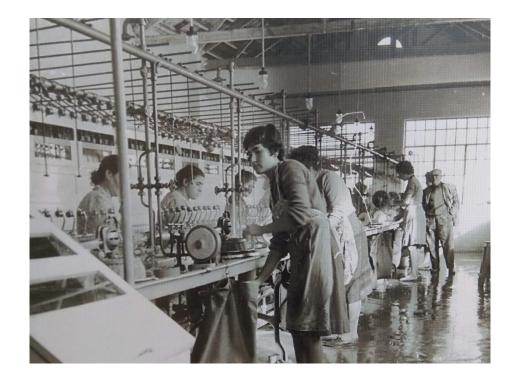
Fig. 52. The Silk Factory Etmetzoglou is among the very few cases where industrial machinery survives intact and remains as an exhibit.

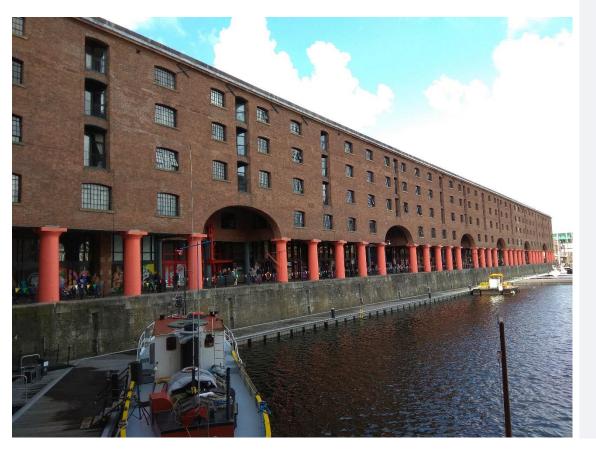
Fig. 54. Conversion of part of one warehouse stack into the Tate Liverpool by James Stirling, Michael Wilford, and Associates.

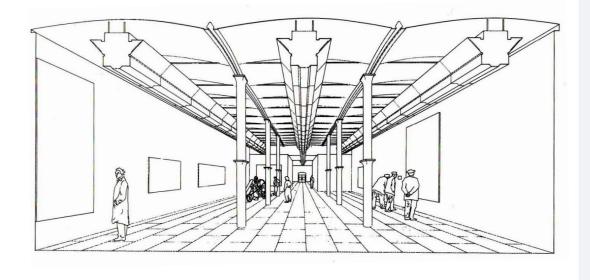
Fig. 59. In the Tate
Liverpool galleries,
ventilation duct and
lighting units are
combined, providing all
the gallery services
without altering the
existing building fabric.
