Heritage Conservation and Tourism Development in
Vernacular Settlements: The Case of Dana Village in
Jordan

A thesis submitted for the degree of Doctor of Philosophy

Kent School of Architecture and Planning

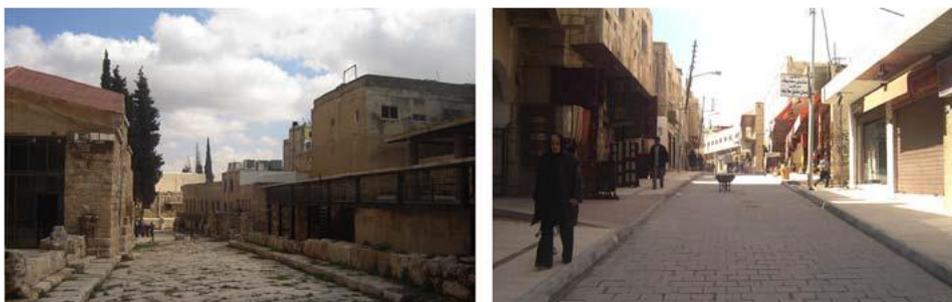
Figure 4.5: The stone pavement as appears in the mosaic churches surrounding the Roman Cardo (left) and the imported style of pavement as occurred in a recently regenerated street in Madaba (right) (Al Rabady 2013)

Four urban centres were the target of such concept, including Amman, Al-Salt, Irbid, and Madaba. Madaba was regenerated to become an active tourist destination in Jordan. The emphasis was on preserving the ‘high-profile’ tangible heritage while neglecting the intangible heritage, leading to superficial improvements to the quality of Madaba’s spaces (Al Rabady 2013). For instance, the stone pavement of pathways and streets was transformed into a new style imported from outside (**Figure 4.5**).

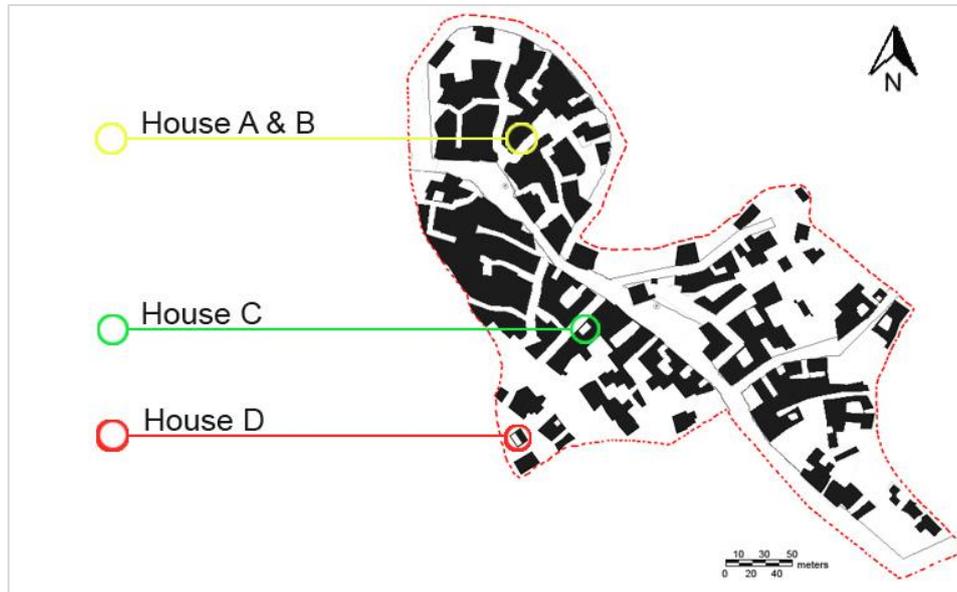
Figure 5.4: Location of the houses that represent the house typology of Dana village (Author 2019)

these three types, with (A) and (B) representing the single-space houses; (C) the courtyard houses; and (D) the front-yard houses (**Figure 5.4**).

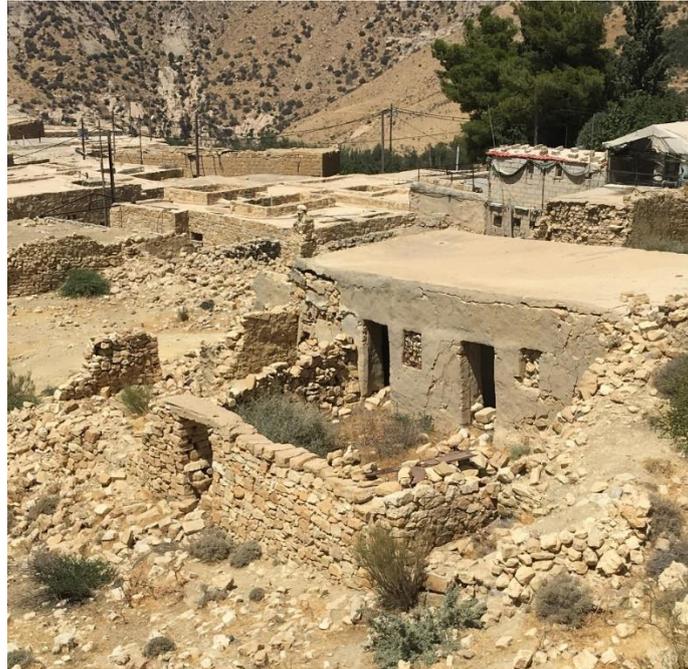
Figure 5.9: Current situation of house D, showing the clad walls and shut windows (Author 2019)

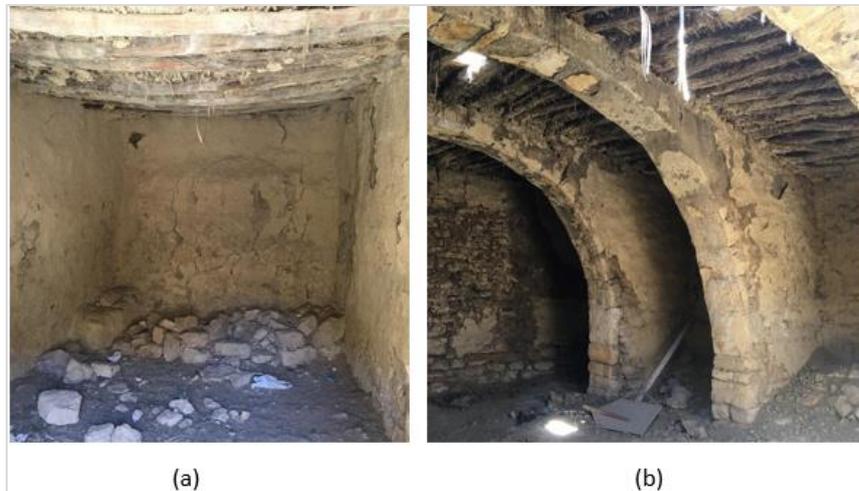
Figure 5.10: Current situation of houses A and B, showing how they were left to ruin after they were abandoned (Author 2019)

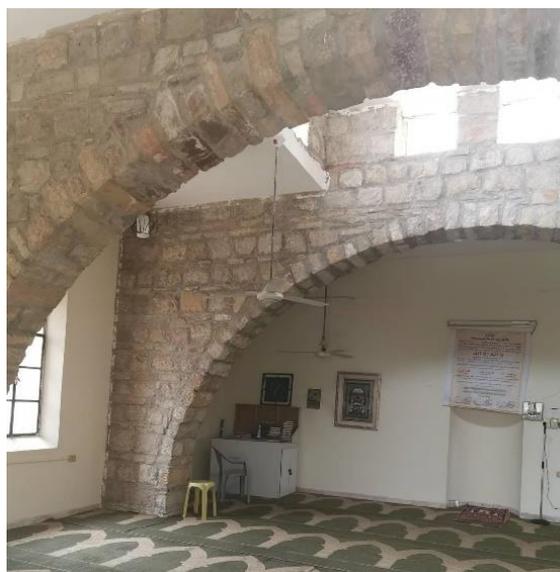
Figure 5.14: The added clerestory windows and 'Mihrab' of Dana Mosque (Author 2020)

The arches divide the interior into three spaces: the entrance space, the 'Mihrab' space, which contains the first two prayers rows, and the middle space, which contains the clerestory windows. The eight clerestory windows located at the centre of the mosque were built to allow sunlight to enter the indoor space (**Figure 5.14**). From the outside, the mosque is surrounded by a yard which was added to provide outdoor facilities, such as a planting area, ablution area, WC, and the Imam's house. The yard of the mosque has two entrances because of the different levels; one from the car park and one from the pedestrian way at the lower level.

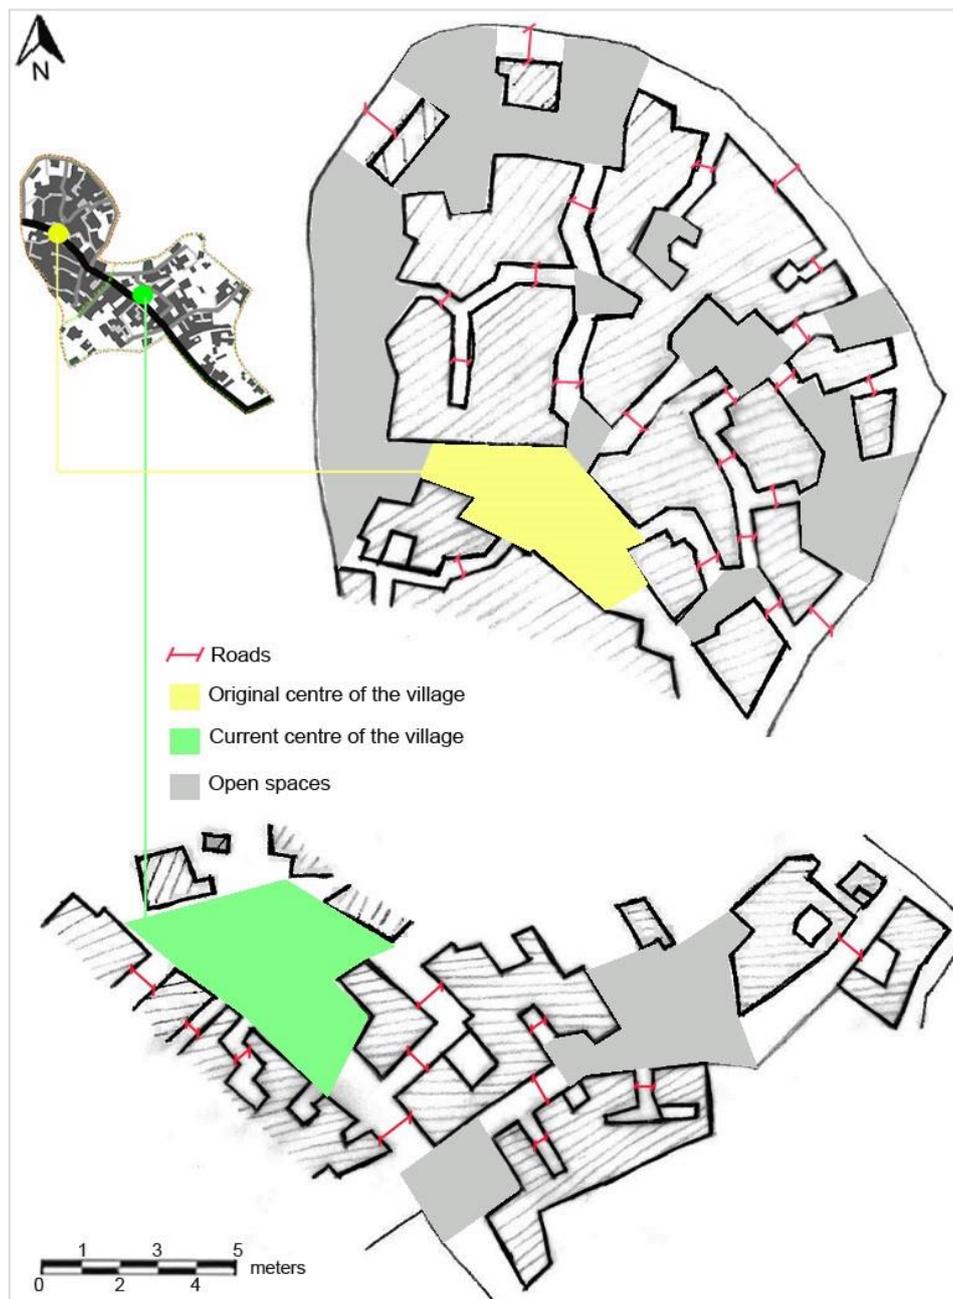
Figure 5.19: Urban open spaces in the upper and lower parts of Dana village (Author 2019)

(Figure 5.19). The local community used to take part in recreational activities in the neighbouring roads and open spaces due to the limited space in the houses, such as gatherings, celebrations, and cooking. The streets, roads, and open spaces were used as public spaces for socialising in addition to transportation, due to the low volume traffic and the lack of planned public transportation networks.

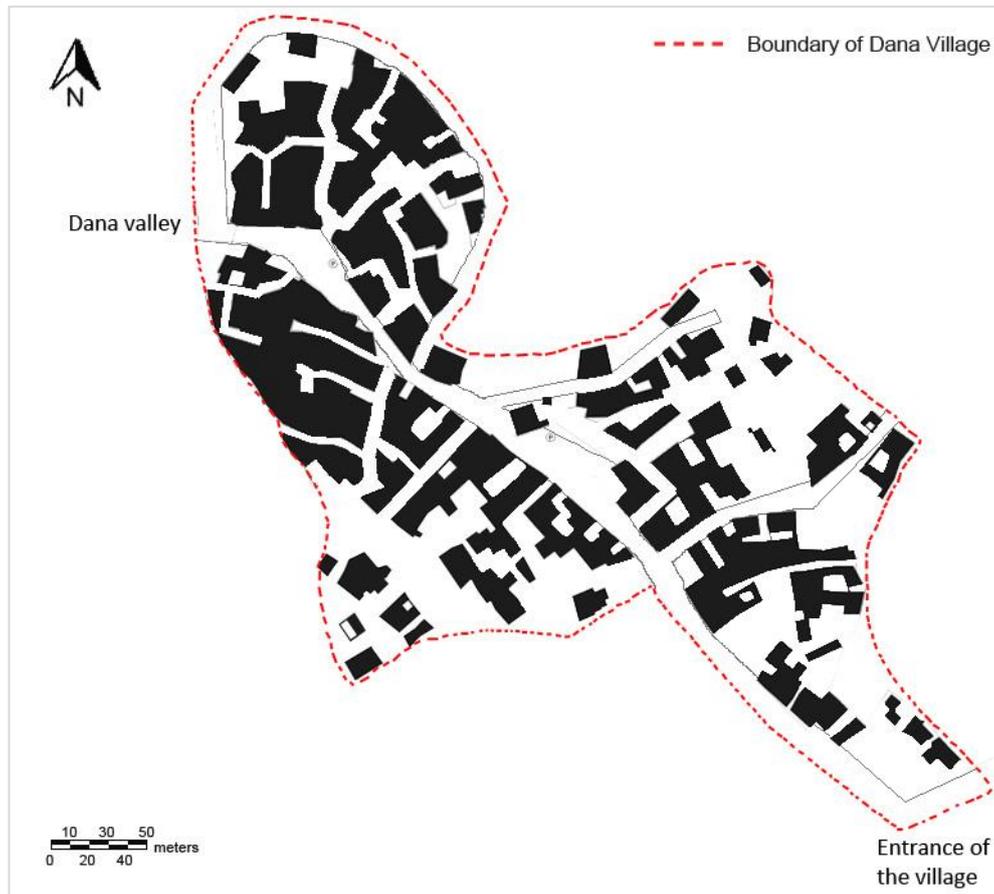
Figure 5.20: Figure Ground Plan of Dana Village (Author 2019)

Dana village reflects the harmony of its urban fabric with the surrounding natural environment and the geological features. By the end of the 20th century, the built-up area occupied 65% of the total village area; the public open spaces occupied 20%; while streets, roads, and pathways covered the remaining 15% (**Figure 5.20**). The figure ground plan received no changes

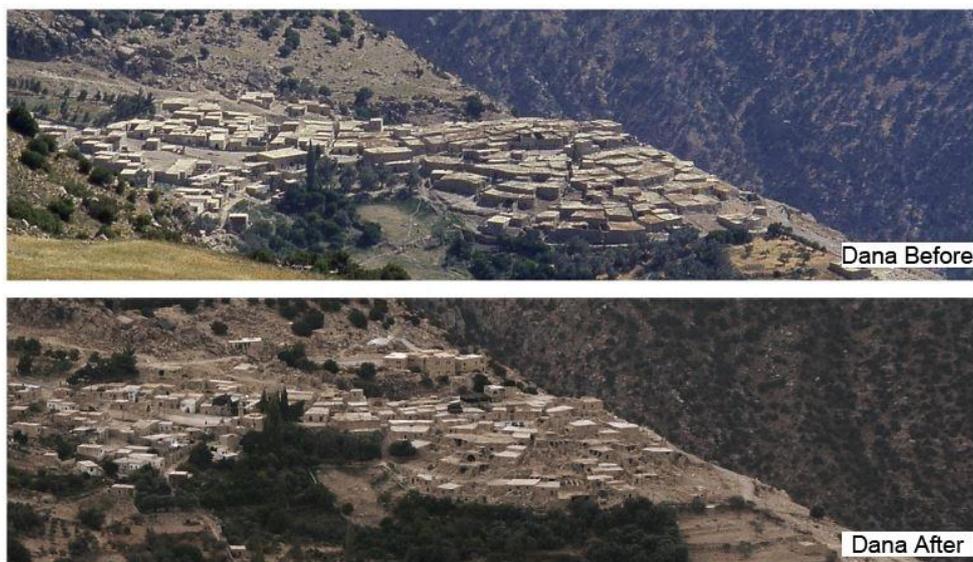
Figure 5.21: Dana village in the 1930s before it was abandoned (top), and at the end of the 20th century after it was abandoned (bottom) (Archive, RSCN 2019)

By the end of the 20th century, due to abandonment, most buildings deteriorated as some parts collapsed, such as roofs and arches (**Figure 5.21**). Approximately 45% of Dana's buildings had collapsed roofs, and more than 80% of the house roofs had deteriorated and needed restoration. The RSCN claimed that fewer than 20% of buildings were in good condition, only taking into consideration if the buildings were used or occupied (Alhasan 2019). Indeed, the buildings in use had a better chance of surviving, while the abandoned buildings tended to deteriorate rapidly. The RSCN explained that even if there were no problems with the roofs and walls, their integrity would be affected over time due to their abandonment. Not only would the integrity of roofs and walls be affected, but also that of the plaster, pavement, doors, and windows, which are essential elements that also need to be conserved.

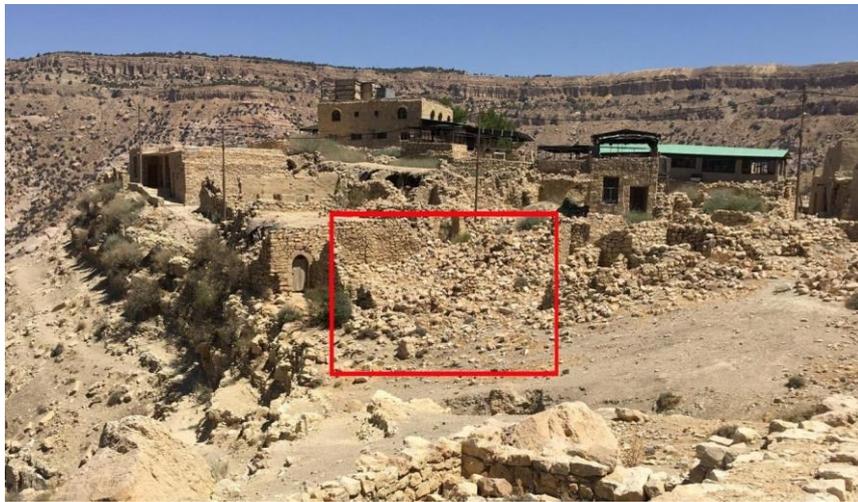
Figure 6.2: Demolished roof and walls of a totally ruined building (Author 2019)

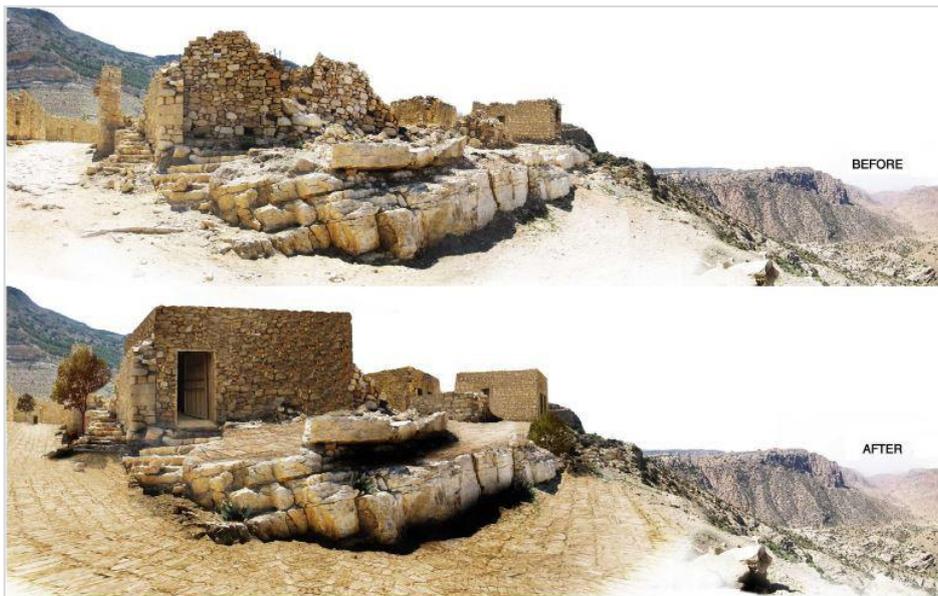
Figure 6.3: A building before the rehabilitation project, showing the wall borders in bad condition (upper), and the building after it was totally restored (lower) (Archive, RSCN 2019)

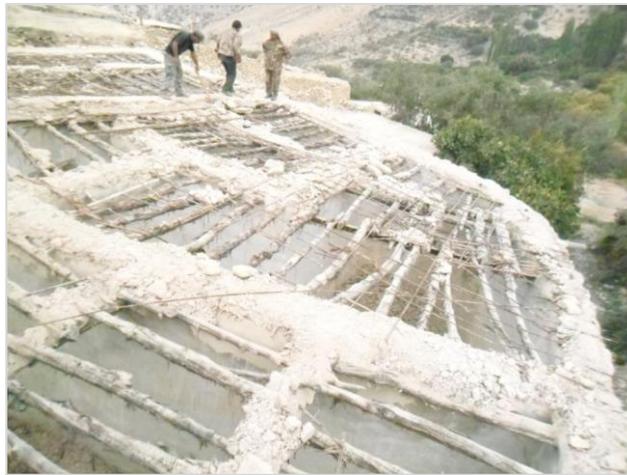
Figure 6.4: Original roof of timber beams and canes before being removed (Archive, RSCN 2019)

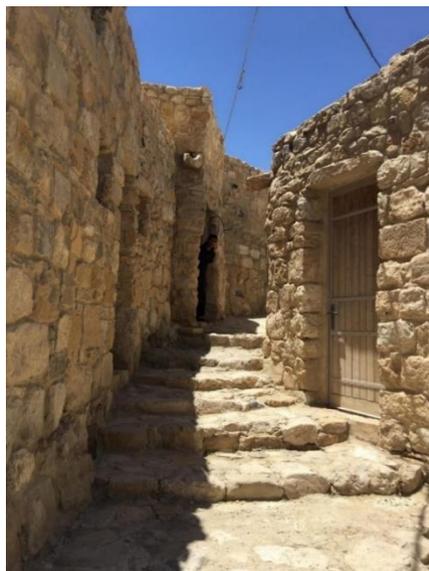
Figure 6.7: Rubble stone masonry facades of the restored buildings (Author 2019)

The rubble stone masonry and irregular horizontal courses of the original buildings were conserved in the restored buildings. The stone masonry was either left without being repointed or repointed with cement mortar to avoid insects and reptiles. The suitable proportions of cement mortar were as follows: 1 unit of white cement to 2 units of fine powder to 2 units of Dana village soil (Naanaa 2019). Plastering the external faces of stone walls was prohibited, as permitted use of roughcast or smooth plaster was limited to the internal wall faces (**Figure 6.8**).

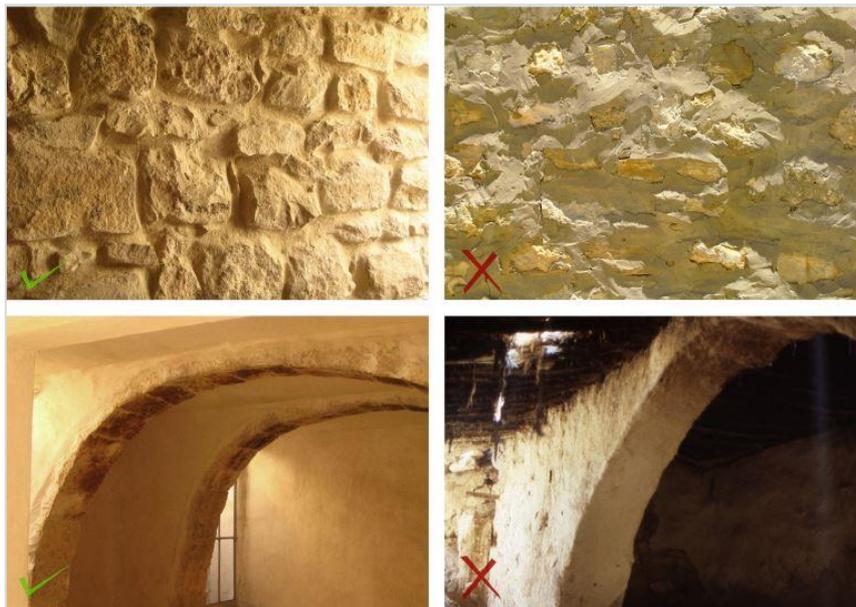
Figure 6.8: Permitted and prohibited external and internal wall plaster (Archive, RSCN 2019)

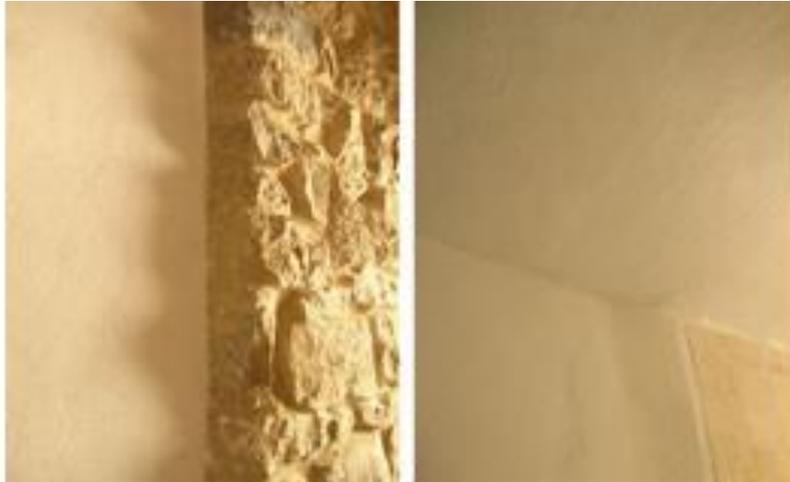
Figure 6.9: Permitted new finishing of the internal wall face (Archive, RSCN 2019)

To finish the internal wall faces, some were left without plaster, leaving the inner face of the stone exposed. These walls were repointed with cement mortar whose colour was the same or close to that of the stone. However, most internal walls were plastered using either roughcast or smooth plaster, again with the same or similar colour to the stone; it is forbidden to use plaster with exaggerated textures. Like Dana's rebuilt roofs, the painting was done with white 'sheed' paint on the interior walls because it is free of lead, anti-

insect, and affordable (**Figure 6.9**). In contrast, the internal arches were conserved by not removing them, nor changing their texture or covering them with plaster or painting.

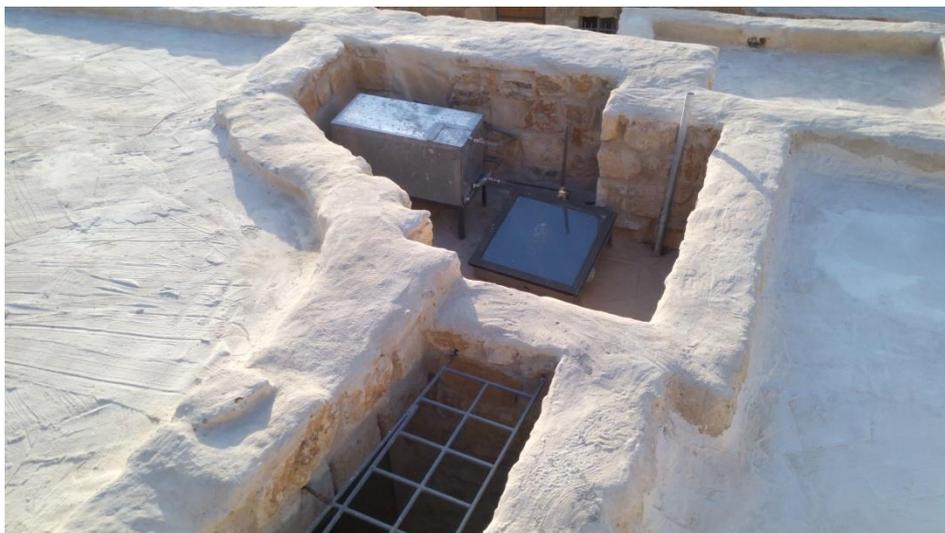
Figure 6.11: Recess in the roof to hold the water tank and any other elements that are usually placed on the roof (Author 2019)

Each restored building was connected to a manhole, which is a part of the sewage network, to dispose of wastewater. Further changes were also implemented as a result of placing several elements on the roofs of the buildings that had not been used previously. For instance, water tanks were installed after the village was connected to the water supply network. Solar panels were also installed for sustainability and energy-saving reasons. Therefore, the RSCN proposed a solution to hide the added water tanks and any other elements in a way that conserved and did not distort the general image of the village. The solution invented recesses in the roofs in which to place and hide the water tanks and any other added elements, respecting the village skyline (**Figure 6.11**).

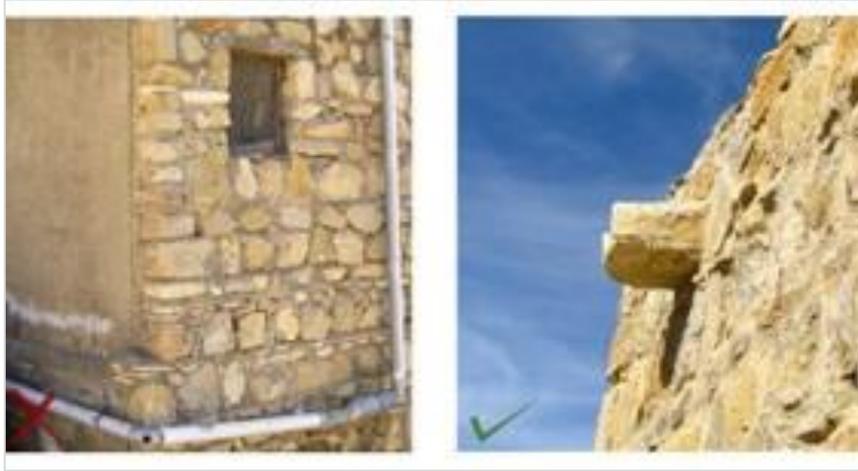
Figure 6.13: Prohibited rain gutters visible on the external walls (left); permitted gutters (right) (Author 2019)

The rain gutters are hidden in the external walls because they should not be exposed to the outside. It is not allowed by the RSCN to install elements on the external facades because they would ruin the harmony and general image of the village. Alternatively, stone gutters that are consistent with the village architecture were used to direct the rainwater away from the external wall faces (**Figure 6.13**). These interventions were required to meet the needs of transforming Dana's houses into hotel rooms and to complete the functionality of the added indoor facilities, including the bathrooms.

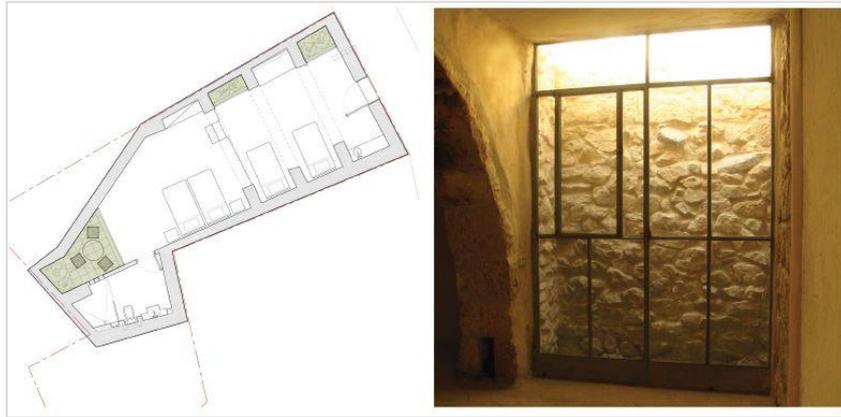
Figure 6.14: Shafts devised for lighting and ventilation (Archive, RSCN 2019)

Furthermore, new lighting shafts were created to provide more lighting and better ventilation (Naanaa 2019). The lighting shafts that were devised aimed to keep the inward orientation of buildings and maintain the privacy and visual image of the village while improving the lighting and ventilation of the indoor spaces. The addition of the lighting shafts succeeded in this respect, representing an approach to adapting the restored buildings with new uses that required more lighting and better ventilation. They were composed of a rectangular opening in the roof, a glass wall on one or two sides, stone walls on the other sides, and a paved or planted floor (**Figure 6.14**).

The lighting shafts were inspired by the work of Hasan Fathy and Rasem Badran, who demonstrated the significance of windcatchers in bioclimates such as that of Jordan. Windcatchers are used to catch wind from outside the building and transfer it into interior spaces (Badran 2003; Suleiman and Himmo 2012). Similarly, the introverted lighting shafts bring air and light from outside to the indoor area (Naanaa 2019). To achieve suitable natural lighting in each room, the RSCN claimed that the glass area, which brings the sunlight into the indoor spaces, should be no less than 2 m² per room, and the

opening area in the roof should be no less than 1.5 m² for each room. Moreover, the rainwater drainage was treated in some shafts by rainwater soakaways and in others by planting floors to prevent flooding and waterlogging.

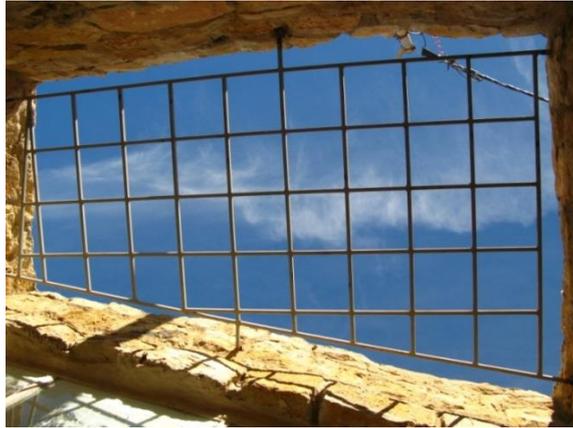
Figure 6.15: Shaft protected with security and safety bars (Archive, RSCN 2019)

Within the last few years, the RSCN claims that there have been no problems with the rainwater because the area of the roof openings is not large, and the average rainfall does not exceed 300 ml/year (Naanaa 2019). Nevertheless, some shafts are covered from the top with transparent sheets to prevent rainwater from entering them in winter. Security and safety bars were added to the roof opening to maintain privacy and safety (**Figure 6.15**). Artificial lighting was also added to the shafts to lighten them at night. This gives a distinguished light effect on the stone walls, which some tourists described as built-in candles (**Figure 6.16**). As a consequence, the shafts became one of the features and best attributes of the restored buildings, representing an example of how new interventions can add to the character of a village without disrupting it.

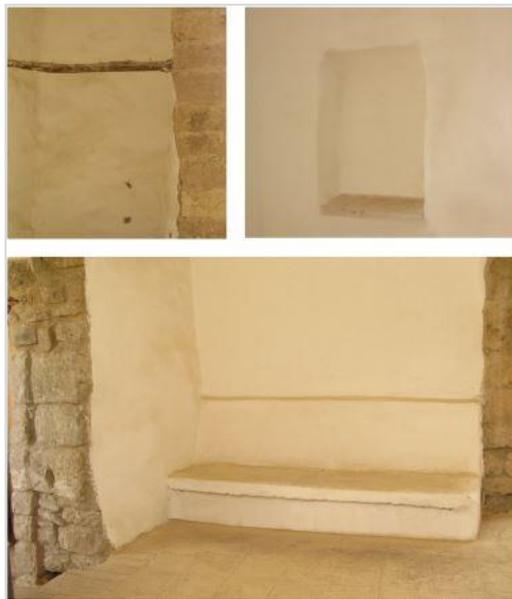
Figure 6.18: Permitted built-in furniture (Archive, RSCN 2019)

The approach adopted to restoring the internal arch wall was by removing the arch wall or any part of it after giving each piece a number for it to be rebuilt in the same place. A timber framework was used to support and reconstruct

the internal arch walls. Furthermore, the original built-in furniture was restored as much as possible, such as stone shelves and juniper tree trunks. The furniture was built in close proportions to the original, including seats and shelves attached to the walls and floors of the interior space (**Figure 6.18**). In addition, wooden furniture was installed in colours that were the same or close to the colour of the village stone. Furniture was made of simple designs and natural materials, as plastic furniture (chairs and tables) is not allowed.

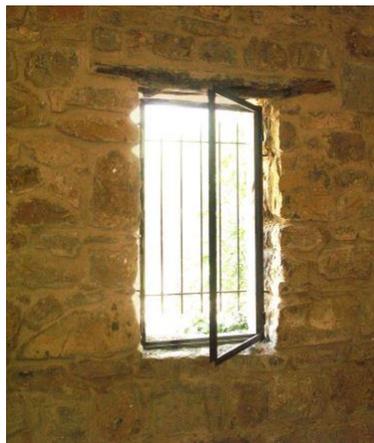
Figure 6.20: Enlarged window in a totally restored building (Author 2019)

Providing natural lighting and ventilation was one of the most critical issues in the transformation process of Dana's openings, especially the hotel rooms (Naanaa 2019). In the case of partial restoration, the structural openings were restored closely following the proportions of the original openings. On the other hand, in the case of total restoration, the structural openings were enlarged to provide more lighting and better ventilation, while keeping the original proportions to avoid any extraneous details that were inconsistent with the short stone lintels of the original openings (**Figure 6.20**).

original size and proportion of the windows and buildings. In each case of buildings, windows were proportionally enlarged up to a certain limit due to the different parameters of each building (Naanaa 2019). As a result, it was challenging to maintain the original window proportions while improving daylighting. In some buildings, therefore, the windows were enlarged with different proportions, or additional windows were added. Both solutions were somewhat problematic.

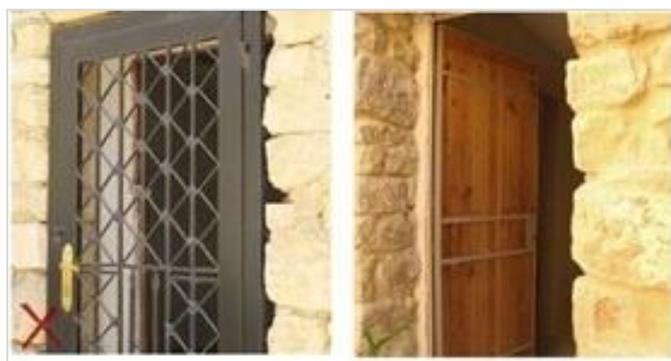
Figure 6.21: Prohibited (left) and permitted (right) materials and colours of the new doors (Archive, RSCN 2019)

Changing proportions and adding windows are contradictory to the conservation of vernacular architecture (Šiožinytė and Antuchevičienė 2013, p. 876). This means that new types of windows and different facades not in-keeping with the original ones would appear. This was not a good solution, at least from an aesthetic point of view. Moreover, the doors were made of steel core and covered with an additional layer of juniper wood. Aluminium doors were prohibited for both the restored and new buildings (**Figure 6.21**).

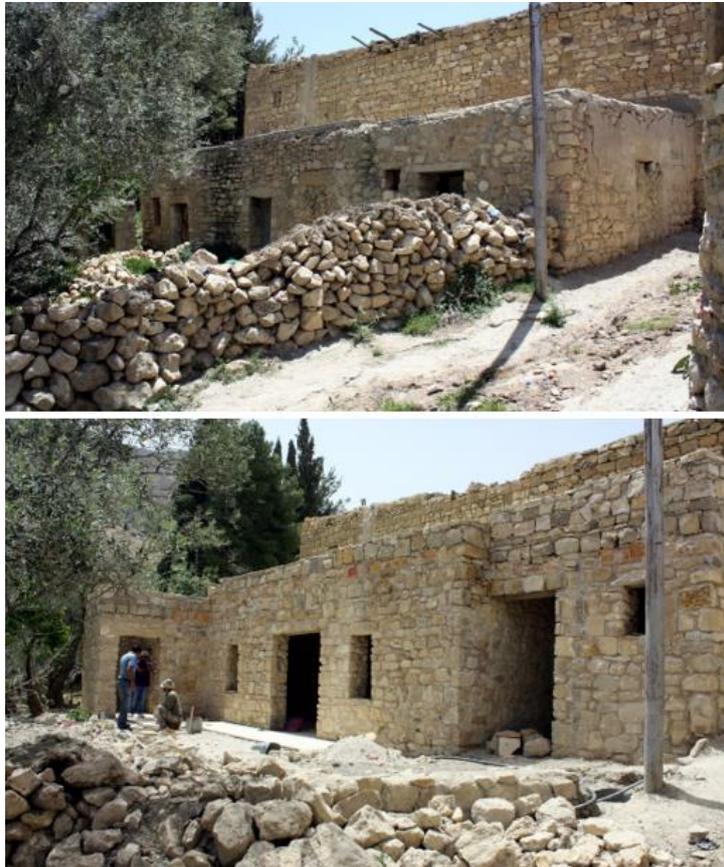
Figure 6.25: Original facade of a building in Dana before transformation (top), and new facade after transformation (bottom) (Archive, RSCN 2019)

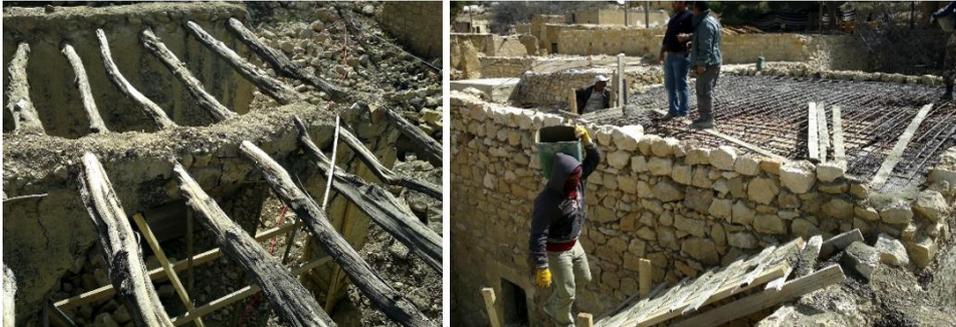
Figure 6.26: Replacement of the original timber roofs (left) with new reinforced concrete ones (right) (Archive, RSCN 2019)

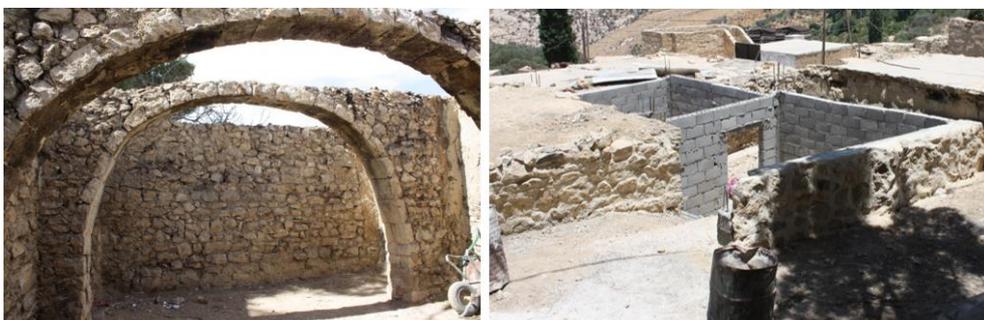
Figure 6.27: Replacement of the original bearing masonry walls (left) with thinner non-bearing ones (right) (Archive, RSCN 2019)

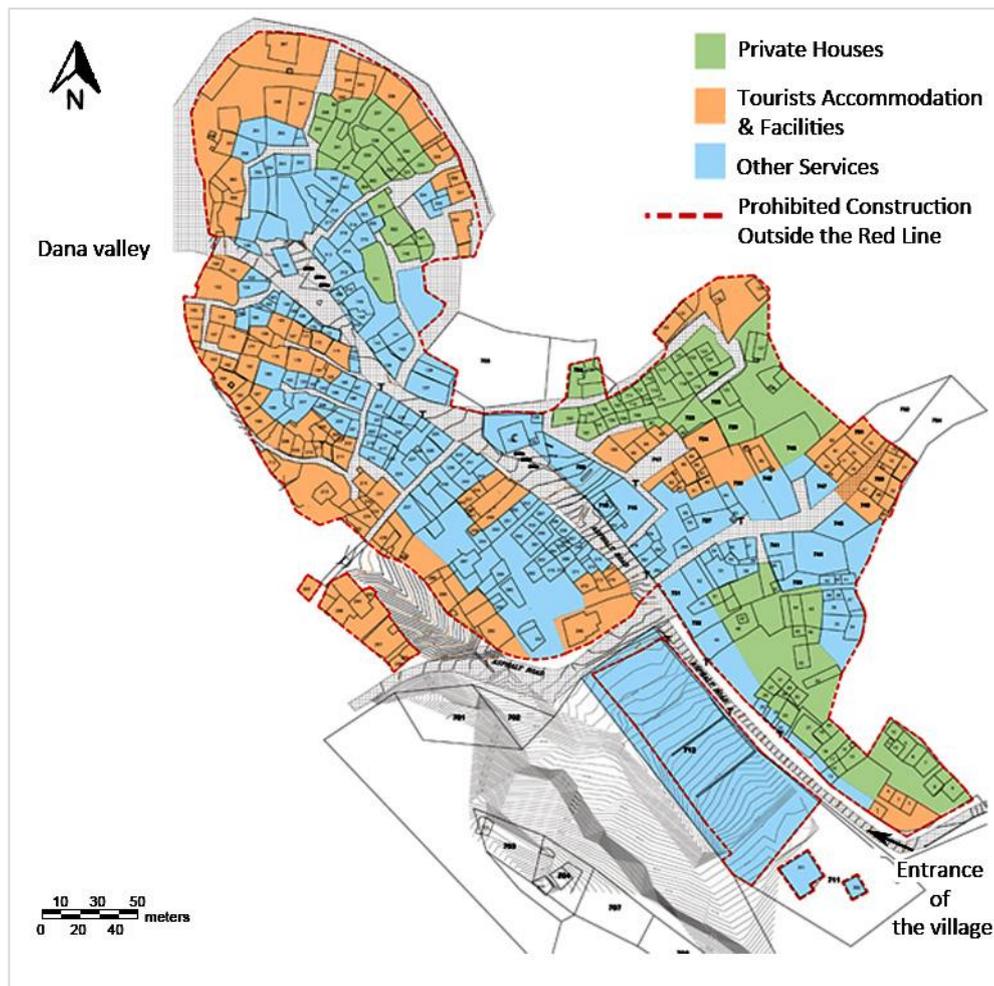
Figure 7.1: Land-use master plan that illustrates the proposed new uses of the whole village (Archive, RSCN 2019)

Ammar Khammash engineering consulting office proposed a new land-use master plan, including all stages of the rehabilitation project (**Figure 7.1**). This proposal resulted from an in-depth analysis of the built environment situation, the hotels presently in operation, the needs of the local community, and the requirements of sustainable ecotourism development. The general aim was as far as possible to restore the original form of Dana's urban pattern and vernacular houses by adapting their uses into private, tourist, cultural, and other activities.

Approximately 20% of Dana’s buildings were private houses, 30% hotel rooms, while 50% were commercial shops and mixed-use buildings (commercial and residential). The proposed land-use plan divided the village into three categories: tourist accommodation and facilities, private residential use, and other services. The three categories were equally distributed in the north-eastern and north-western zones, while the southern zone contains just tourist accommodation and facilities and other services.

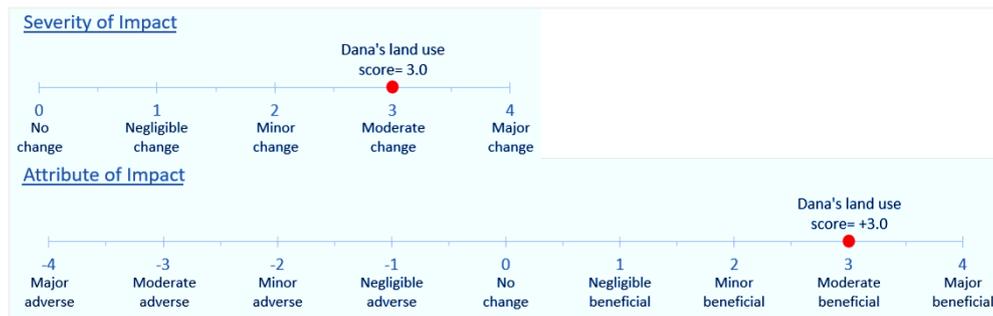
Figure 7.5: Severity of impact (top) and attribute of impact (bottom) of transforming Dana’s land use (Author 2022)

Table 7.1 and **Figure 7.5** illustrate the HIA of transforming Dana’s land use and the final results of calculating the severity of impact and the attribute of overall impact. The results conclude that the transformation of the land use led to significant socio-cultural and economic benefits, following the revival of the abandoned houses and reusing them as hotel rooms that bring income to the local owners. Overall, the adaptive reuse of Dana, presented in the current land use, reconciled the conservation of Dana’s heritage with the recent tourism development.

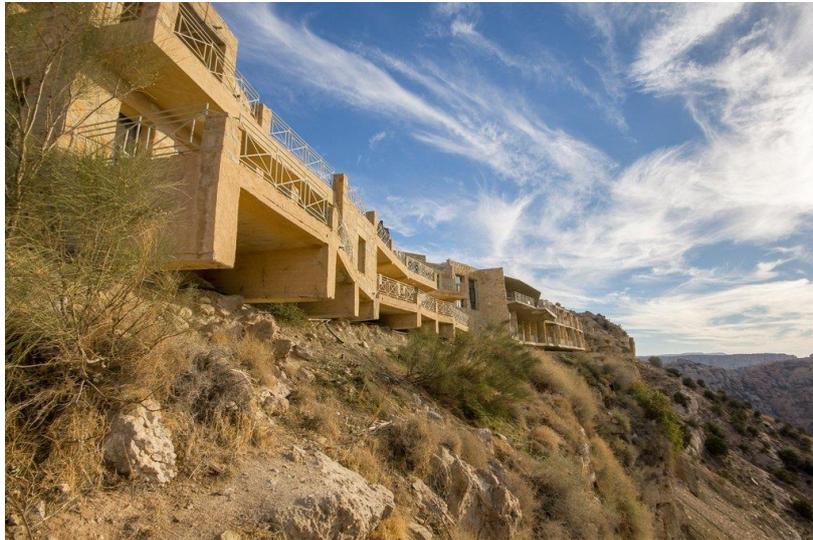
Figure 7.7: Dana guesthouse over the edge of Dana valley (Author 2019)

Starting with buildings for tourist accommodation, Dana guesthouse is a new hotel established by the RSCN to accommodate tourists who are unlikely to stay in the restored hotel rooms.³¹ It was built over the edge of Dana valley, offering a unique view over it. However, the hotel was constructed of a massive concrete block, introducing long, straight lines into the landscape composed of small, clustered units. The hotel's massive scale reflects the very poor adaptation to the scale of the urban block compared with the detached buildings. **Figure 7.7** shows how the guesthouse does not follow the site's

topography over the edge of Dana valley. The beams, on which the balconies sit, create cavities below them, showing poor adaptation to the landscape.

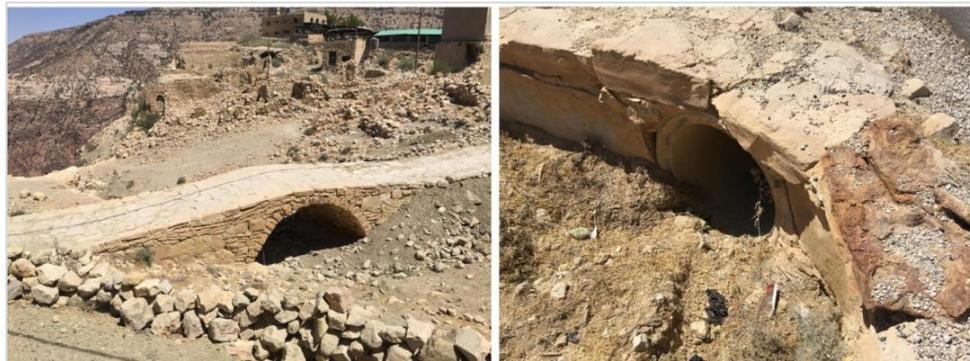
Figure 7.10: New bridge to connect the old and new parts of the village over the surface and overland water runoff (left), Concrete drainage pipes under the new road for natural rainwater drainage (right) (Author 2019)

A new bridge was also constructed to connect the old and new parts of the village over the surface and overland water runoff. Additionally, concrete drainage pipes were constructed under the new primary street for natural rainwater drainage (**Figure 7.10**). This drainage system was necessary because the added street and roads were placed over the rainwater runoff that flows downhill due to the steep slope and topography of the village (**Figure 7.11**). Developing the infrastructure was also an essential part of developing the village. Integrated potable water and sewage networks were installed under the built environment, including the original and restored buildings.

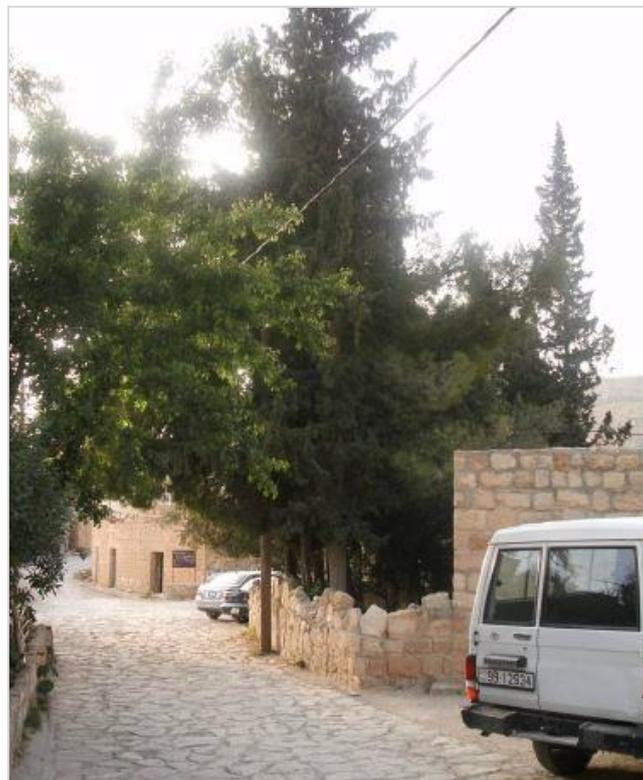
Figure 7.13: The mosque's large trees that were conserved to shade its outdoor spaces
(Author 2019)

conserved by encouraging locals to do further planting, taking into account the common and appropriate plants for Dana. The plants and trees that were appropriate for the nature of the village included figs, terebinth, carob, pomegranate, and oak. Furthermore, the village trees, especially the productive and large ones, were conserved to shade the roads, outdoor yards, or inner courtyards (**Figure 7.13**). The outdoor spaces, used for sitting or other outdoor activities, were also shaded using grape arbour or juniper tree canes. White or desert fabric sunshades were also used to provide shading.

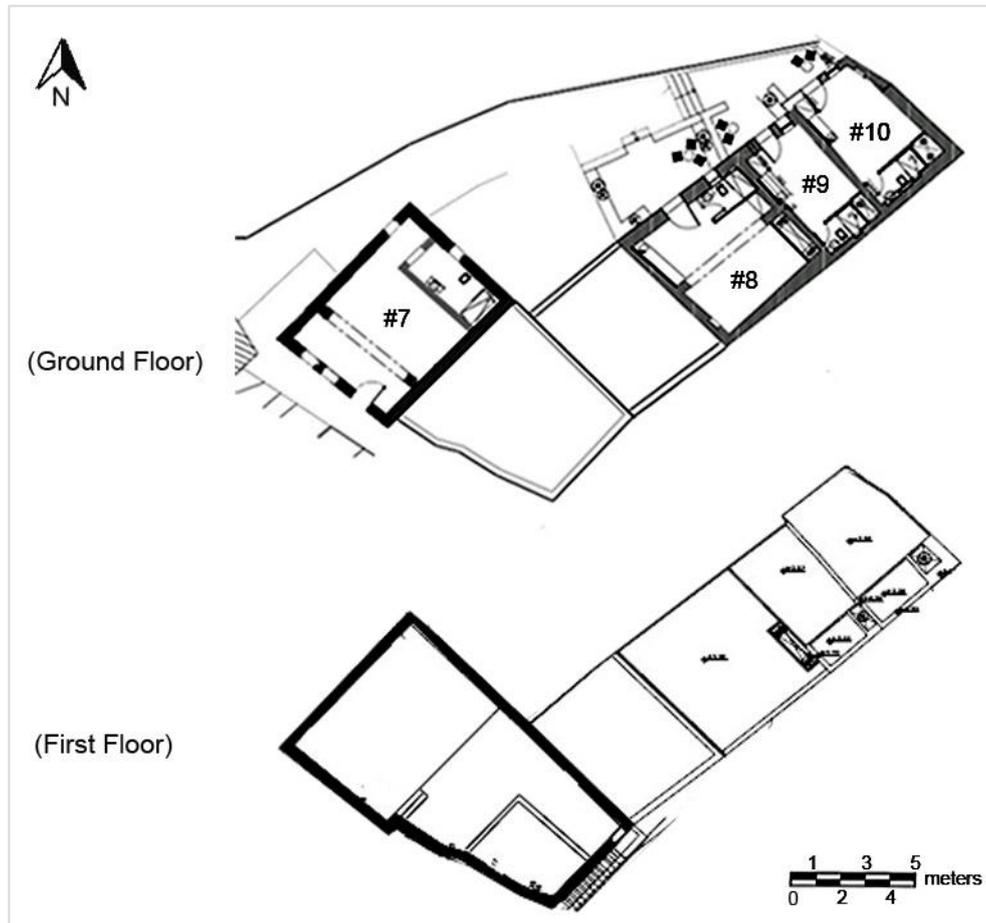
Figure 8.4: Ground floor plan (top) and first floor plan (bottom) of the rebuilt part of Dana hotel (Archive, RSCN 2019, adapted by the author 2020)

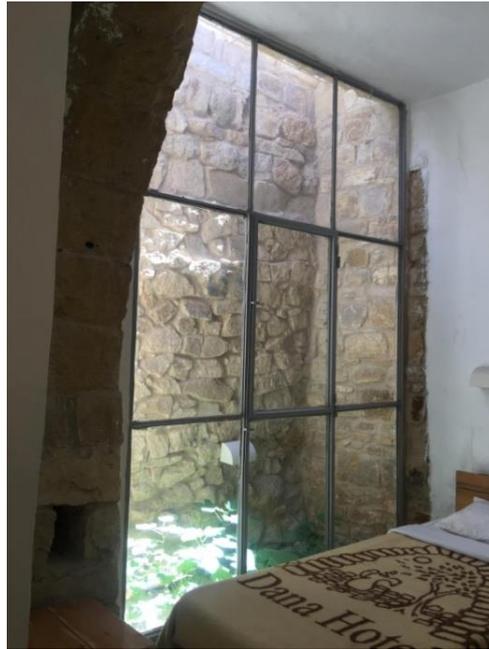
Figure 8.5: Lighting shaft, room #8 (Author 2019)

bedroom, private bathroom, and kitchenette, showing different indoor facilities and organisation compared with the original ones (Figure 8.4). Also, lighting shafts were added to rooms #8, #9, and #10 to enhance air movement, ventilation, and lighting (Figure 8.5).

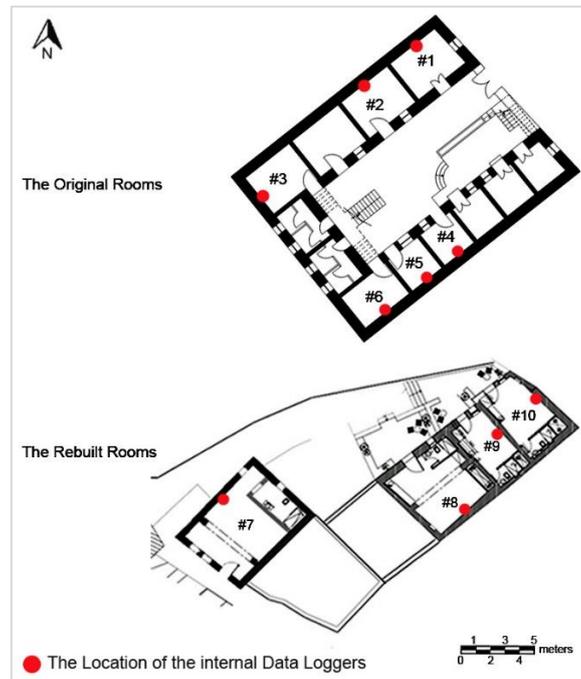
Figure 8.7: Location of the data loggers in the original rooms (top) and rebuilt rooms (bottom) (Author 2020)

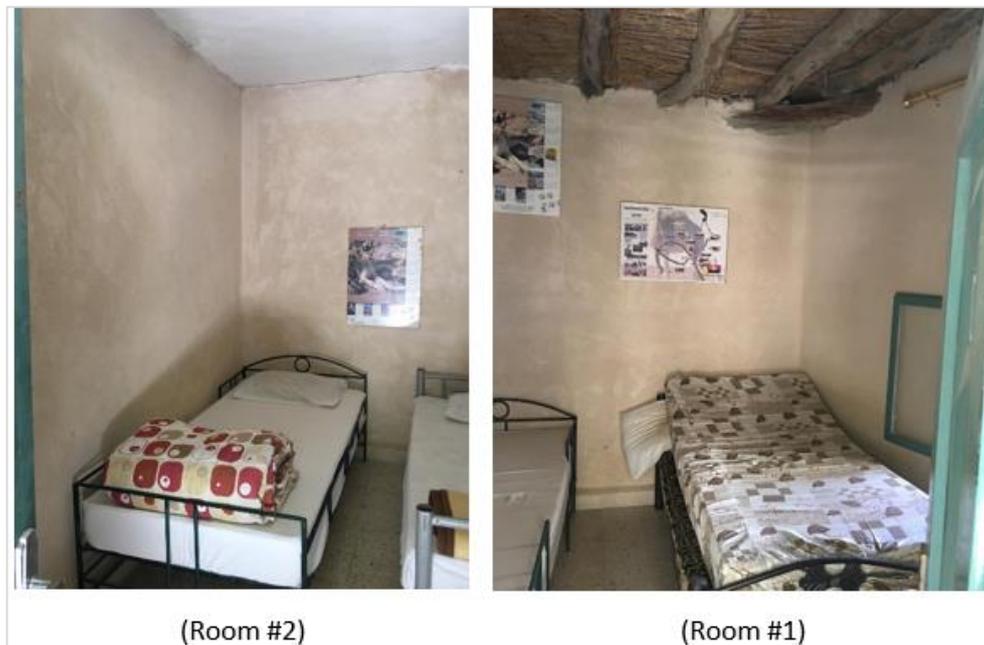
Figure 8.11: Different types of roofs in the original part of Dana hotel; concrete roof in room #2 (left) and clay roof in room #1 (right) (Author 2019)

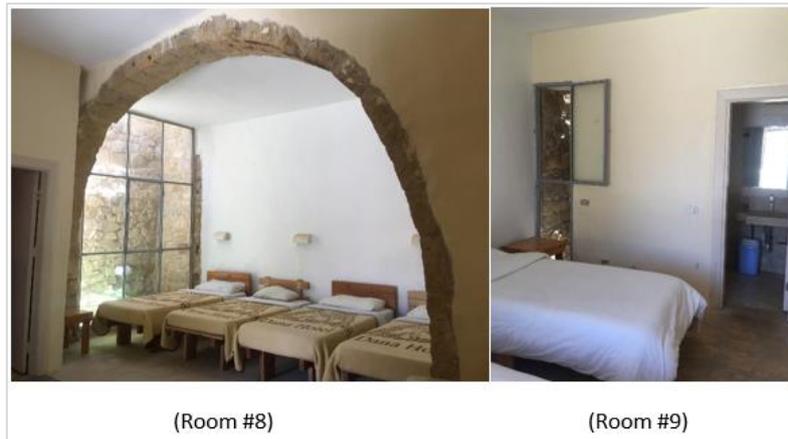
Figure 8.19: Different sizes of rooms #8 and #9 (Author 2019)

It was also observed that room #8 has slightly colder conditions than rooms #9 and #10, although they have the same building envelope, opening sizes, and orientation. This is because room #8 is bigger, thus increasing the heat transfer area and reducing the density of furniture in it (**Figure 8.19**). The lower the density of furniture, the more free space there is for heat to disperse and for the room to cool down (Dave 2011). Moreover, rooms #7 and #8 have approximately the same area, but the former is slightly warmer as it has southwest-facing windows that introduce solar gains, warming up the indoor conditions in the afternoon.

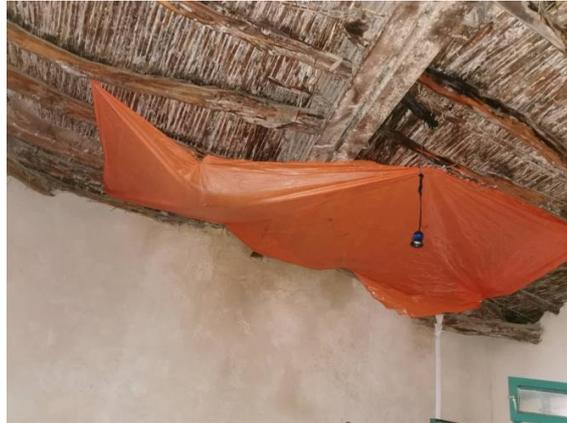
Figure 9.6: Water leakage from the roof of one of the original rooms (Author 2020)

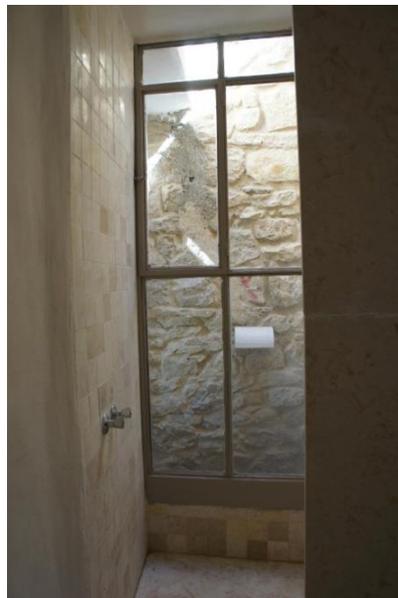
Figure 9.26: The glass wall of the shaft that faces the shower area in one of the rebuilt rooms (Author 2019)
