**Pendry, Richard (2016) *MH17 Two years later*. Bellingcat, 43 pp.**

MH17

The Open Source Investigation  
Two Years Later

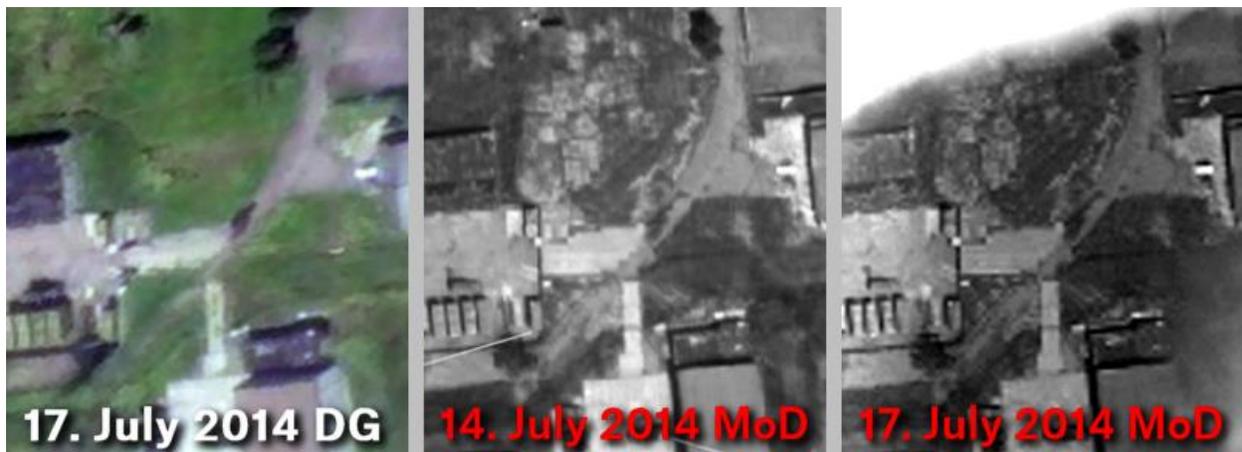
Figure 34: Comparison of Digital Globe July 17 2014 imagery to Russian Defence Ministry July 14 and 17 2014 satellite imagery

An analysis from two analysts at the American Association for the Advancement of Science (AAAS) provides additional evidence that the Russian Defence Ministry purposefully misdated the images, as they could not have possibly been taken at the time claimed.
