Watkins, Richard, Nikolopoulou, Marialena, Giridharan, R. and Kotopouleas, Alkis (2015) *The Performance of Natural Ventilation In A Dance Studio – Lessons From Tracer Gas Measurements And Control Integration*. In: *Proceedings of 31st International PLEA Conference, Passive Low Energy Architecture: Architecture in (R)Evolution*. .

THE PERFORMANCE OF NATURAL VENTILATION IN A DANCE STUDIO – LESSONS FROM TRACER GAS MEASUREMENTS AND CONTROL INTEGRATION

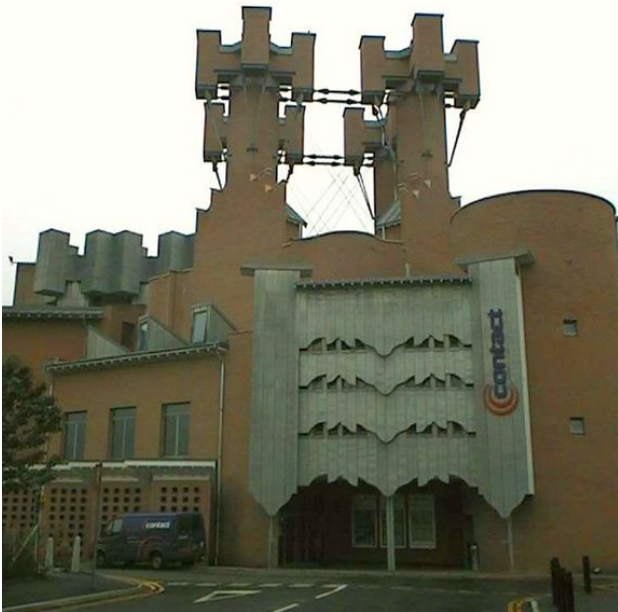
Fig 2: The naturally ventilated Contact Theatre, UK

for dance and rehearsals, together with a café. Figure 2 shows the main entrance and the ventilation stacks with “H”-pots on top to reduce downdraught (reverse flow) in an urban turbulent environment (Short et al, 2005).

This theatre is designed to operate using passive stack ventilation enabled through nine tall stacks towering over the building, with high level slow moving fans available for peak times. Fresh air is admitted at low level through acoustic attenuators. When the building was assessed in 2001 as part of a European study of good exemplar buildings the occupants were reported as being very satisfied with the building (Kolokotroni et al, 2001).

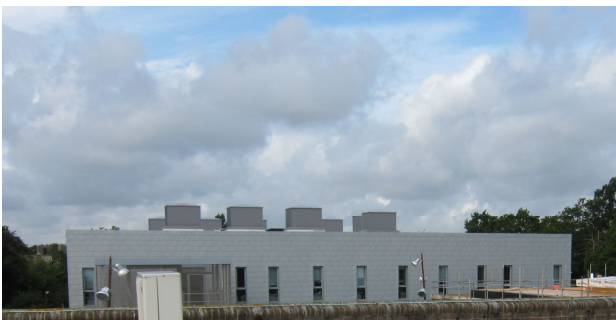
Fig 3: The ventilation stacks of the Jarman building

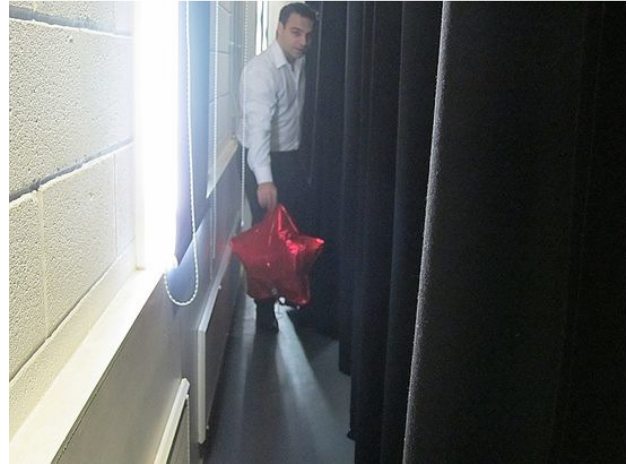
Fig 4: Testing behind the curtains, and showing the perimeter Passivent air inlet grilles

The observations of balloons placed behind the curtains also showed vertical movement but only to two to three metres. What appeared to be happening is that cold air enters at about 300mm above floor level through the Passivent grilles and “accumulates“, is effectively dammed behind the curtains and at the same time starts to be warmed by the floor’s warm surface. The air then migrates through the gaps in the vertical joins in the sections of curtain, and possibly through the fabric itself, and enters the studio’s central area.

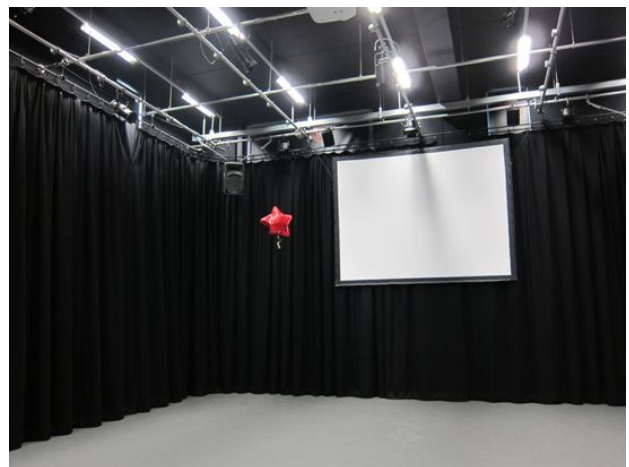
Fig 5: Air movement testing in the dance studio using neutrally buoyant balloons.

The balloons were inflated with a mixture of helium and air. They were released at various points and tracked visually and on camera noting the path taken and their velocity. The advantage of using balloons is that they can be seen and tracked easily in a very large space when alternative methods, e.g. using smoke, are problematic. See Figure 5.

The air movement tests using neutrally buoyant balloons showed that air speeds in the studio are very low (around 0.1 m/s). It was also seen that convection cells exist across the floor, presumably as a result of the high surface temperature of the floor (25°C) from the underfloor heating system. These cells extended upwards but only to 2-2.5m above floor level, when air descended. The cells will encourage mixing of the air.

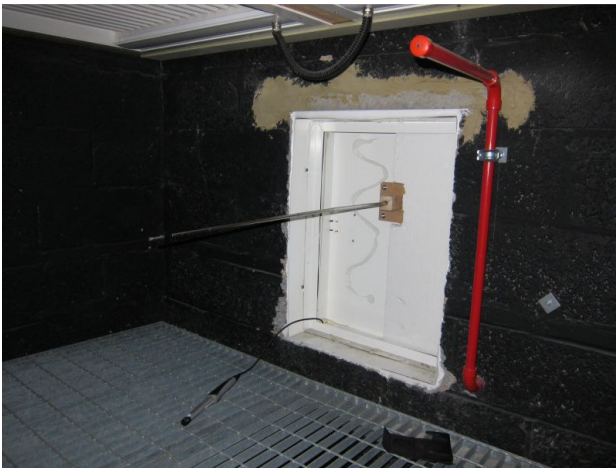
Fig 6: The top of the stack where air velocity, temperature and carbon dioxide were measured.

Exhaust air from the room travels up an insulated stack which passes through the third floor of the building and continues up to four metres above the roof level where there is a louvred stack terminal. A hot wire anemometer and a carbon dioxide probe were placed inside the stack just below the control louvres. See Figure 6. Air temperature here was 23°C.

The stack velocity data were for the velocity upwards at the centre of the stack at high level in the inspection chamber beneath the stack outlet. These data were converted to a mean flow rate to obtain the volumetric flow rate by multiplying the central velocity by 0.60, a factor that was determined by calculation from velocity traverses across the stack diameter.

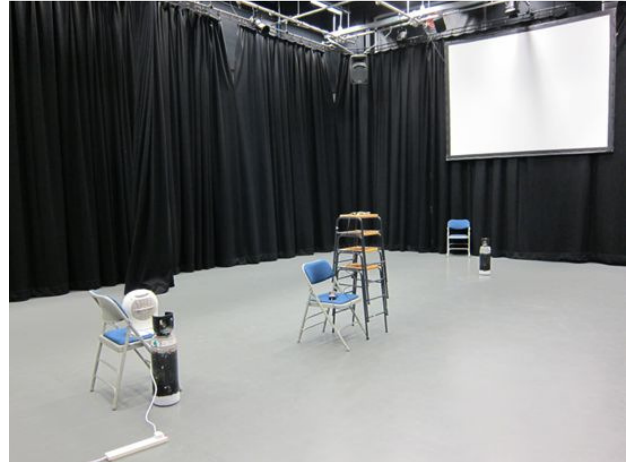
Fig 7: Releasing CO₂ as a tracer gas in the studio.

Carbon dioxide concentration was simultaneously measured in the centre of the drama studio at a height of 1.2m. In a series of tests, the room's CO₂ concentration was increased by releasing CO₂ from two cylinders until a relatively high value (compared to the background level) was obtained, from between 3000 and 4000ppm. See Figure 7. It was then allowed to decay.

In all the tests, the doors into the studio were shut and the window from the control suite shut. CO₂ was discharged near the centre of the room but directed away from the central measurement location. The gas was initially discharged through an electric fan heater to compensate for the temperature drop from the gas expansion. However, this was stopped later as the room temperature climbed when all the windows and vents were closed. After initial use of one cylinder a second gas cylinder was used in different parts of the room to hasten the room charging, and help with mixing. The room was repeatedly manually mixed using two 4m high central room dividing curtains.
