THE INVESTIGATION OF
THE CAUSE AND
SEVERITY OF
CORROSION AT THE
PORT OF DOVER

Thesis Submitted For The Degree Of Research Masters In
Chemistry At The University Of Kent

Abstract

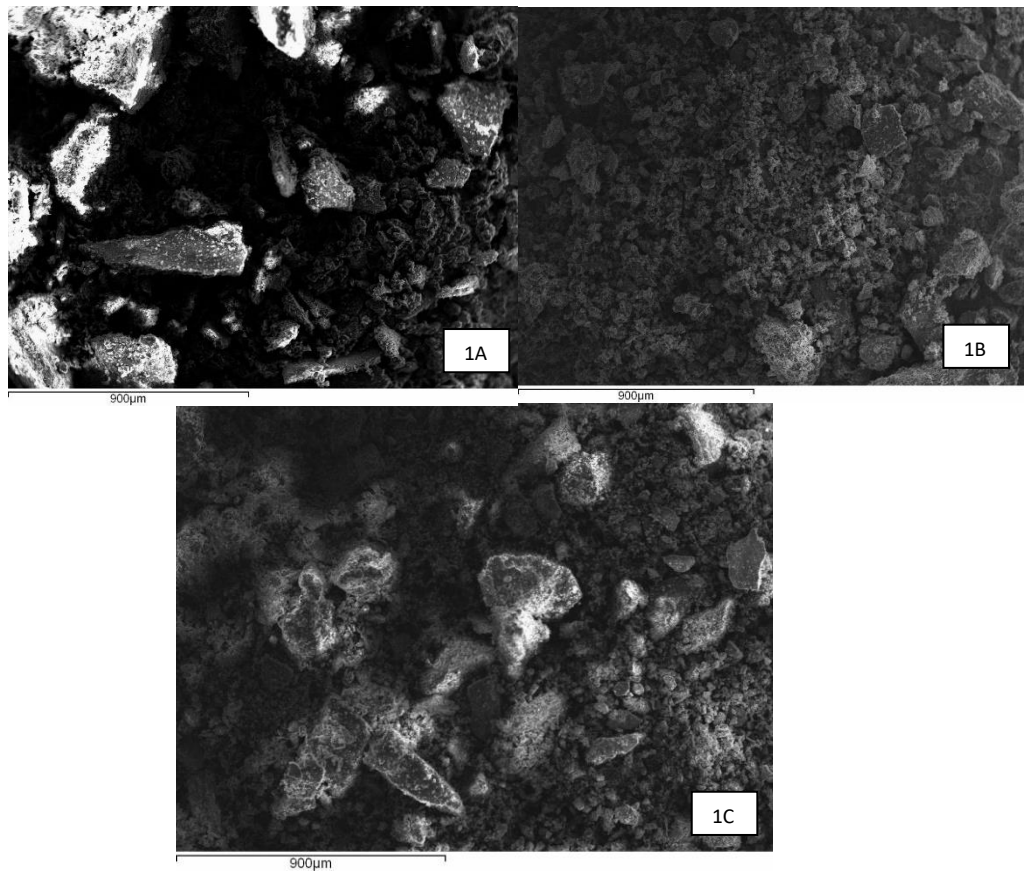
Figure 16. SEM images of samples 1A, 1B and 1C.

The SEM images can be seen in **Figure 16**, the EDX analysis determined that the samples contained the following elements; chlorine, carbon, calcium, titanium, iron, sodium, zinc, silicon, sulfur, magnesium, barium, potassium and manganese. Only samples 1A and 1C contained phosphorus and cerium, sample 1B was the only sample to contain aluminium at this sample site.

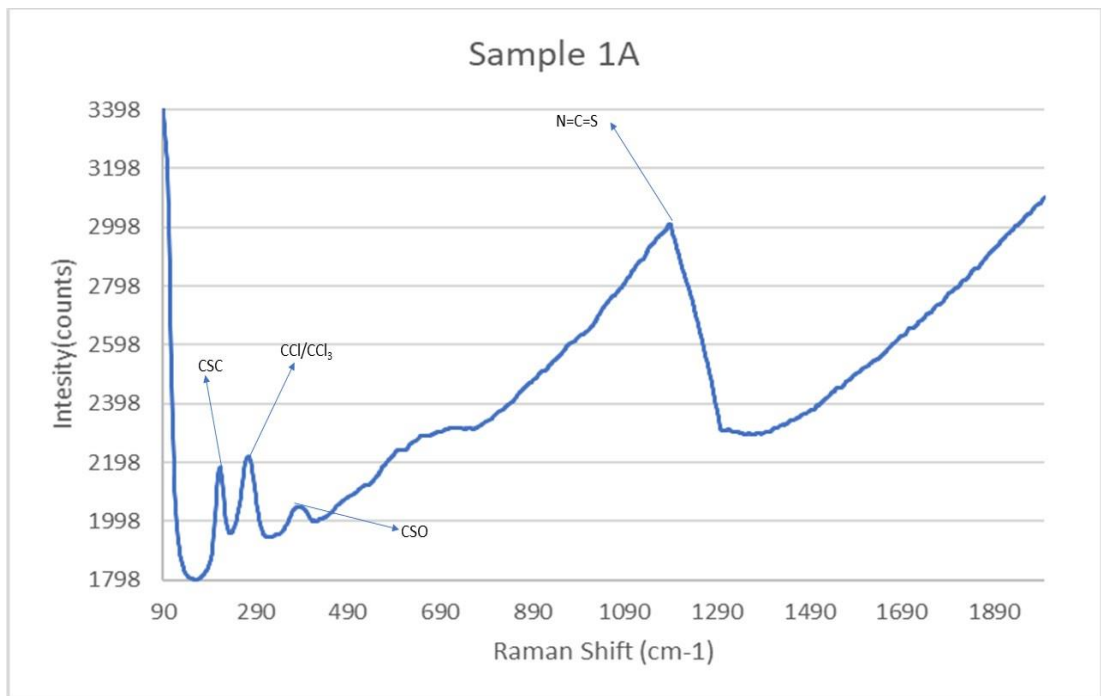
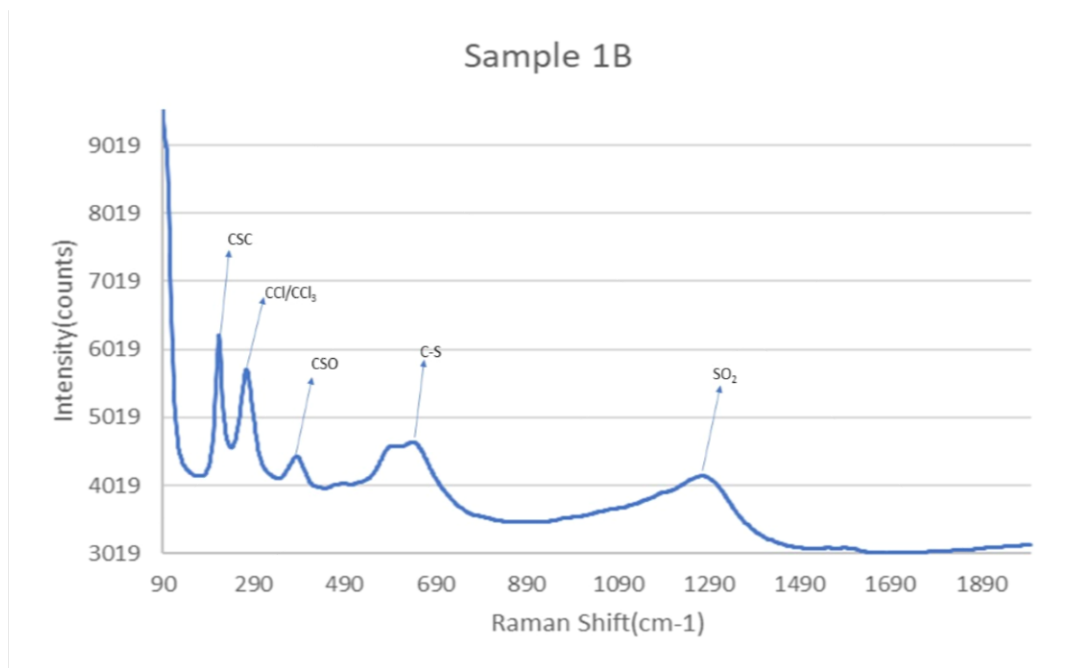
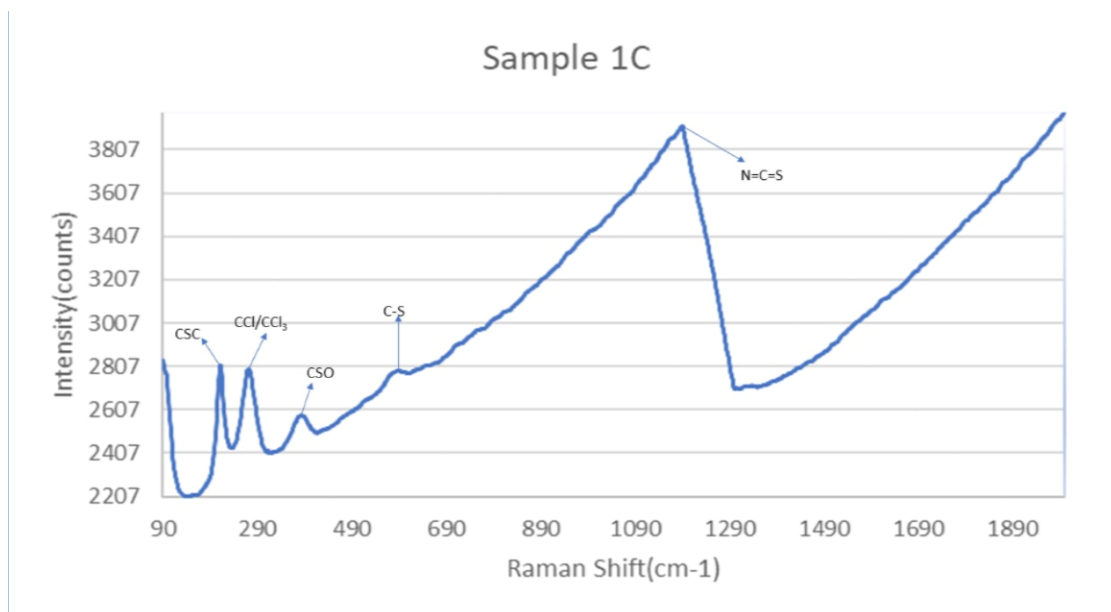
Figure 17. The Raman analysis for samples 1A, 1B and 1C.

By analysing the Raman spectrums as seen in **Figure 17** it was found that sample site 1 contains organic compounds that have mainly carbon and sulfur present. The samples taken from sample site 1 have very similar peaks at 215cm^{-1} (CSC), 270cm^{-1} (CCl/CCl₃) and 380cm^{-1} (CSO) -carbon with sulfur, chlorine and sulphate compounds. Unfortunately, due to fluorescence samples 1A and 1B are difficult to distinguish but there is a peak later at $\sim 1200\text{cm}^{-1}$ which is characteristic for isothiocyanates(N=C=S). There is a shoulder in sample 1A which might be the peak observed in samples 1B and 1C at $\sim 600\text{cm}^{-1}$ (C-S). This can either be aliphatic sulfides and disulphates or covalent sulphates and sulphonic acids(anhydrous). However, seeing as both sulfides and sulphates are present in the sample, they are both overlapping, being represented by the peak at $\sim 600\text{cm}^{-1}$.

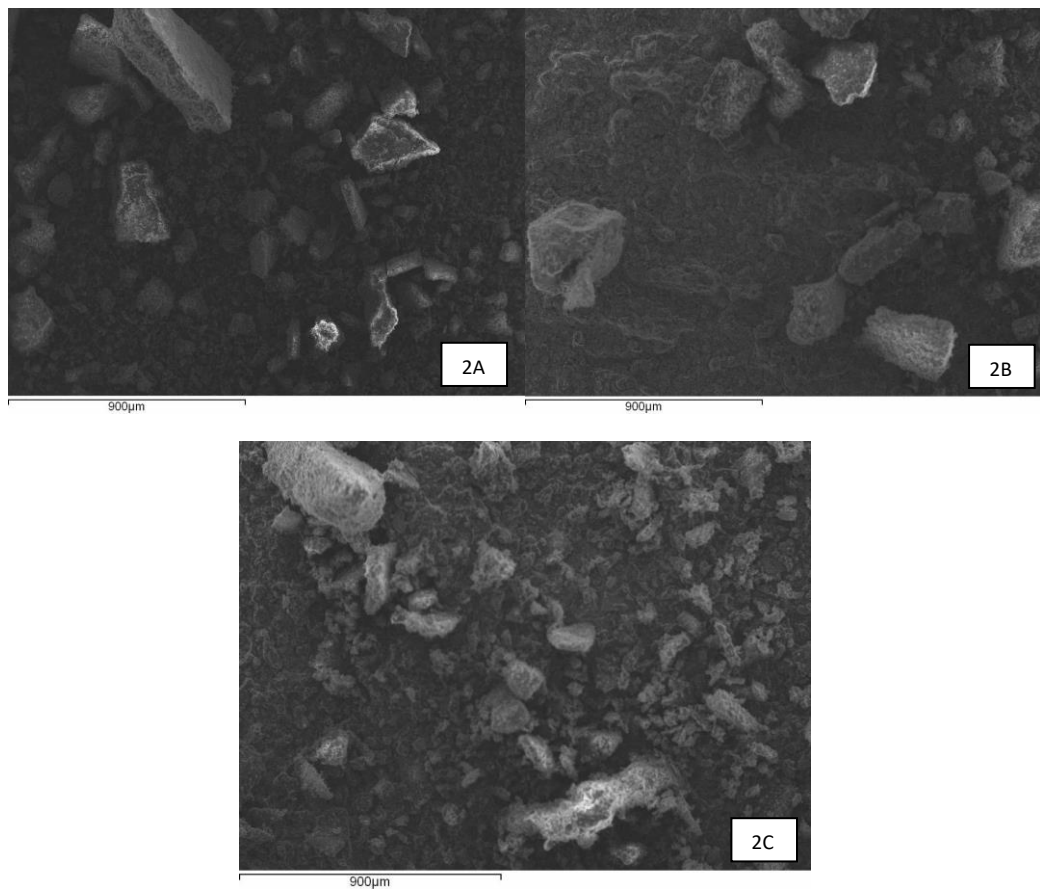
Figure 19. SEM images of sample 2A,2B and 2C.

Figure 19 shows the SEM images for the sample site 2. The following elements were detected using EDX: chlorine, cerium, iron, sulfur, zinc, aluminium, titanium, magnesium, calcium, carbon, potassium, silicon and sodium. Samples 2A and 2B also contain phosphorus, samples 2B and 2C also contain barium, molybdenum and manganese.

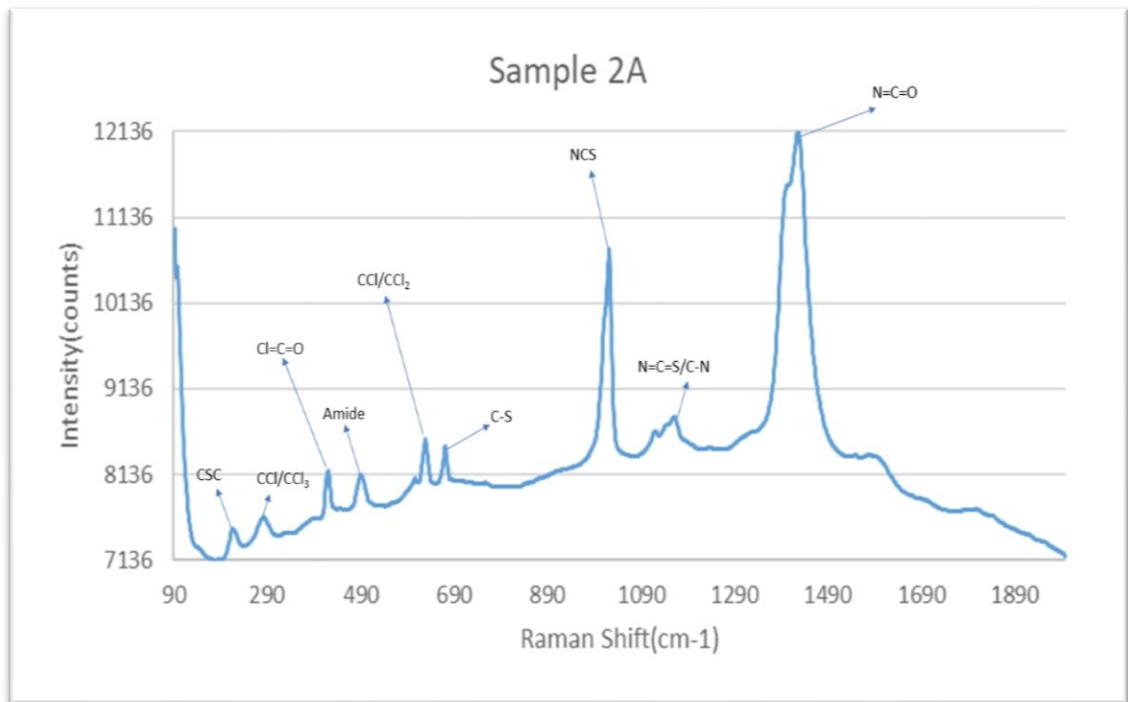
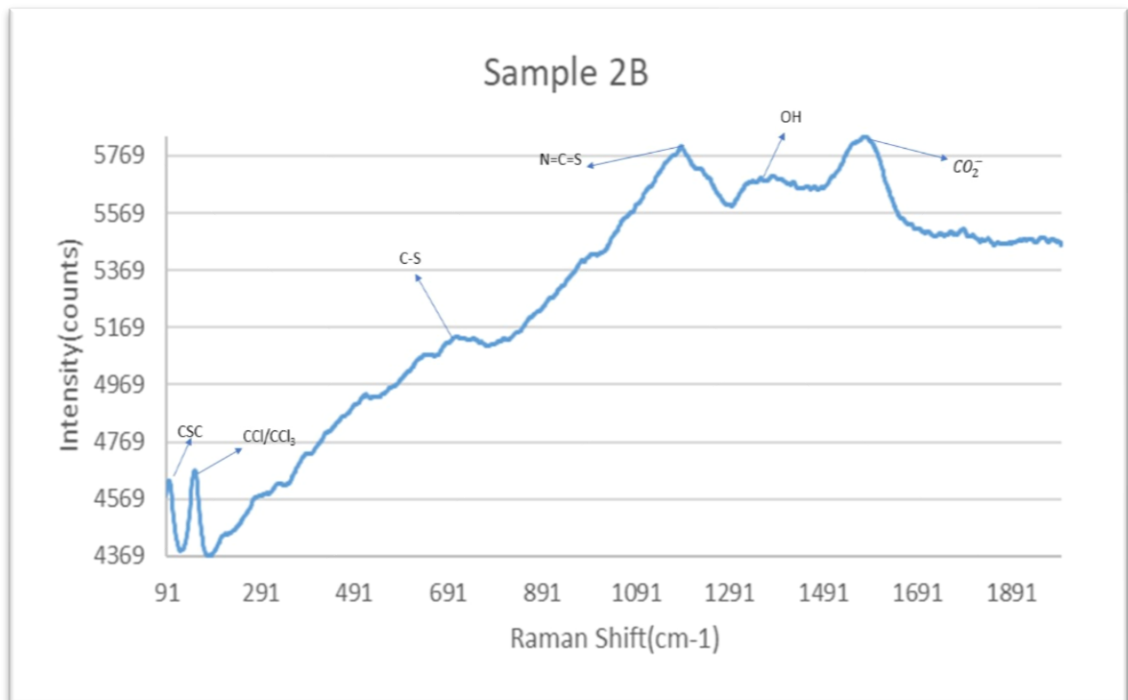
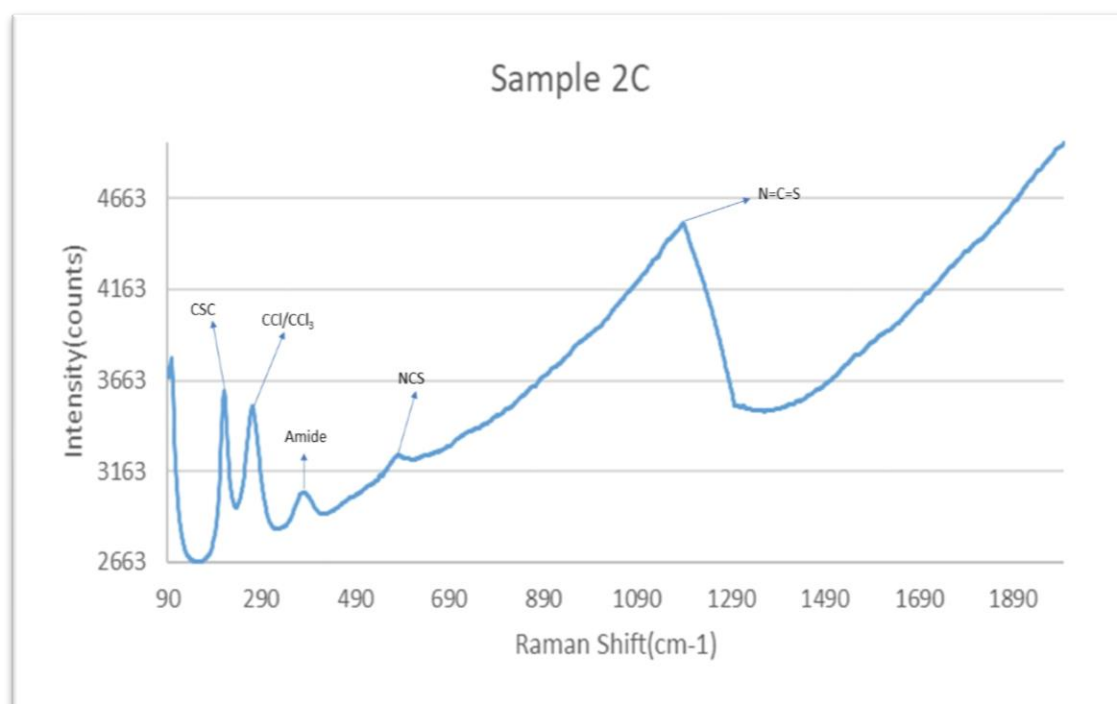
Figure 20. Raman analysis of samples from sample site 2.

All the Raman spectra for the samples taken at sample site 2 are as shown in **Figure 20**. The samples are different from each other. There are only a few similarities at $\sim 210\text{cm}^{-1}$ and $\sim 275\text{cm}^{-1}$ characterised by carbon sulfur and carbon chloride compounds in samples 2A and C. The exception being sample 2B.

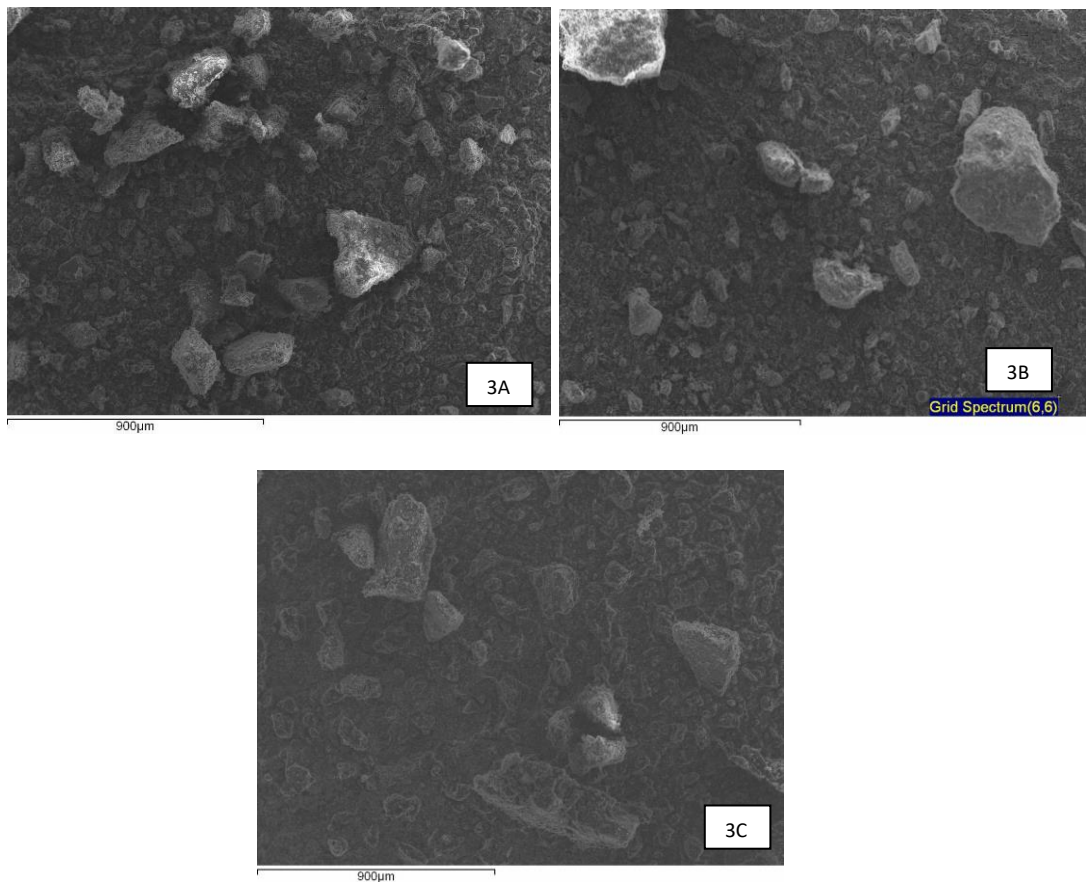
Figure 22.SEM of samples taken from sample site 3.

The analysis from the SEM/EDX as shown in **Figure 22** above contained the following elements: silicon, carbon, sulfur, chlorine, iron, barium, titanium, calcium, magnesium, manganese and zinc. Sample 3A additionally contained aluminium, potassium, phosphorus, sodium, bromine and cerium. Sample 3B also contained molybdenum, phosphorus, sodium, tellurium and aluminium. Sample 3C additionally contained cerium.

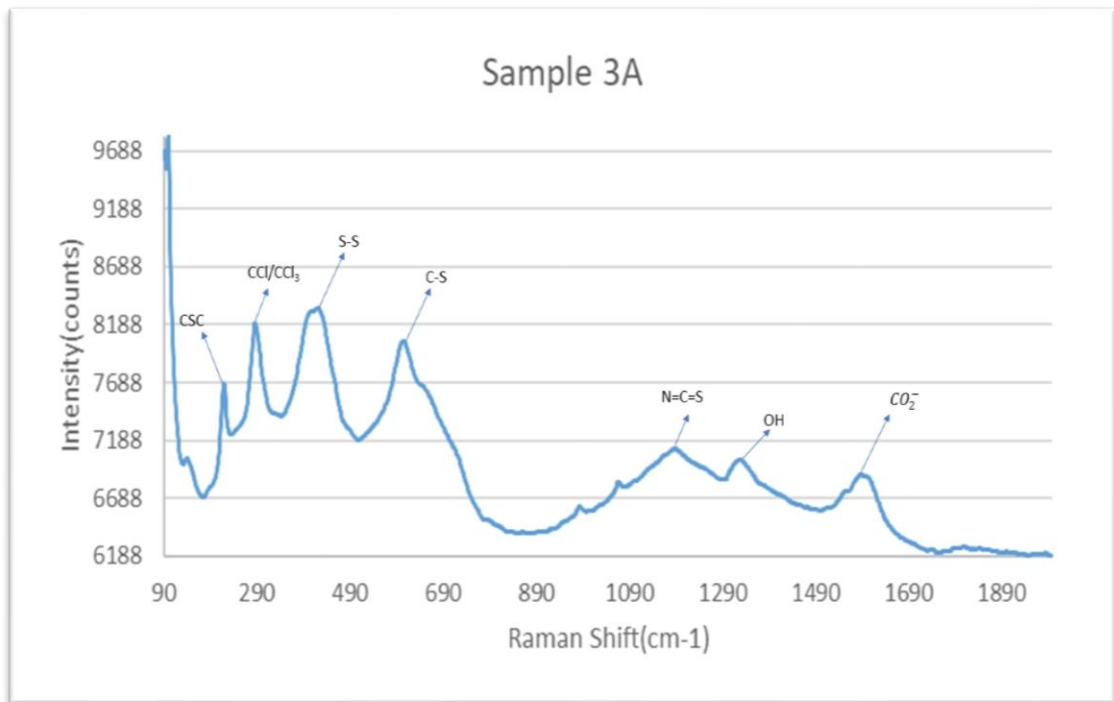
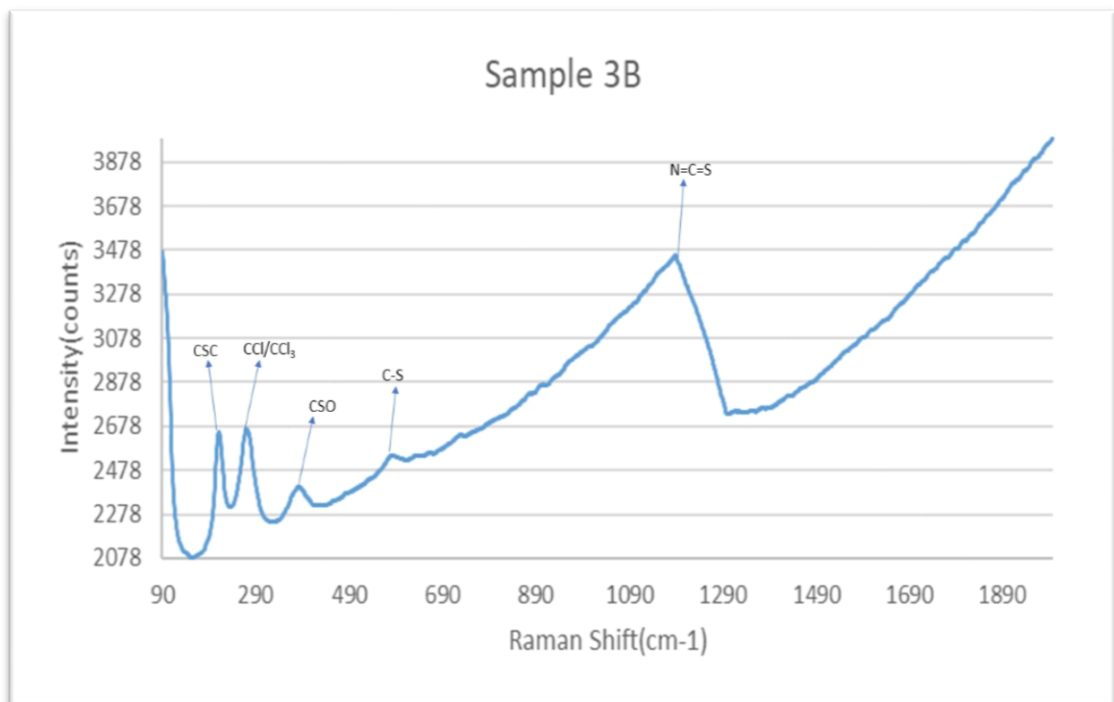
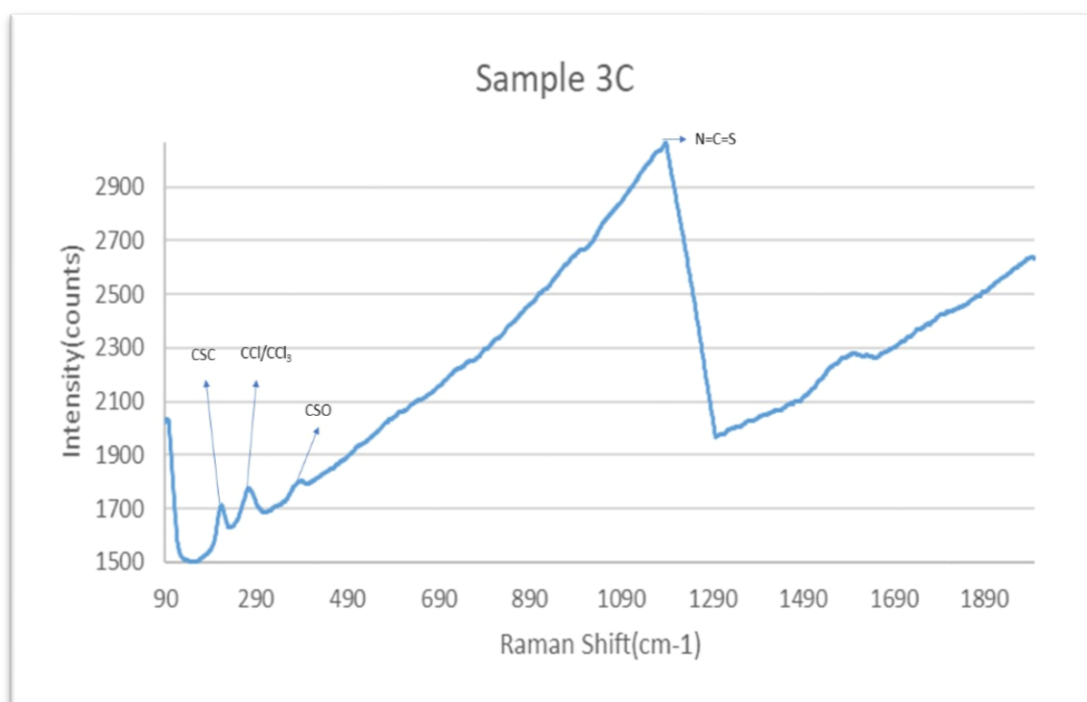
Figure 23. Raman analysis of samples from sample site 3.

Raman spectrums in **Figure 23**, similarly to the other sample sites showed peaks attributing to CSC's and CCl/CCl₃ are common compounds, samples 3B and 3C also have sulphoxides(CSO) at $\sim 380\text{cm}^{-1}$. At a $\sim 400\text{cm}^{-1}$ sample 3A had a larger, almost double peak hence the aliphatic disulfides (S-S) interpretation. The raman shift $\sim 600\text{cm}^{-1}$ was identified as aliphatic sulfides and disulfides (C-S) for samples 3A and 3B. All the samples at $\sim 1180\text{cm}^{-1}$ contain isothiocyanates (N=C=S). Sample 3A then contains another two additional peaks, at 1325cm^{-1} phenols (OH) and at 1580cm^{-1} aromatic acid salts (CO_2^-).

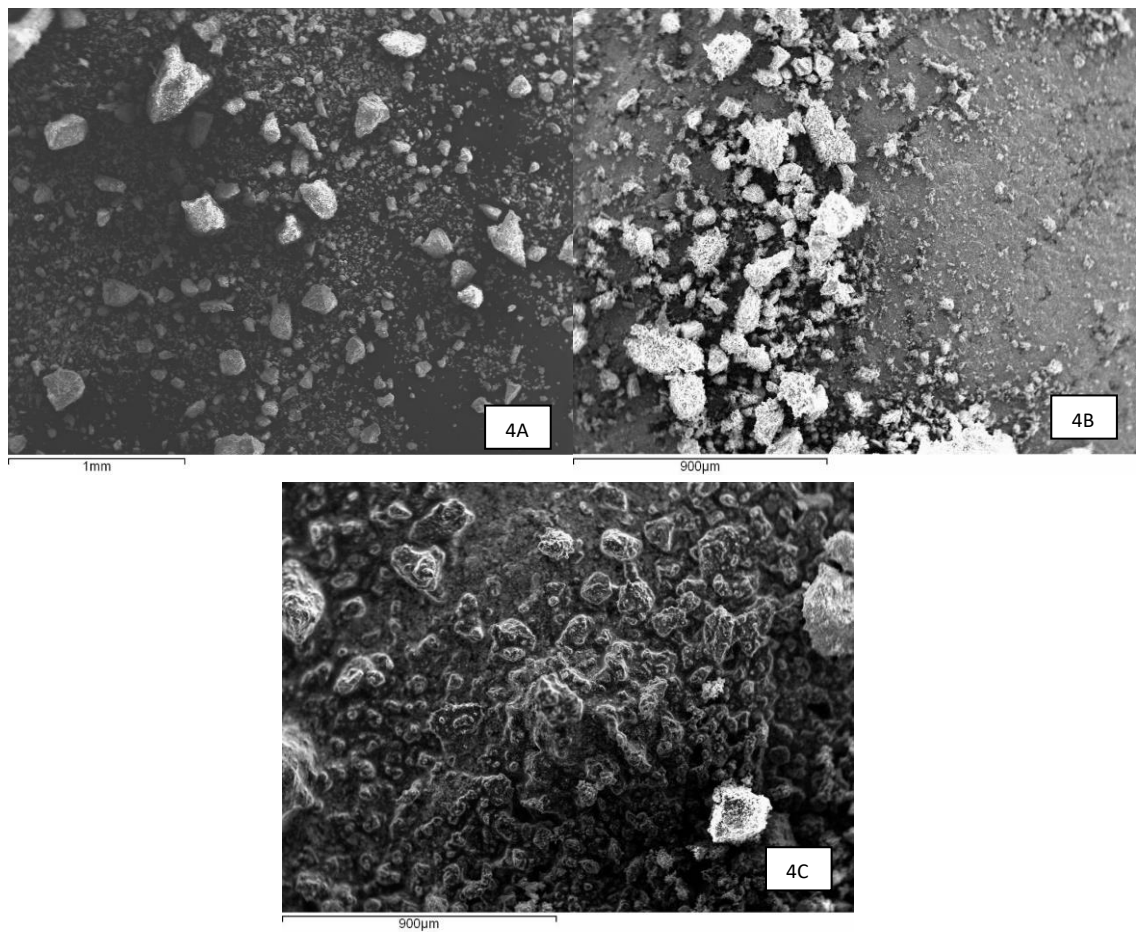
Figure 25. SEM analysis of samples from sample site 4.

The following elements were detected by the SEM/EDX seen in **Figure 25** for sample site 4: carbon, zinc, chlorine, titanium, iron, magnesium, silicon, sulfur, calcium and sodium. Sample 4A also contained manganese, aluminium and potassium. Sample 4B additionally contained, aluminium, copper, arsenic, barium, lead and phosphorus. Sample 4C also contained, cerium, barium, phosphorus, manganese and potassium.

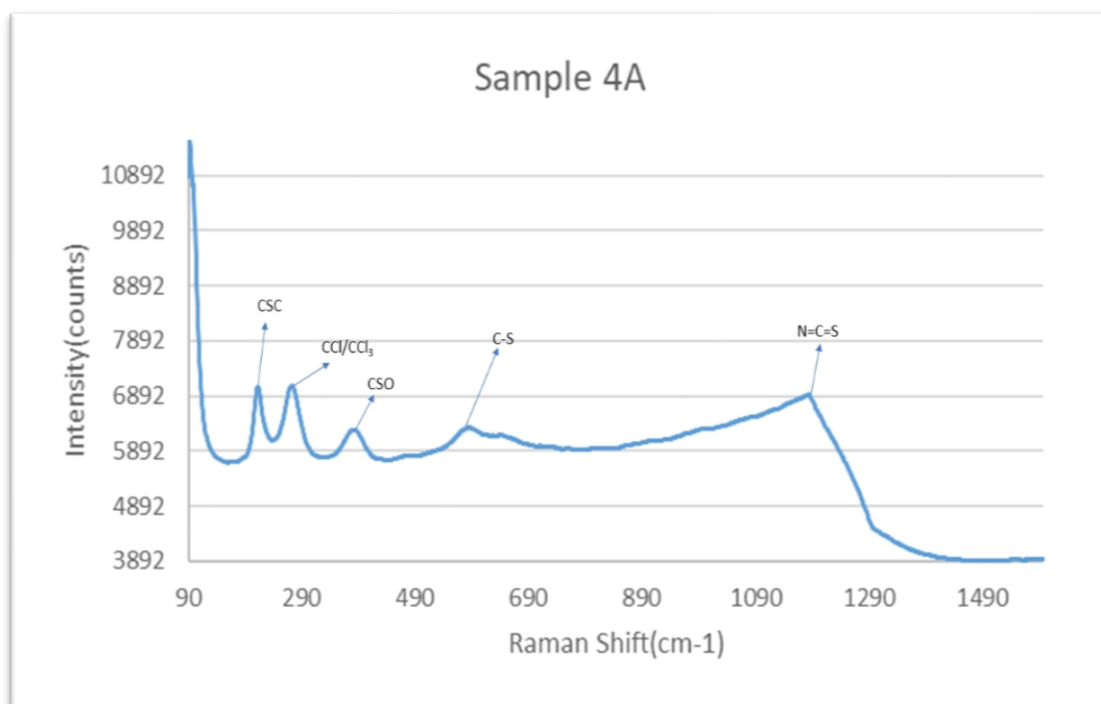
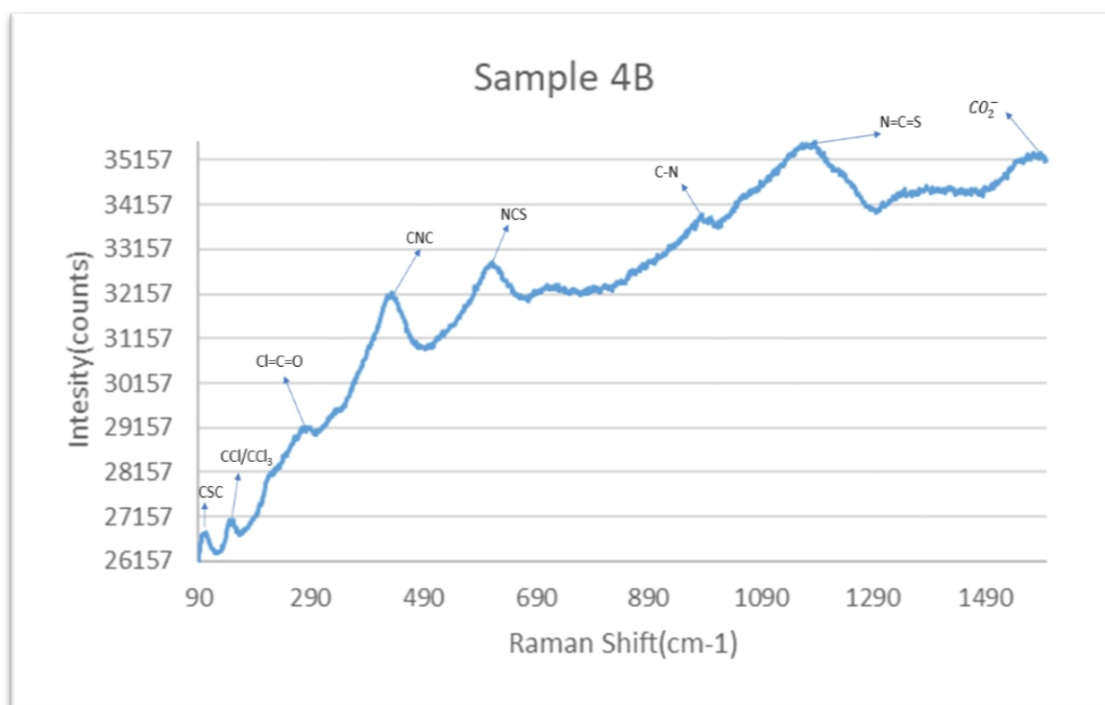
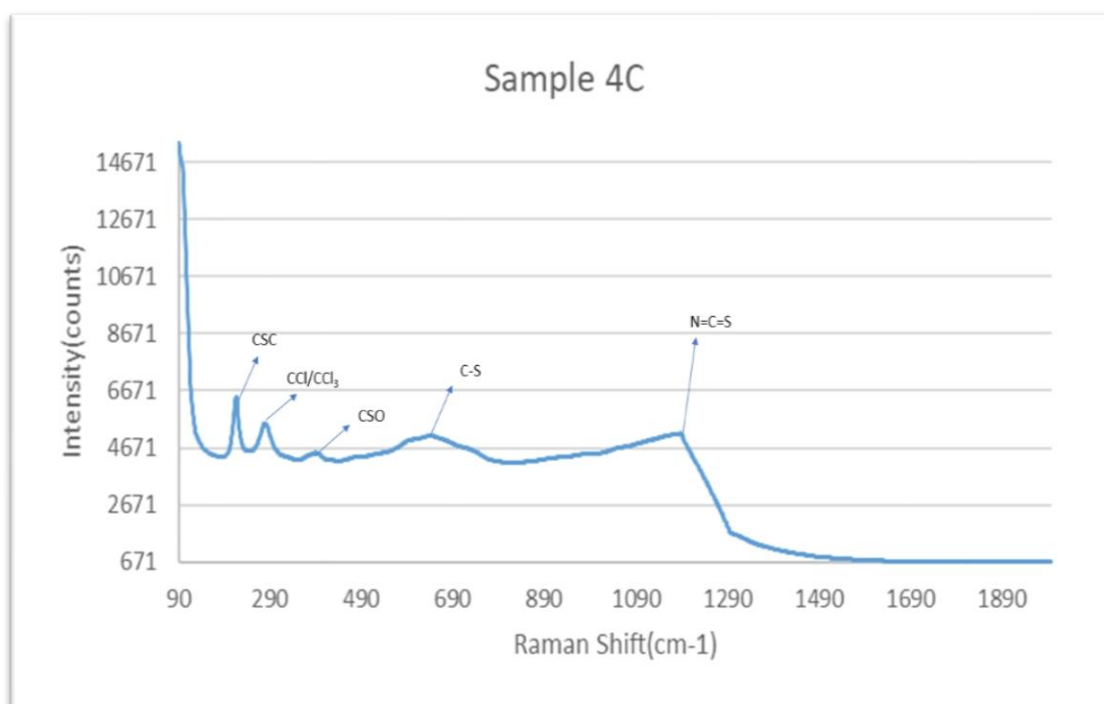
Figure 26. Raman analysis of samples taken from sample site 4.

Raman spectrum shown in **Figure 26** suggests sample 4A and Sample 4C have essentially the same spectrum with isothiocyanates($N=C=S$), carbon sulfur and carbon chloride compounds. Sample 4B has a very different spectrum, the spectrum itself is showing a lot of noise and interference. This is the reason that the lower peaks have still been interpreted as CSC and CCl/CCl_3 . Raman shift $\sim 280\text{cm}^{-1}$ is a shoulder of a peak and is not very defined, identifying it as a saturated aliphatic acid chloride ($Cl=C=O$). The clear peak at 434cm^{-1} was identified as secondary aliphatic amines (CNC), at 610cm^{-1} tertiary thioamides (NCS), at 940cm^{-1} saturated primary and secondary nitro compounds (C-N). Lastly at 1185cm^{-1} and 1597cm^{-1} there are the familiar peaks of Isothiocyanates ($N=C=S$) and aromatic acid salts (CO_2^-) respectively.

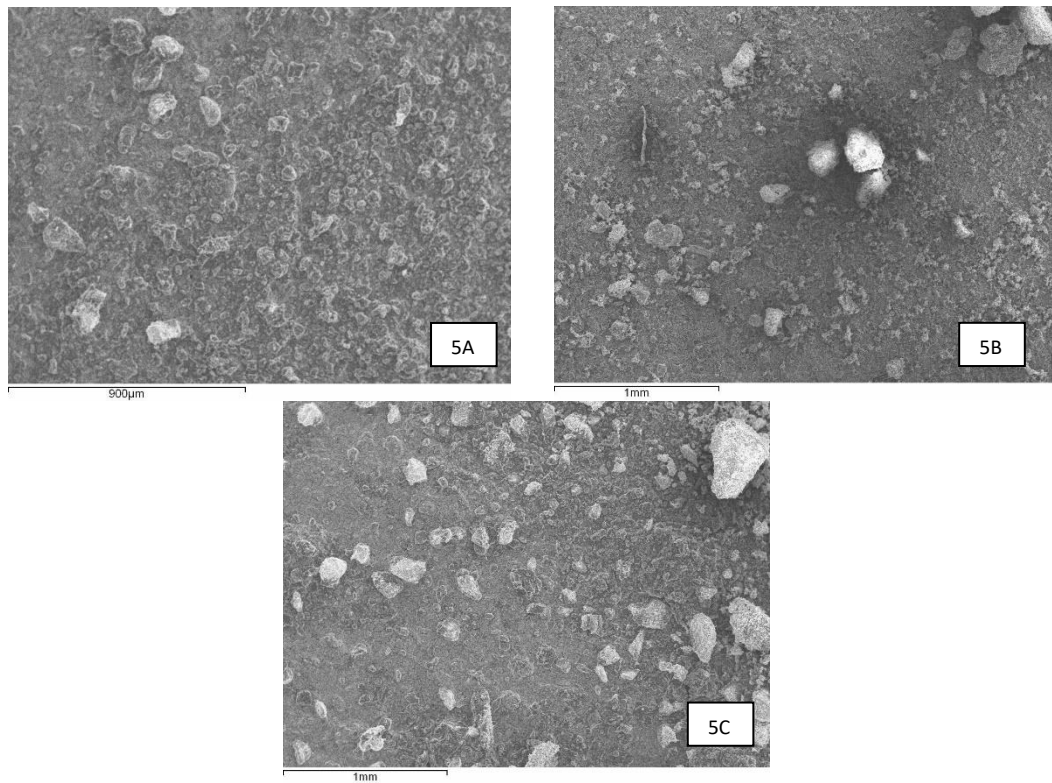
Figure 28. SEM analysis of the samples from sample site 5.

The following elements were detected using the SEM/EDX (**Figure 28**), for all the samples from sample site 5; carbon, magnesium, silicon, chlorine, calcium, sodium, iron, zinc, sulfur and titanium. Sample 5A also contained phosphorus, molybdenum and manganese. Sample 5B additionally had copper, phosphorus and cerium. Sample 5C only had one other element present, which was cerium.

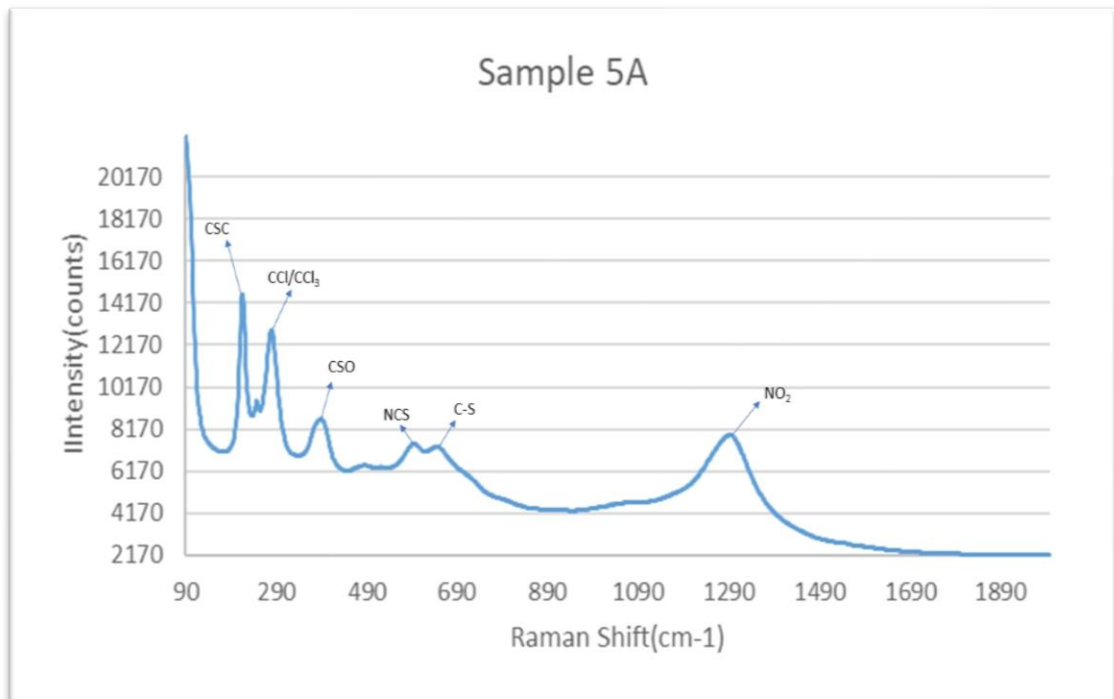
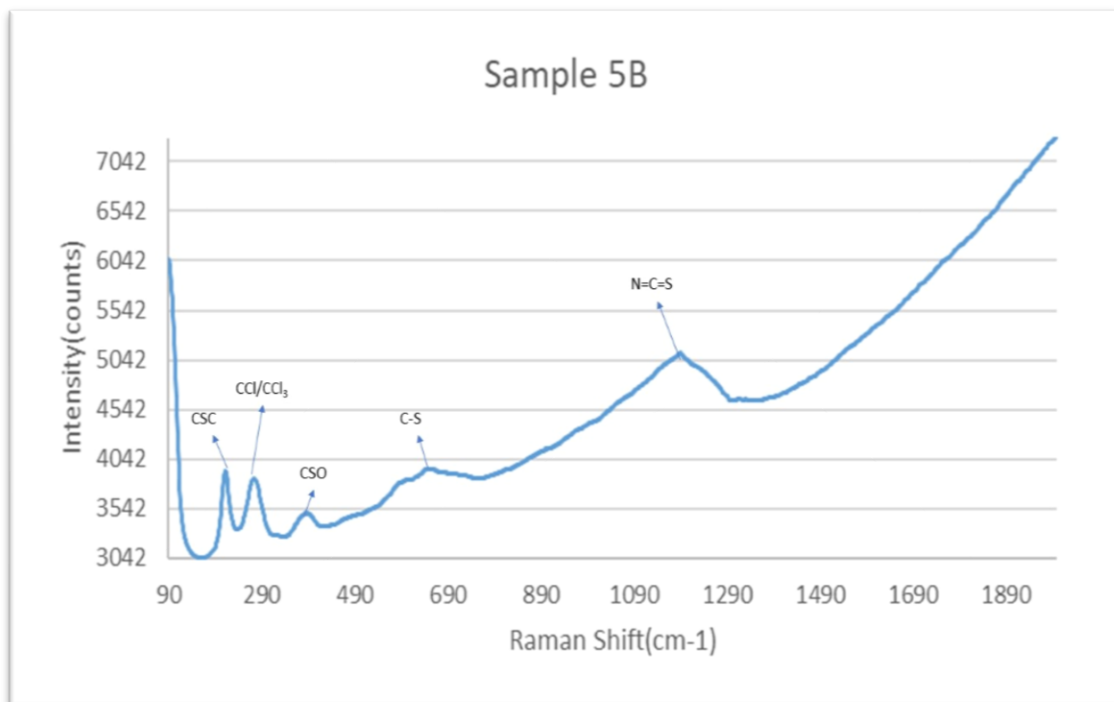
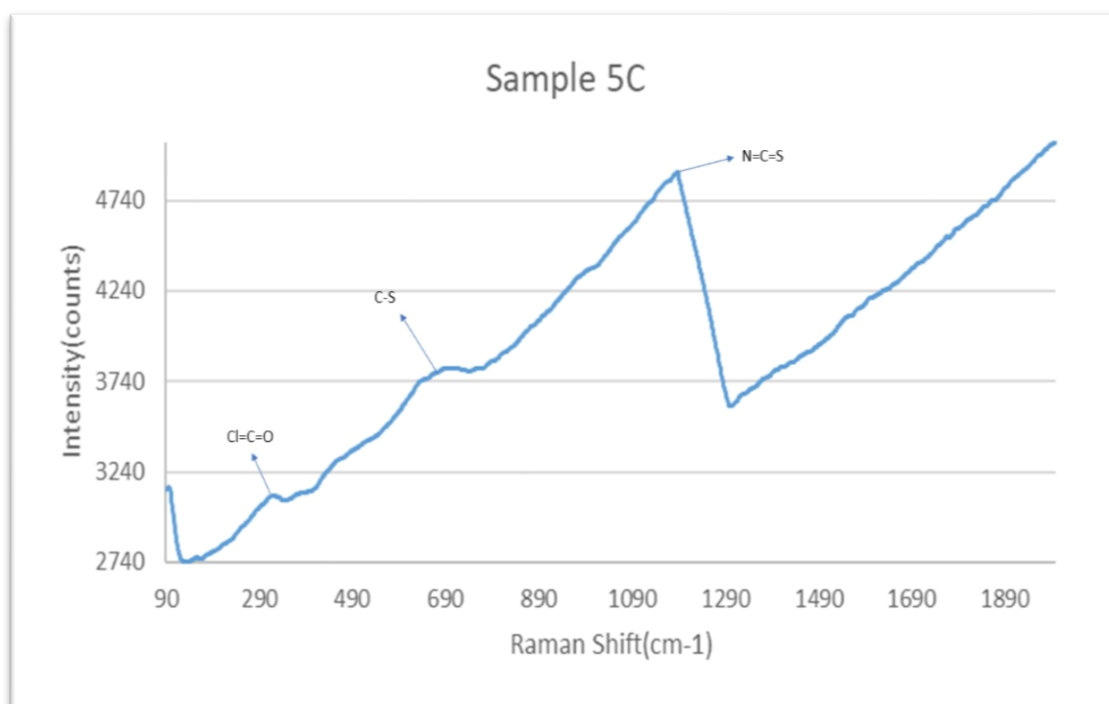
Figure 29. Raman analysis of samples from sample site 5.

The spectrum for samples 5A and 5B is very similar, unfortunately for sample 5C there is a lot of fluorescence interference and only three peaks could be roughly identified as seen in **Figure 29**. Sample 5A contains the same compounds as mentioned for the samples in area 1, the difference being that sample 5A also contains secondary thioamides (NCS) at $\sim 596\text{cm}^{-1}$. This sample also contains nitroamines (NO_2) at $\sim 1294\text{cm}^{-1}$. Sample 5C has saturated aliphatic chlorides ($\text{Cl}=\text{C}=\text{O}$) at 325cm^{-1} , aliphatic sulfides and disulfides (C-S) at 671cm^{-1} and isothiocyanates at 1188cm^{-1} . There is no large difference from the other Raman spectra observed on the bridge so far. The only new identification is sample 5A at 1294cm^{-1} , nitroamines (NO_2).

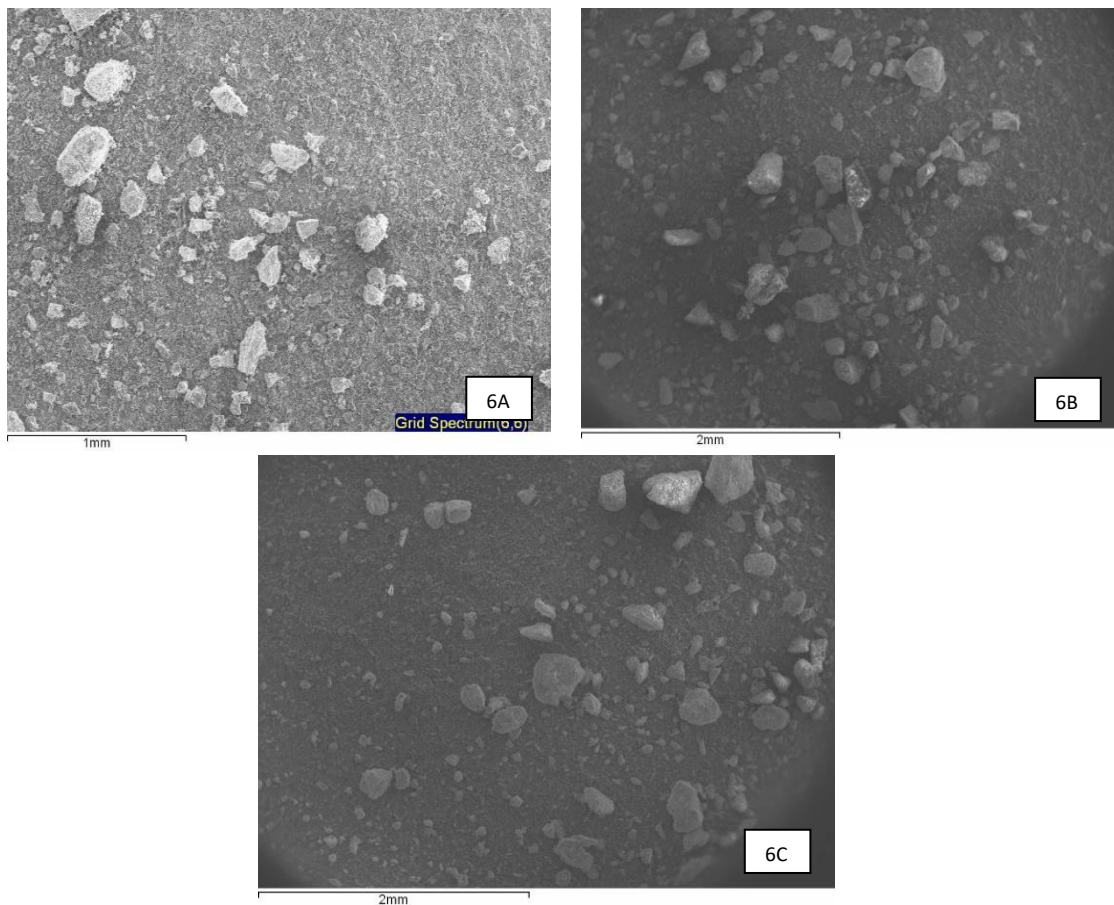
Figure 31. SEM analysis of sample site 6.

Figure 31 shows the SEM images for sample site 6. The following elements were detected in all the samples for sample site 6: carbon, magnesium, chlorine, zinc, iron, calcium, titanium, sulfur, sodium, silicon. Sample 6A also contains phosphorus, potassium and aluminium. Sample 6B additionally contains aluminium and manganese. Sample 6C also contains aluminium, barium and manganese.

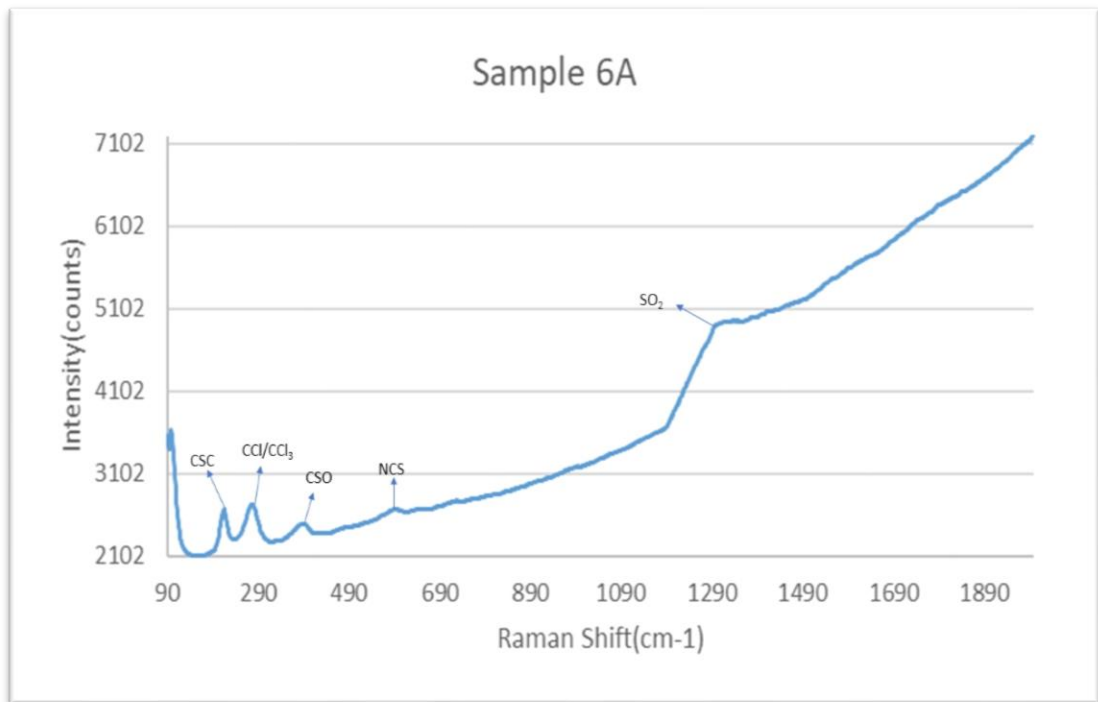
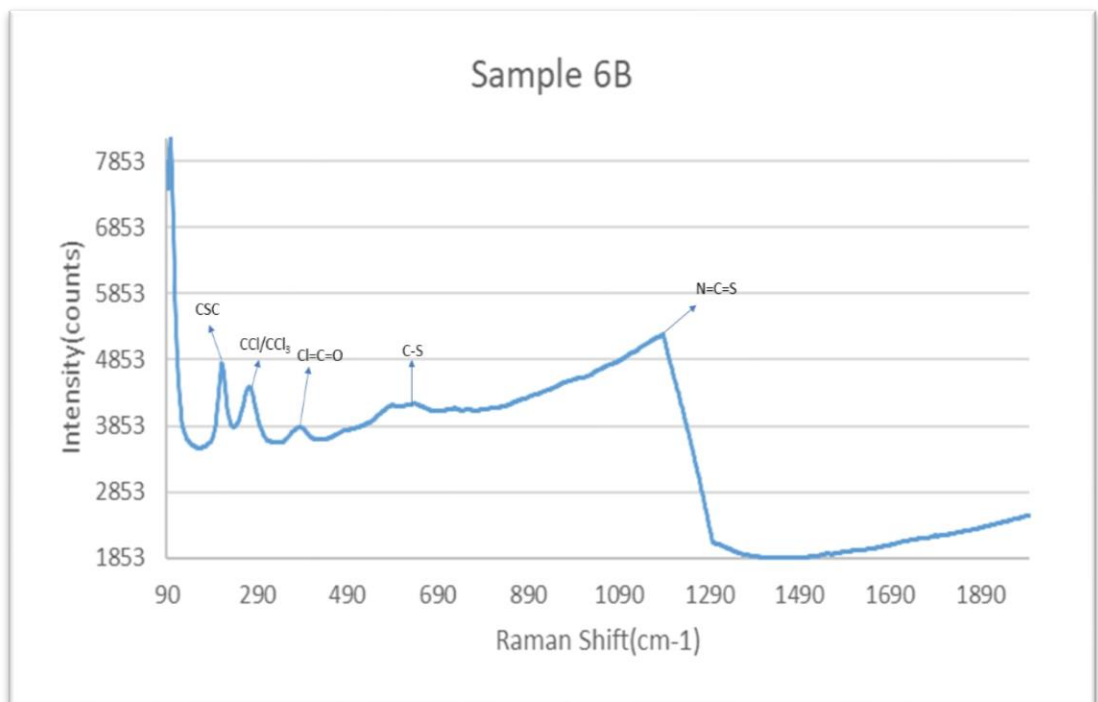
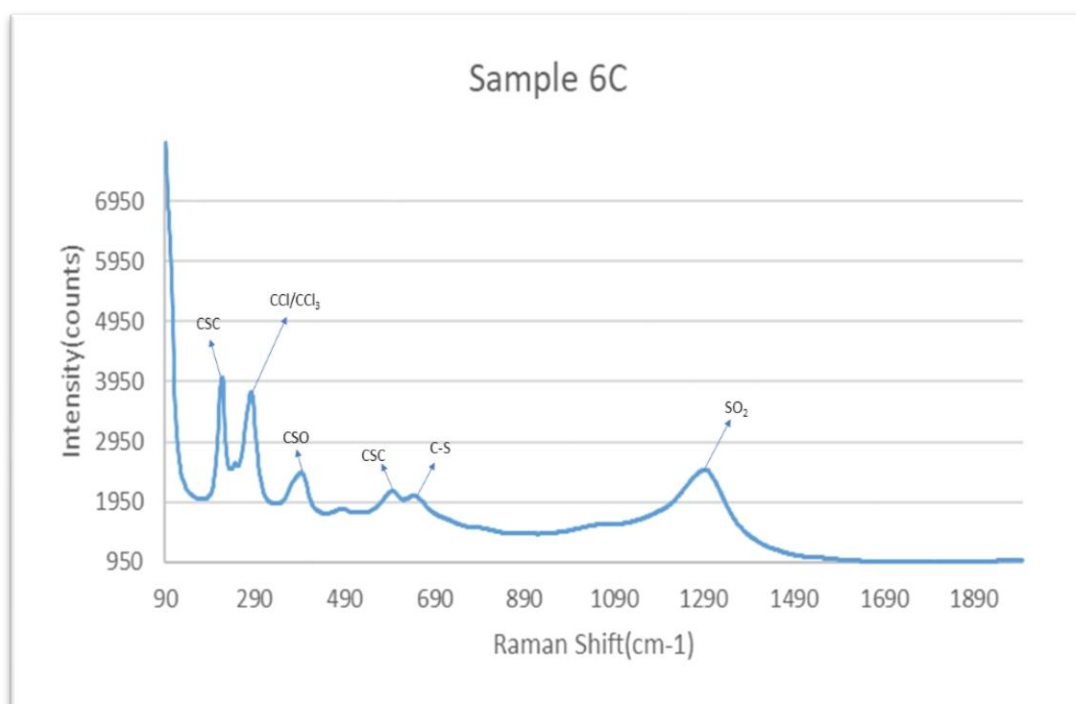
Figure 32. Raman analysis of sample from sample site 6.

Raman spectrum in **Figure 32** shows that sample site 6 contains sulfur and chloride compounds. Sample 6A and C are similar with the differences being that sample 6C has thiocyanates (CSC) at $\sim 550\text{cm}^{-1}$ and aliphatic sulfides and disulfides (C-S) at $\sim 670\text{cm}^{-1}$. Compared to sample 6A having secondary thioamides (NCS) at 584cm^{-1} . The differences between sample 6B and the other sample is the aliphatic acid chloride (Cl=C=O) at $\sim 380\text{cm}^{-1}$ and isothiocyanates (N=C=S) at $\sim 1188\text{cm}^{-1}$. Samples 6A and C have methyl sulphones(SO₂) at $\sim 1290\text{cm}^{-1}$.

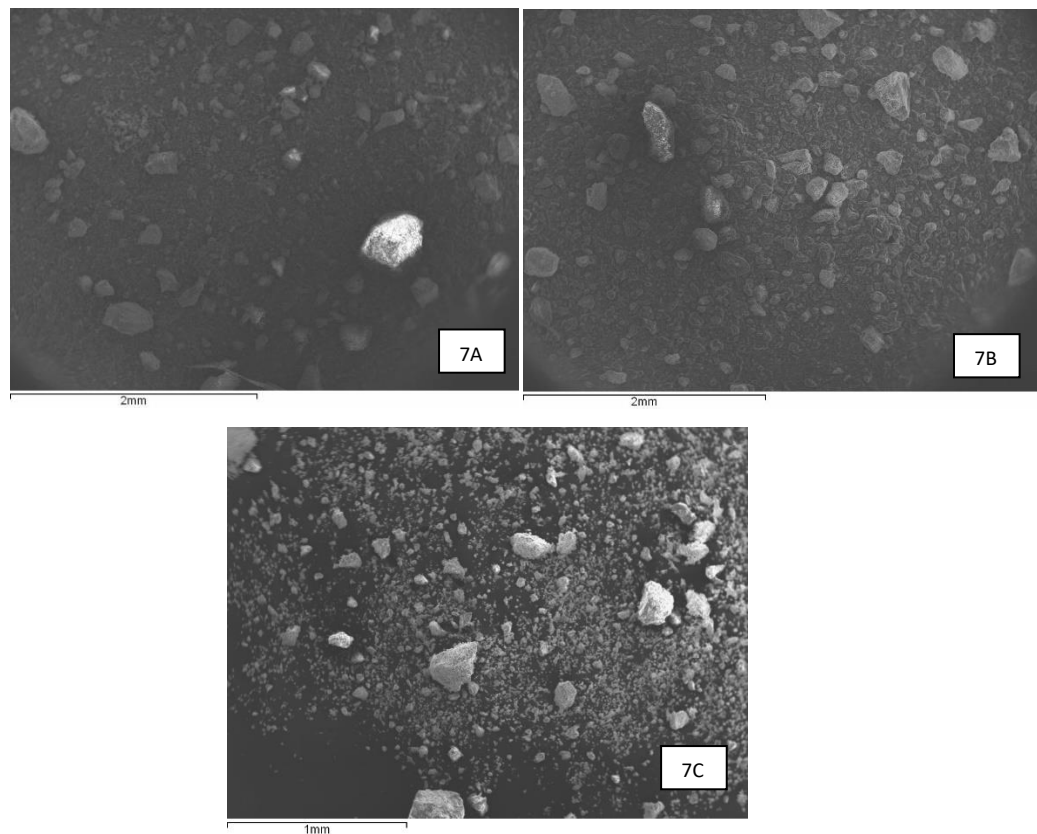
Figure 34. SEM analysis of sample site 7.

Figure 34 shows the SEM images for sample site 7. The EDX detected the following elements in all the samples: carbon, silicon, chlorine, manganese, calcium, sulfur, titanium, iron, zinc, sodium and magnesium, Sample 7A also contained cerium, barium, potassium, phosphorus and aluminium. Sample 7B additionally contained barium and bromine while sample 7C also contained aluminium and potassium.
