THE INVESTIGATION OF
THE CAUSE AND
SEVERITY OF
CORROSION AT THE
PORT OF DOVER

Thesis Submitted For The Degree Of Research Masters In
Chemistry At The University Of Kent

Abstract

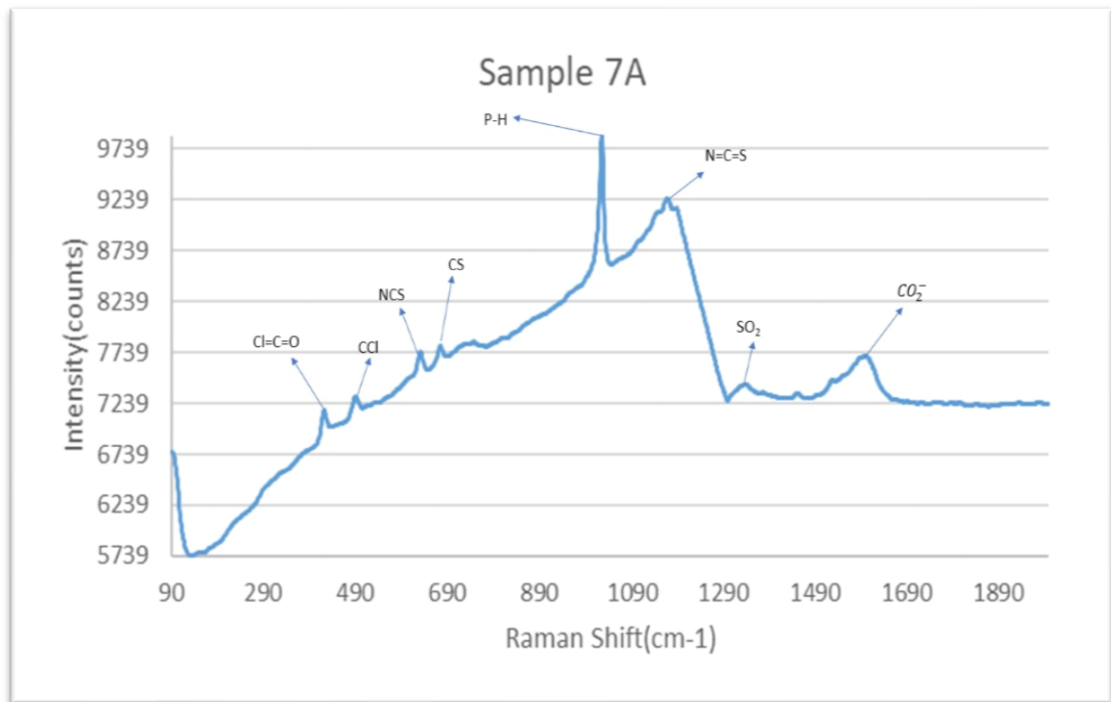
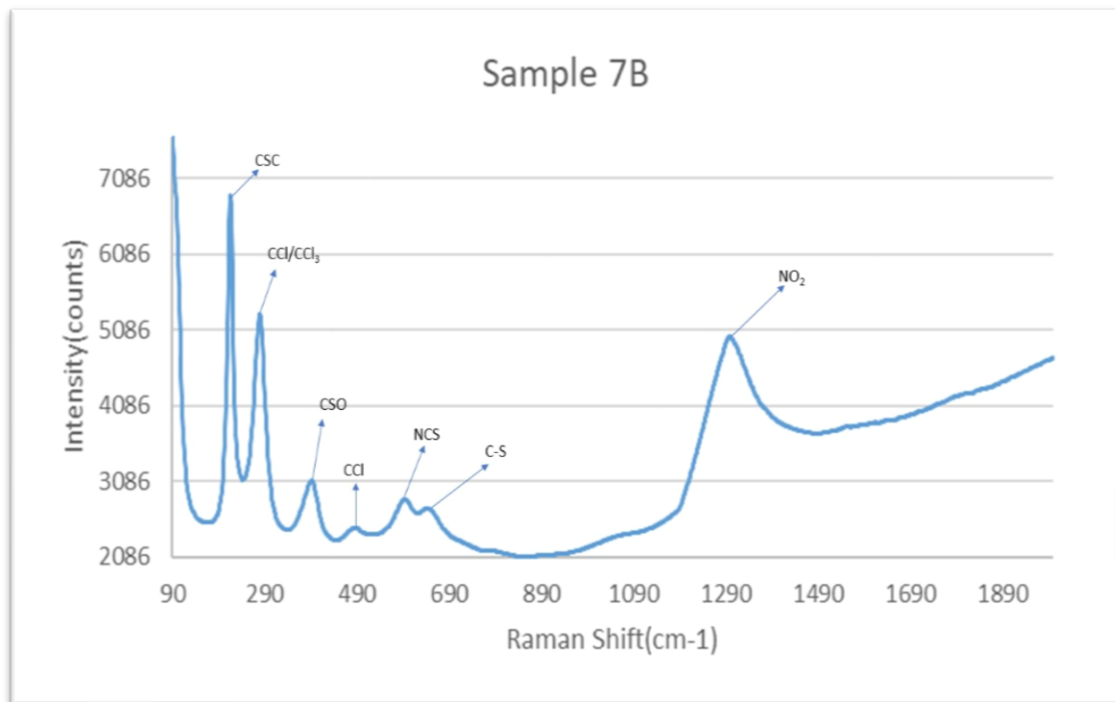
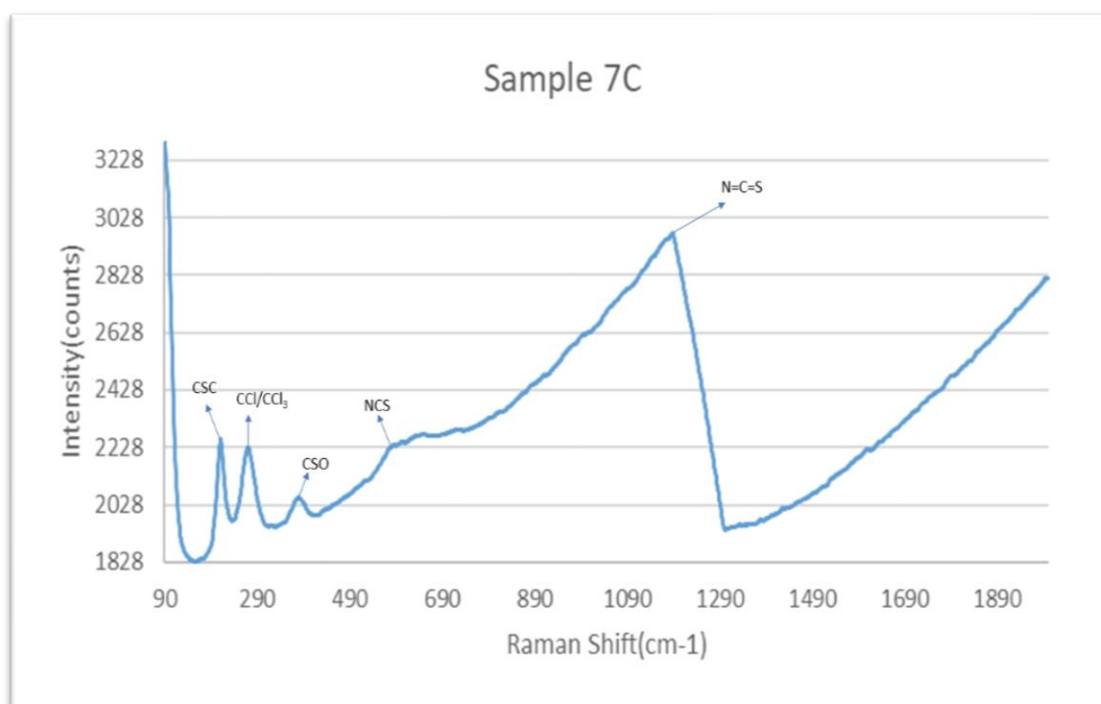
Figure 35. Raman analysis of samples from sample site 7.

Figure 35 shows the Raman spectrum for the samples from sample site 7. Samples 7B and 7C have spectrum, which have already been previously discussed containing compounds that are made up of mainly carbon, sulfur, nitrogen and chlorine. Sample 7A is the different spectrum for this sample site containing: aliphatic acid chlorides($\text{Cl}=\text{C}=\text{O}$) at 423cm^{-1} , aliphatic chloroformates(CCl) at 491cm^{-1} , tertiary thioamides(NCS) at 584cm^{-1} , aliphatic sulfides and disulfides (C-S) at 676cm^{-1} , phosphorus to hydrogen bonding (P-H) at 1025cm^{-1} , isothiocyanates($\text{N}=\text{C}=\text{S}$) at $\sim 1188\text{cm}^{-1}$, methyl sulphones (SO_2) at $\sim 1290\text{cm}^{-1}$ and lastly aromatic acid salts (CO_2^-) at $\sim 1550\text{cm}^{-1}$.

The sharpest peak in sample 7A is the phosphorus to hydrogen bond, which has not been seen in other sample site containing phosphorus. Another new peak was at $\sim 1550\text{cm}^{-1}$, which has been identified as being aromatic acid salts. This is evidence that there is a corrosive environment and that carbon is helping with the deposition as aromaticity is usually from benzene ring made up of carbon.

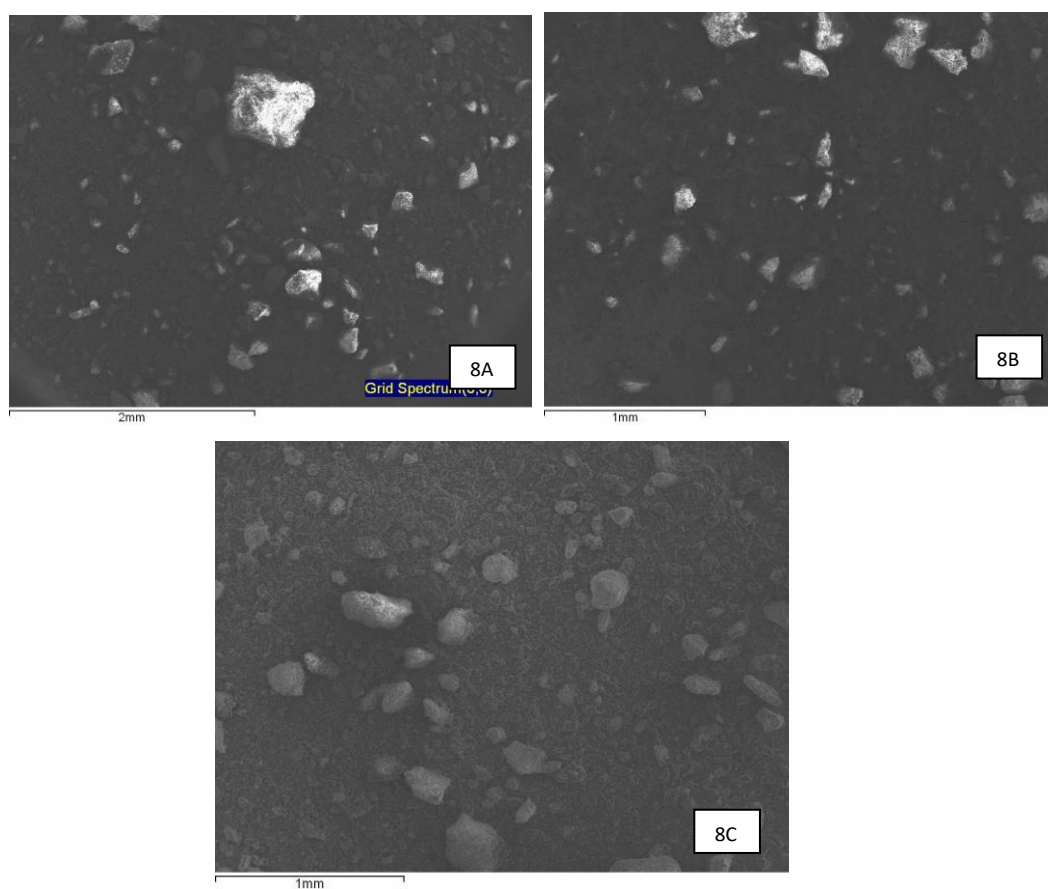
Figure 37. SEM analysis of samples from sample site 8.

Figure 37 shows the SEM images for sample site 8. Compounds detected by the EDX for sample site 8 where: chlorine, aluminium, carbon, silicon, calcium, sulfur, titanium, zinc, iron, cerium, sodium and magnesium. Sample 8A also contained barium, bromine, phosphorus and europium. Sample 8B additionally contained barium, phosphorus, rubidium, potassium and bromine. Sample 8C also contained potassium.

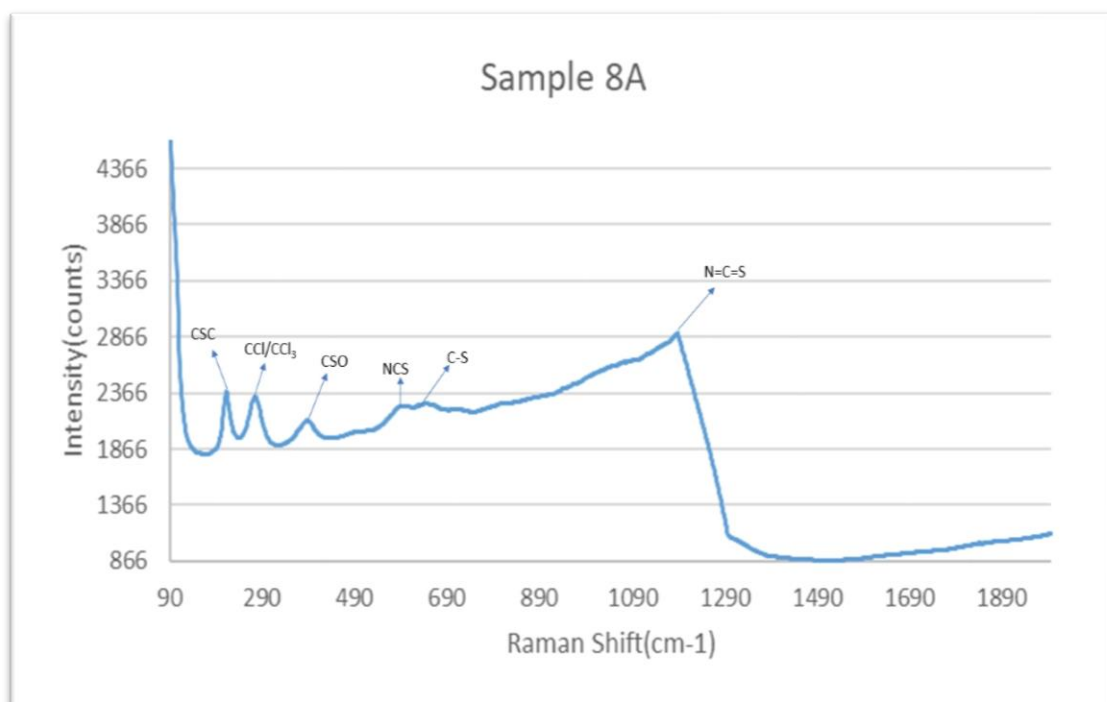
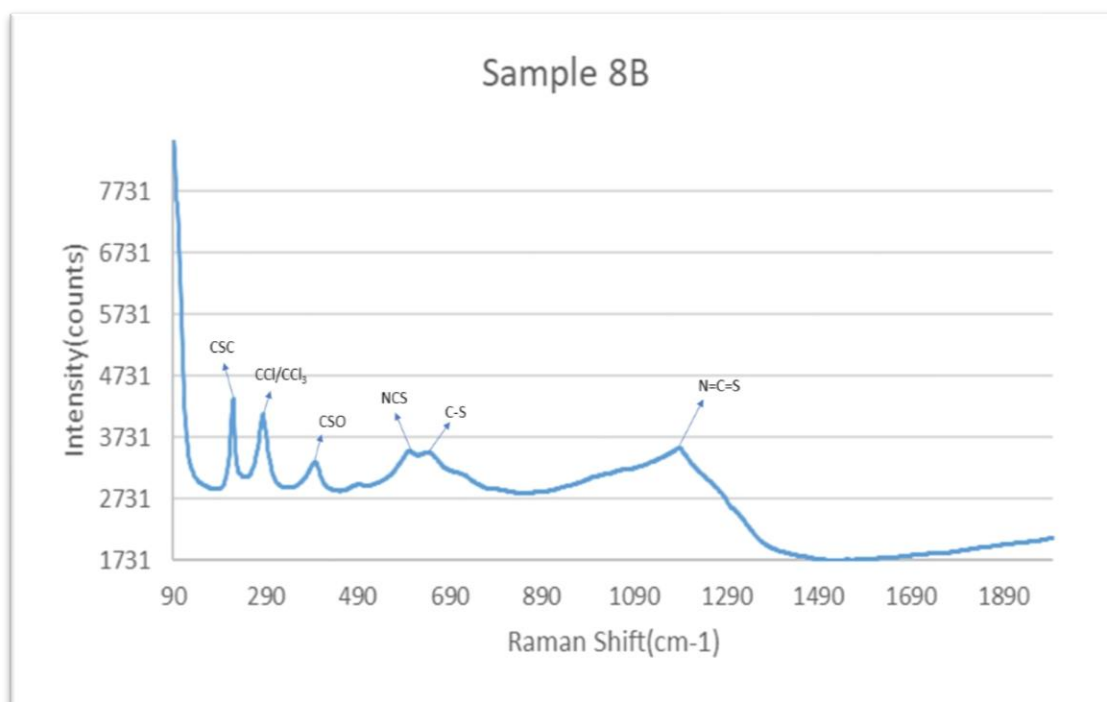
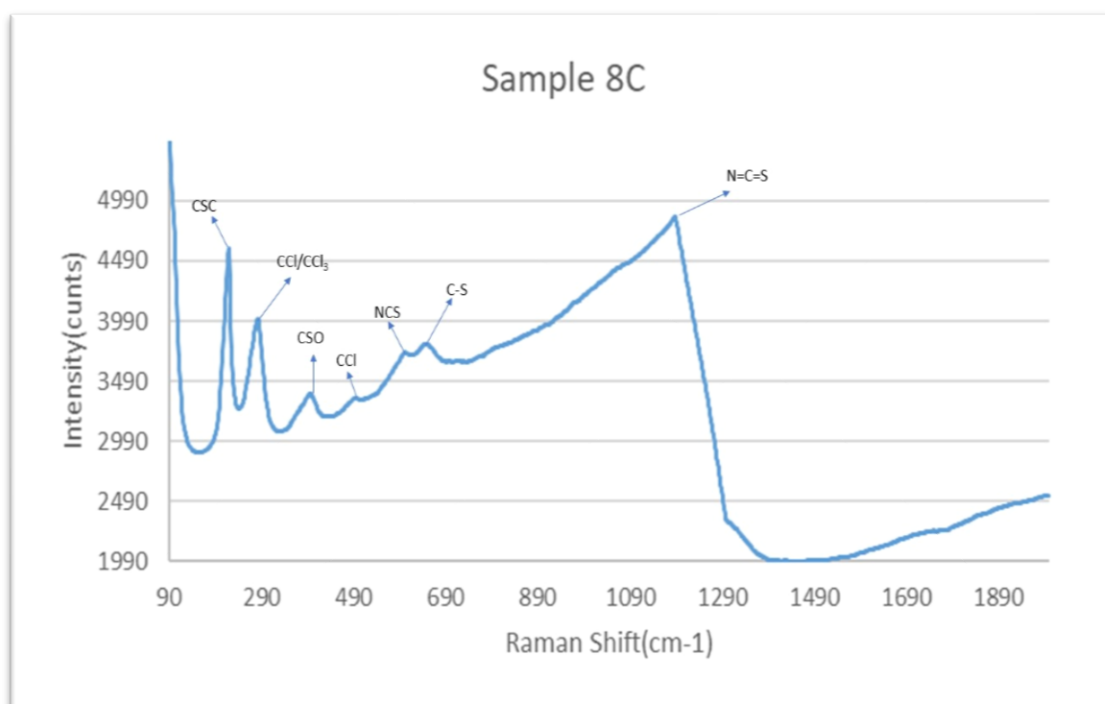
Figure 38. Raman analysis of samples from sample site 8.

All the samples for sample site 8 have been identified to have the same compounds present as shown in **Figure 38**. The only differences between the spectrum, is the presence of aliphatic chloroformates (CCl) at $\sim 490\text{cm}^{-1}$ in sample 8C and that sample 8B has got a lot less fluorescence than the other two samples for sample site 8.

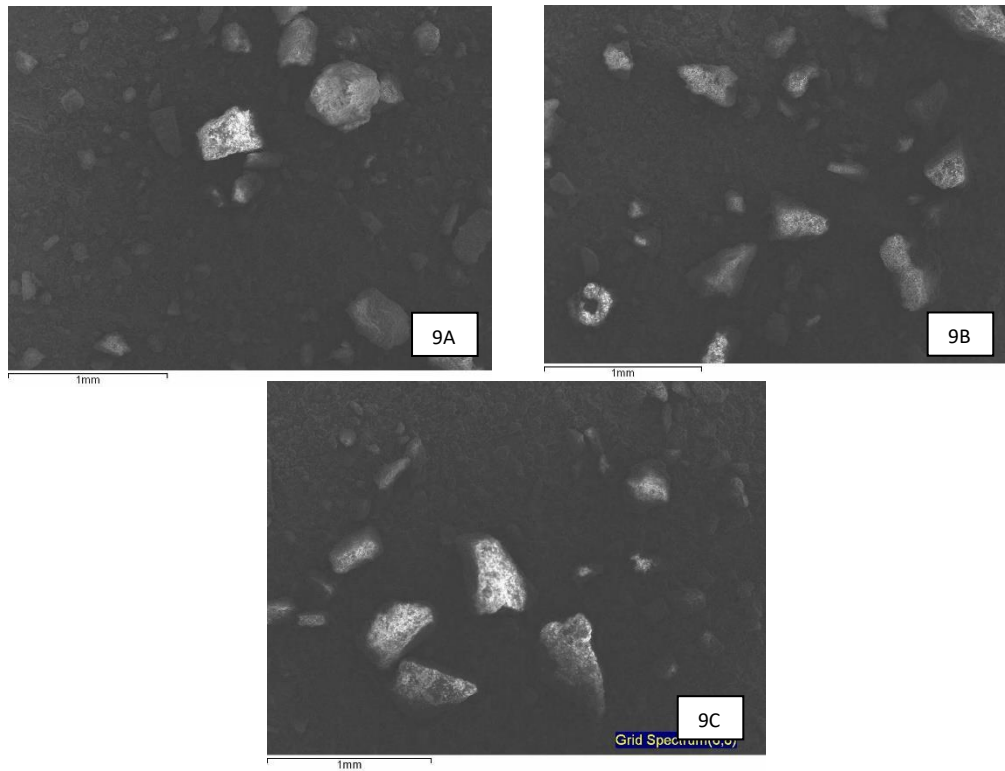
Figure 40. SEM analysis of samples from sample site 9.

The SEM images are shown in **Figure 40**, the following elements were detected: carbon, sulfur, titanium, manganese, chlorine, iron, phosphorus, calcium, zinc, aluminium, magnesium, sodium, silicon. Sample 9A also contained bromine, arsenic and barium. Sample 9B additionally contained cerium and barium, Sample 9C also contained cerium and potassium.

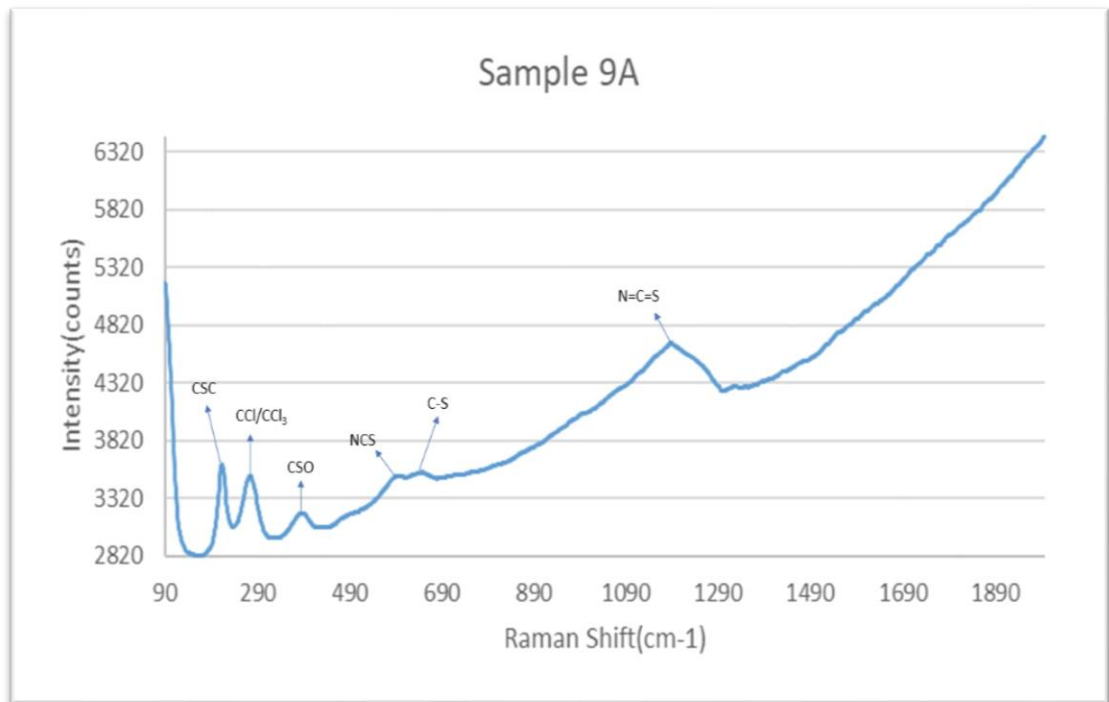
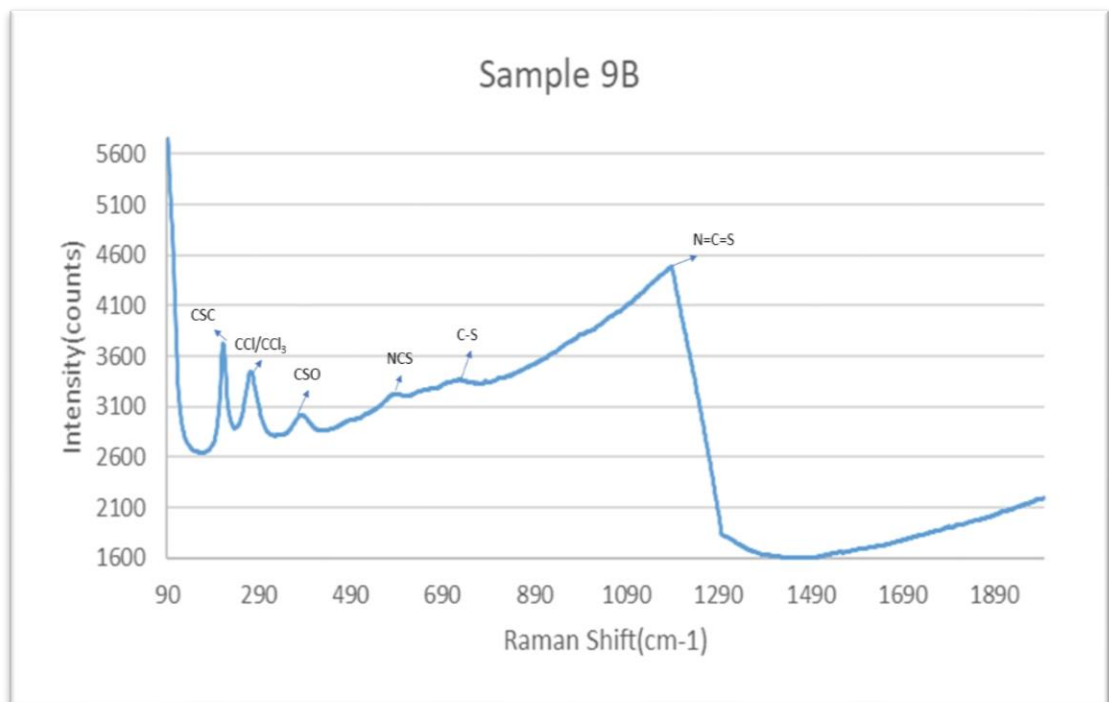
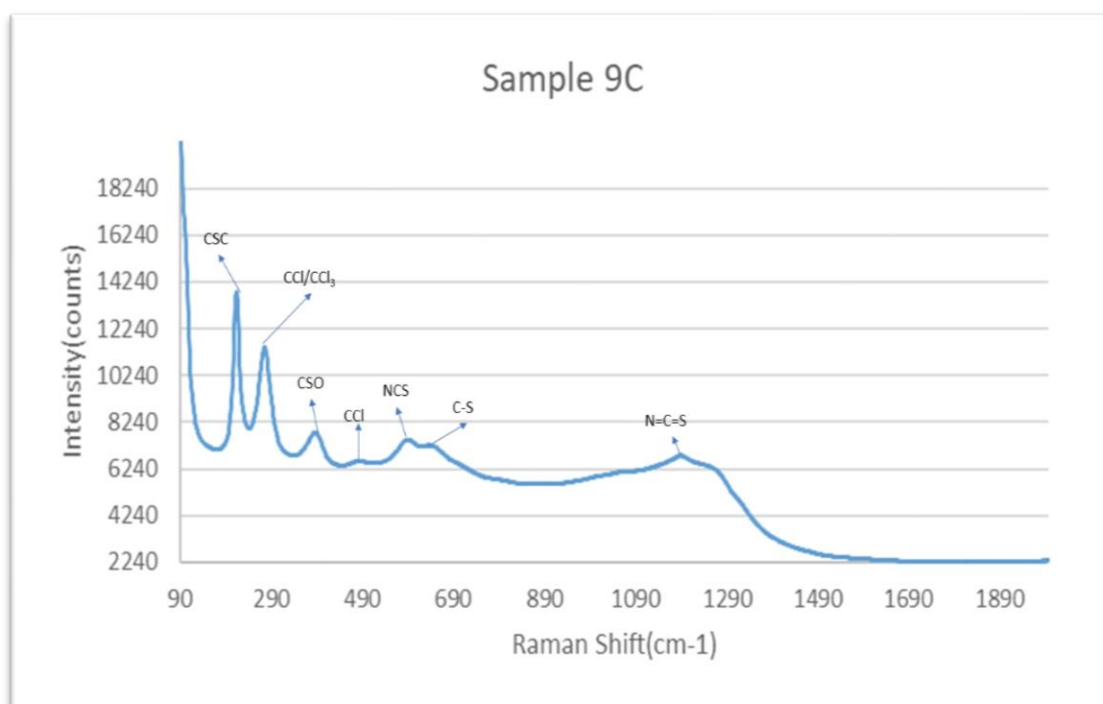
Figure 41. Raman analysis of samples from sample site 9.

The Raman spectra shown in **Figure 41**, are very similar to those recorded for sample site 8, where sample 9C contains the additional peak at $\sim 490\text{cm}^{-1}$ for aliphatic chloroformates (CCl). Sample 9C demonstrated little fluorescence interference when compared to the other samples of sample site 9, which explains why that extra peak was able to be identified.

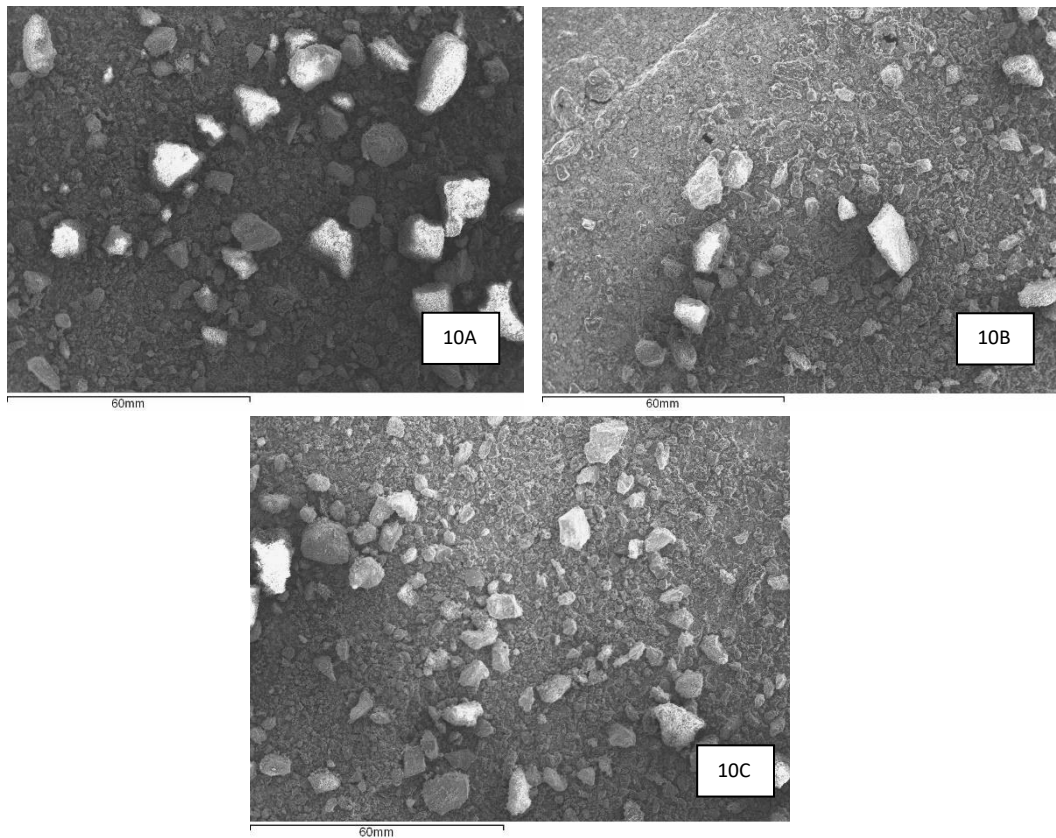
Figure 43. SEM analysis of samples from sample site 10.

The SEM images can be seen in **Figure 43**. The EDX detected the following elements that were seen in all the samples: chlorine, silicon, sulfur, manganese, cadmium, titanium, fluorine, calcium, sodium, zinc, iron, aluminium, carbon, potassium and magnesium. Samples 9A and 9B also contained phosphorus.

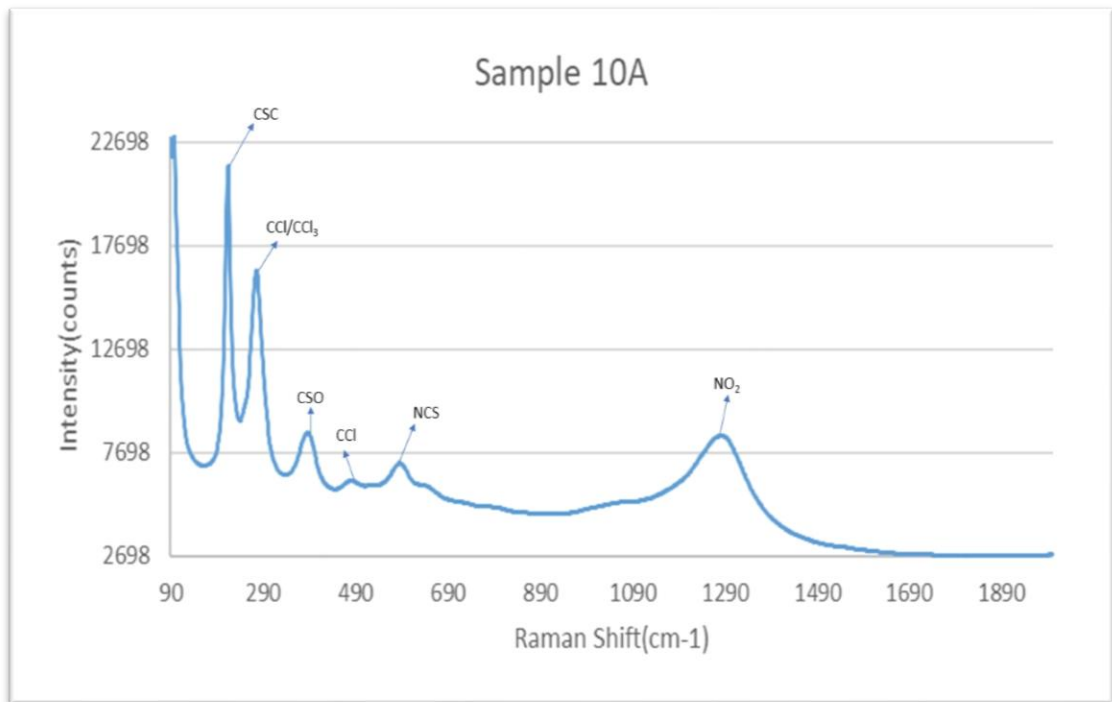
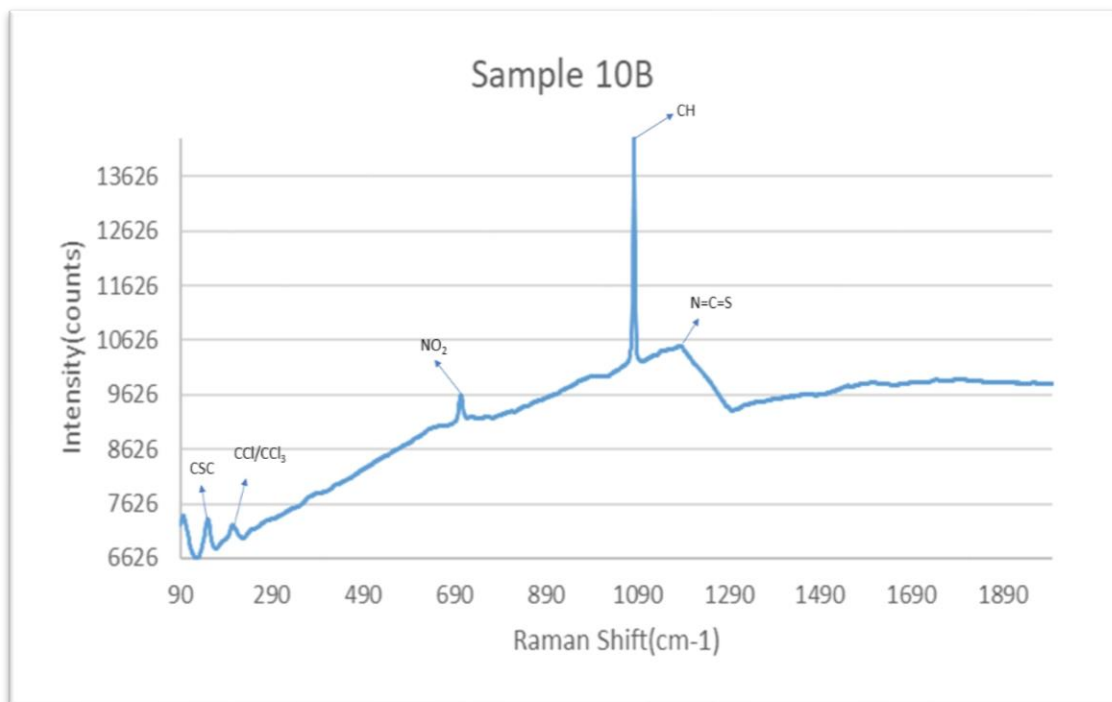
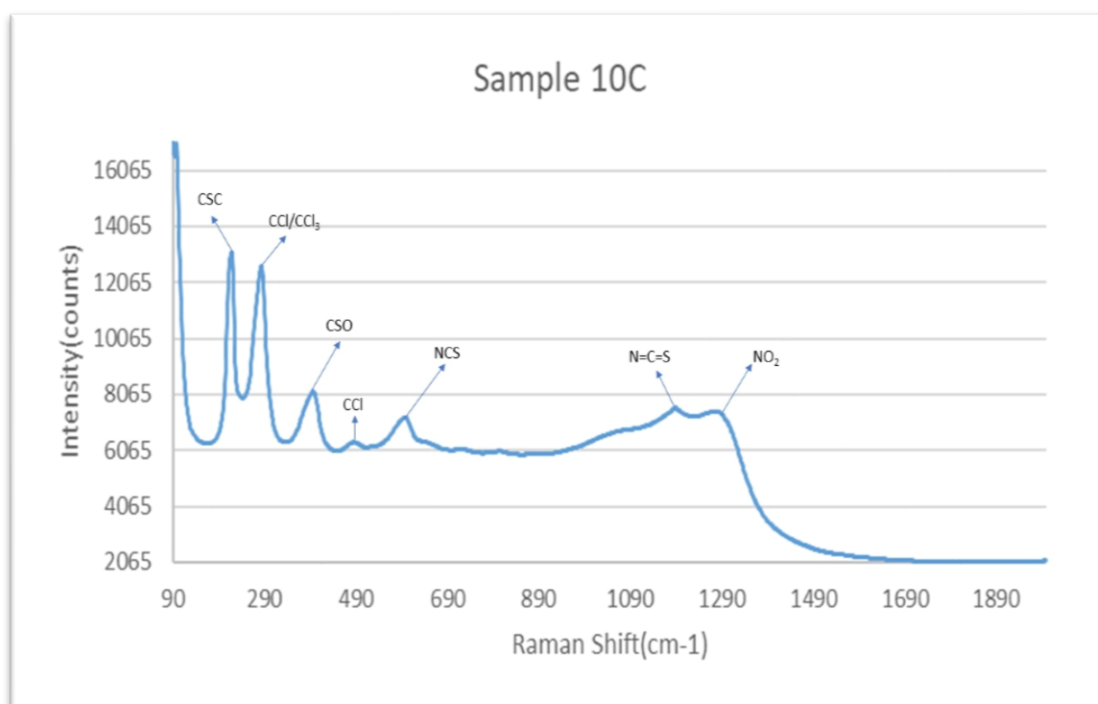
Figure 44. Raman analysis of samples from sample site 10.

Samples 10A and 10C have similar Raman spectra (**Figure 44**) with sample 10C having the additional peak at $\sim 1188\text{cm}^{-1}$ of isothiocyanates ($\text{N}=\text{C}=\text{S}$) close to the peak at $\sim 1270\text{cm}^{-1}$ nitroamines (NO_2). Both spectra have low fluorescence interference as seen in **Figure 44**.

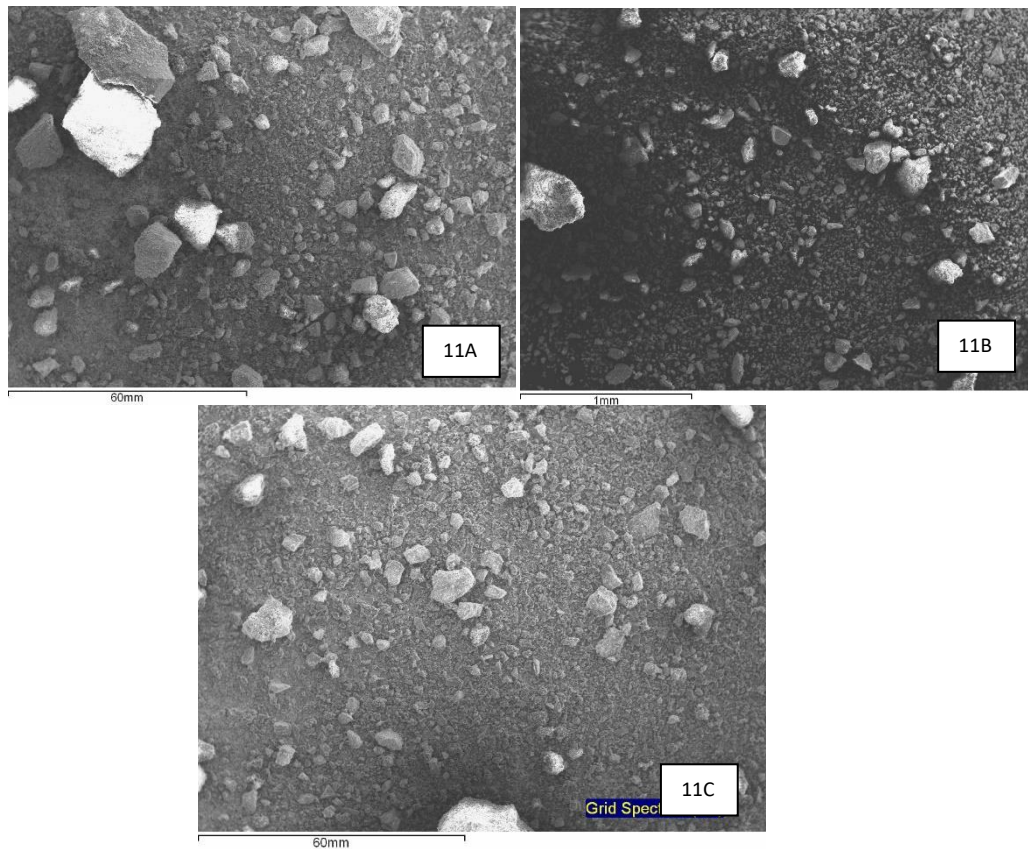
Figure 46. SEM analysis of samples from sample site 11.

All the samples in **Figure 46** contained the following elements: chlorine, sodium, calcium, titanium, iron, manganese, magnesium, zinc, silicon and sulfur. Sample 11A also contained fluorine, phosphorus and cadmium. Sample 11B additionally contains aluminium, potassium and cerium. Sample 11C also contained cadmium, fluorine, phosphorus, aluminium and potassium.

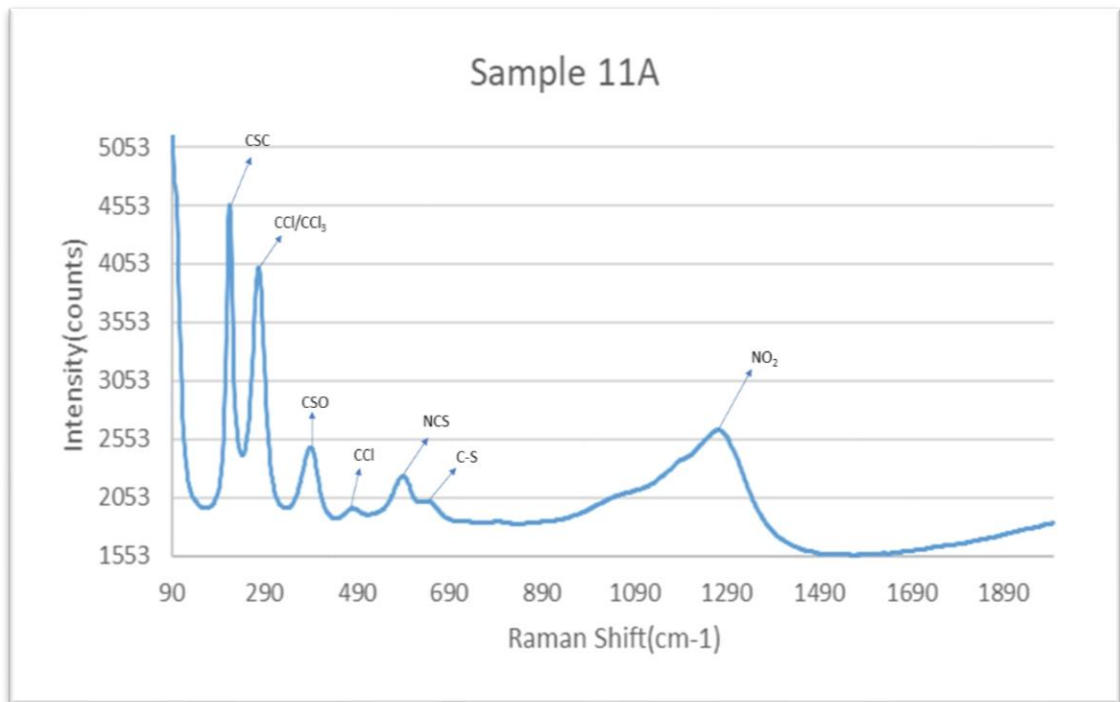
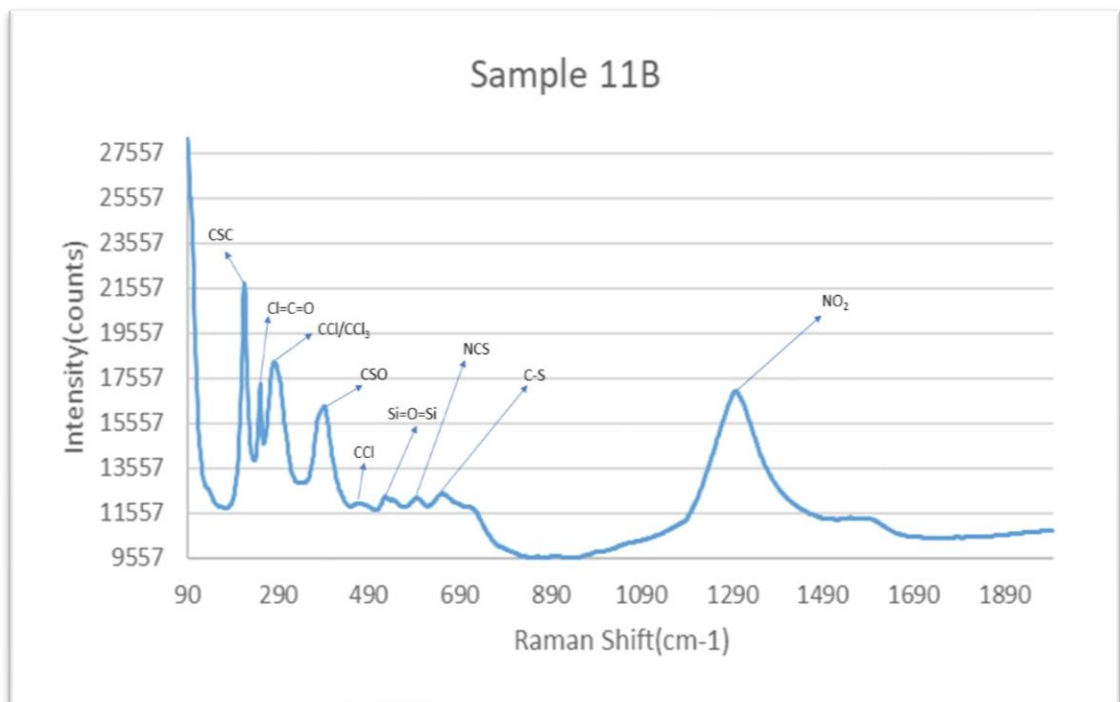
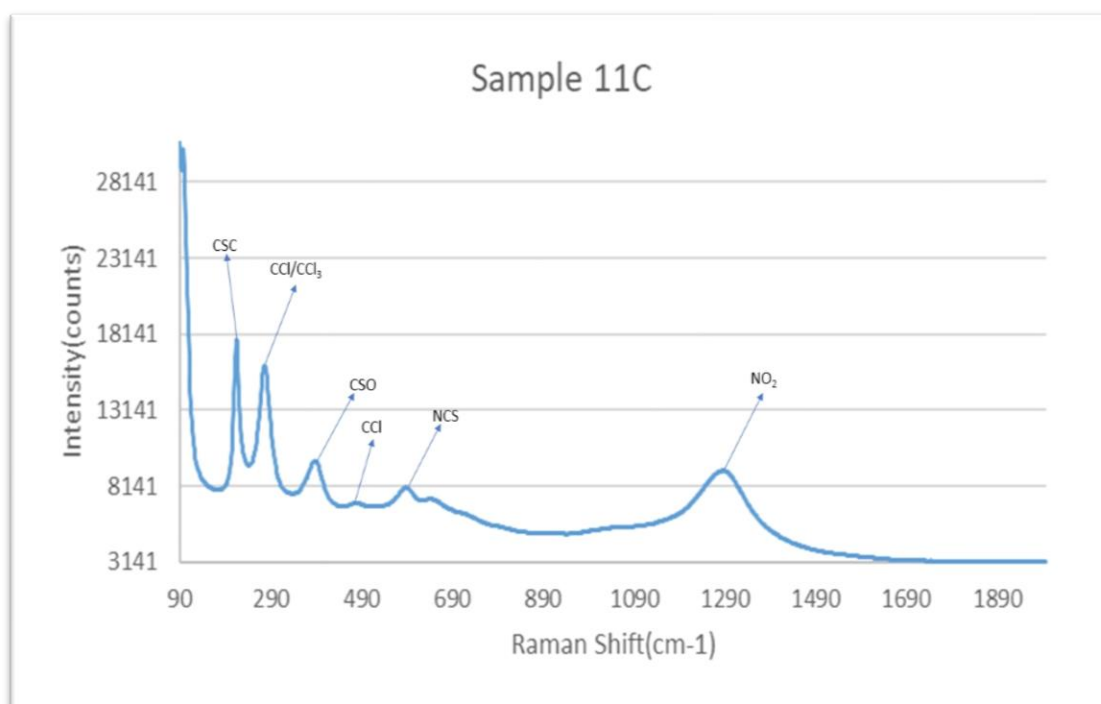
Figure 47. Raman analysis of samples from sample site 11.

The Raman spectra seen in **Figure 47**, are from the analysed samples taken from sample site 11, the spectra have low fluorescence interference. Spectrum for sample 11A and 11C are very similar with 11A containing an additional peak at $\sim 650\text{cm}^{-1}$ of aliphatic sulfides and disulfides. Sample 11B contains more peaks than the other spectrum. The differences being: a peak at $\sim 250\text{cm}^{-1}$ aliphatic acid chloride ($\text{Cl}=\text{C}=\text{O}$) and a peak at $\sim 500\text{cm}^{-1}$, which has been identified as silicon oxide ($\text{Si}-\text{O}-\text{Si}$).

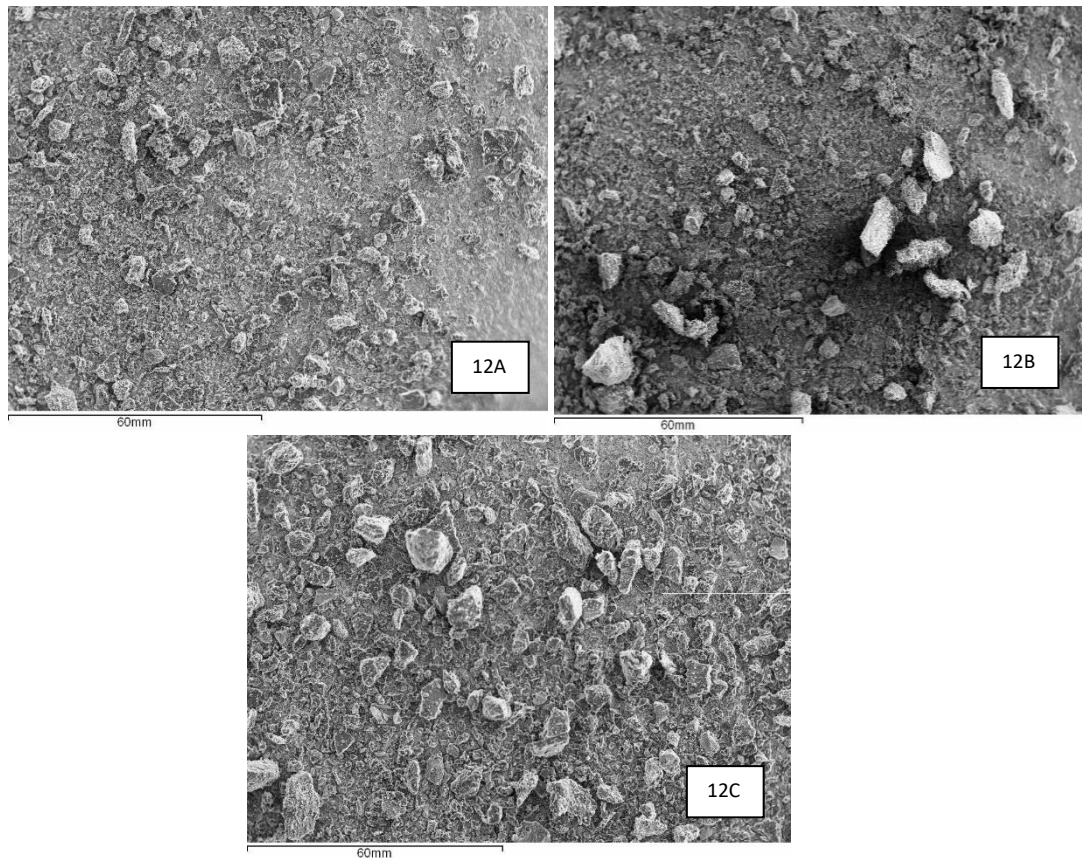
Figure 49. SEM analysis of samples from sample site 12.

Figure 49 shows the SEM images for sample site 12. The following elements were found in all the samples from samples site 10: carbon, iron, titanium, magnesium, silicon, sulfur, chlorine, fluorine, sodium, cadmium, calcium, zinc and phosphorus. Sample 12A also contained aluminium. Sample 12B additionally contained aluminium, manganese and copper.

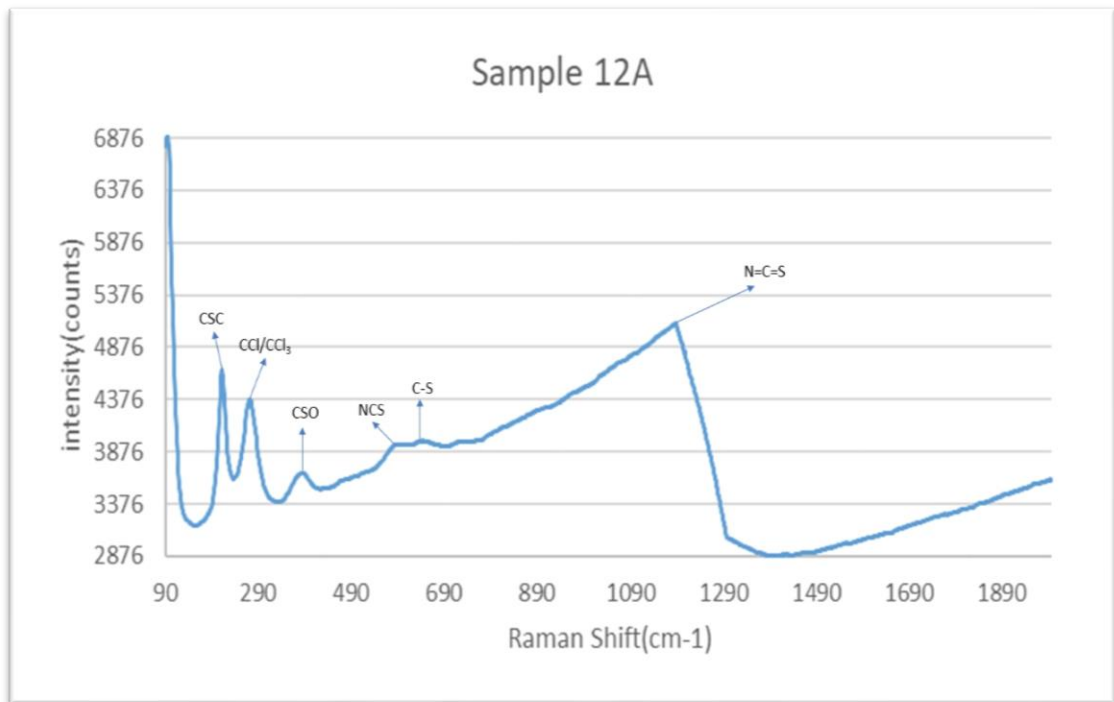
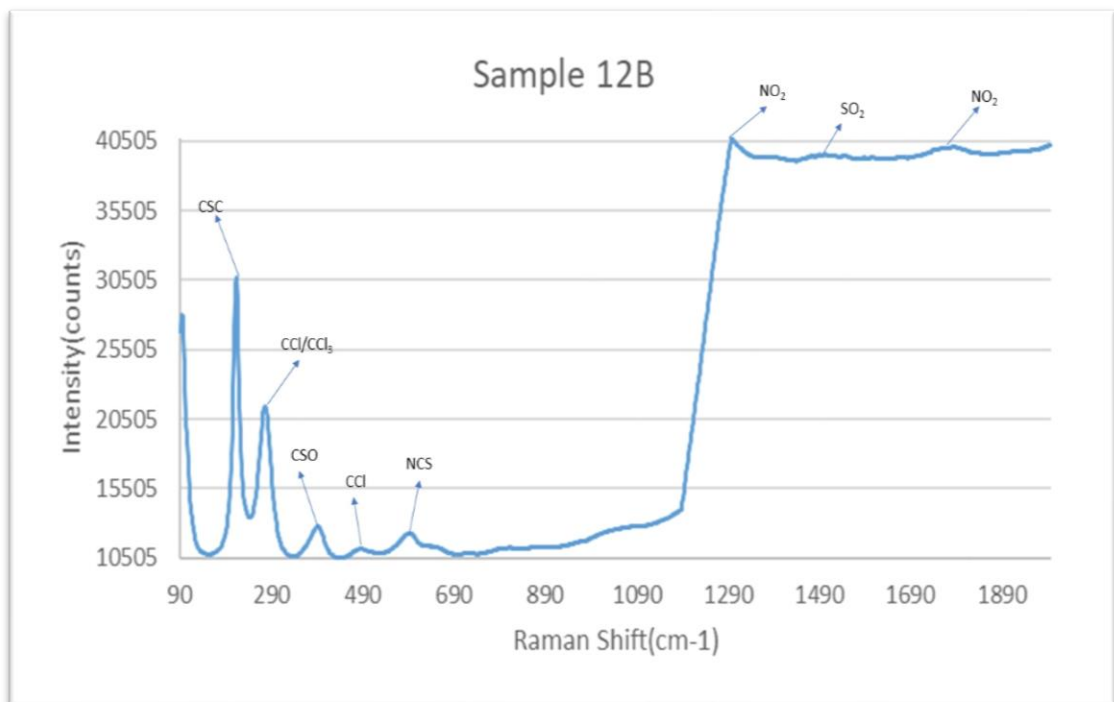
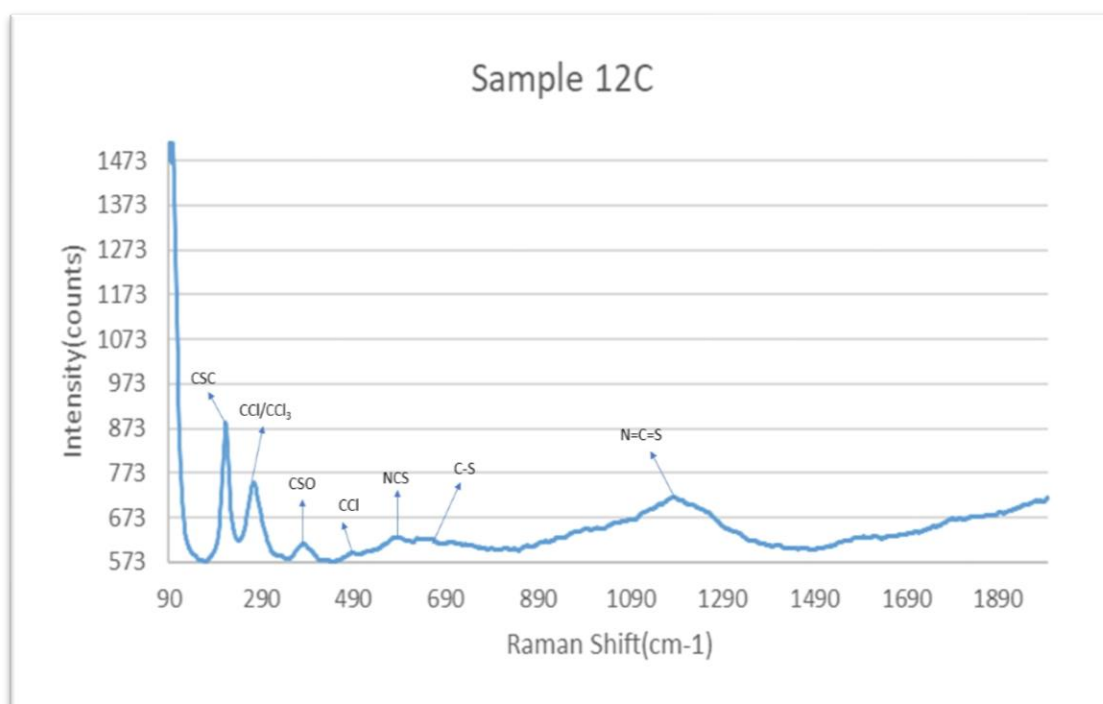
Figure 50. Raman analysis of samples from sample site 12.

The Raman spectra from sample site 12 shown in **Figure 50**, have similar characteristic peaks with low fluorescence interference. Sample 12B having the most differences at $\sim 1290\text{cm}^{-1}$, interpreted as nitroamimes (NO_2), at $\sim 1355\text{cm}^{-1}$ methyl sulphones (SO_2) and at $\sim 1502\text{cm}^{-1}$ aromatic nitro compounds (NO_2).

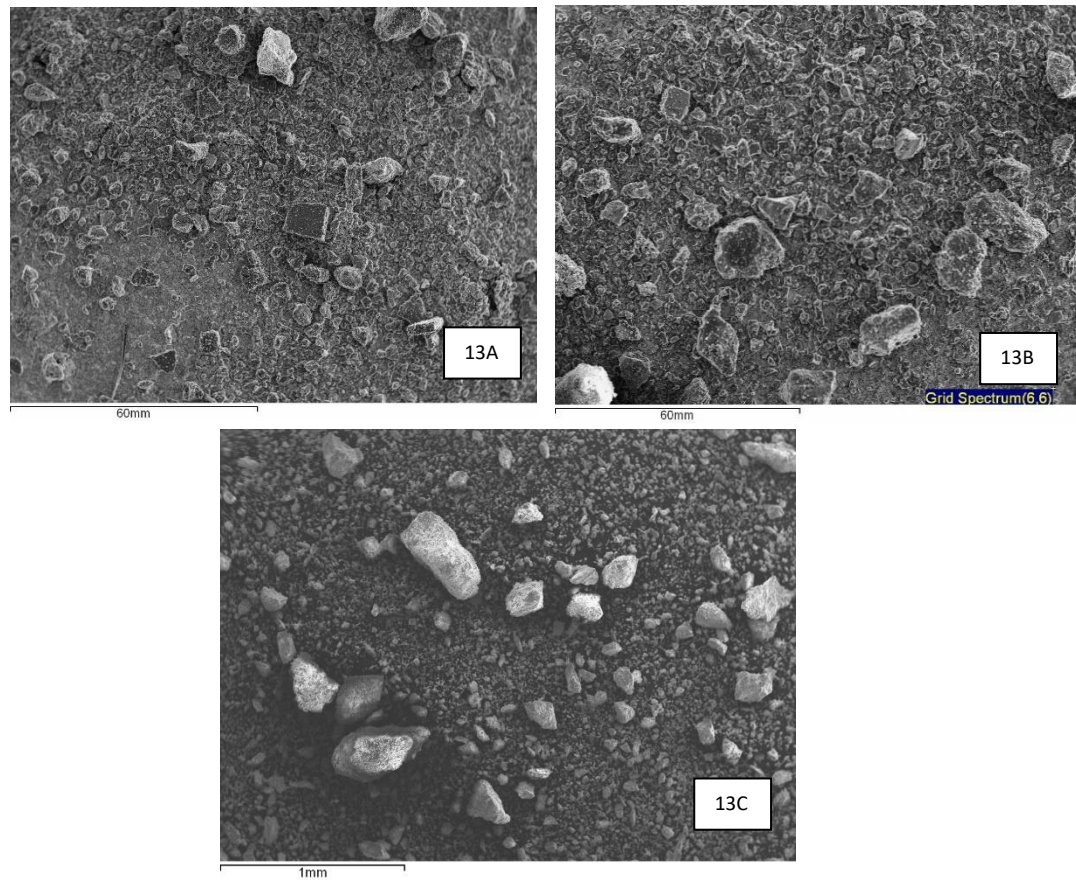
Figure 52. SEM analysis of samples from sample site 13.

Figure 52 shows the SEM images of sample site 13. The following elements were found in all the samples for sample site 13: carbon, iron, titanium, sodium, silicon, sulfur, calcium and chlorine. Sample site 13A and 13B also contained fluorine, and cadmium. Sample 13B additionally contained phosphorus. Sample 13C contained aluminium, potassium, manganese, cerium and barium.
