THE INVESTIGATION OF
THE CAUSE AND
SEVERITY OF
CORROSION AT THE
PORT OF DOVER

Thesis Submitted For The Degree Of Research Masters In
Chemistry At The University Of Kent

Abstract

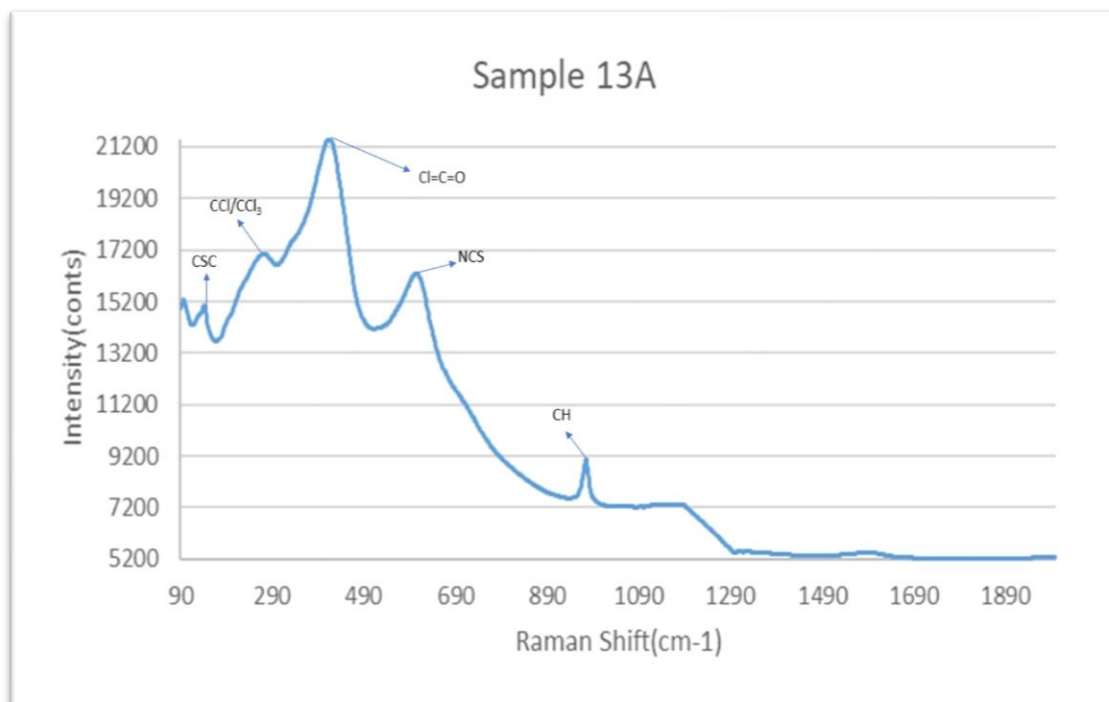
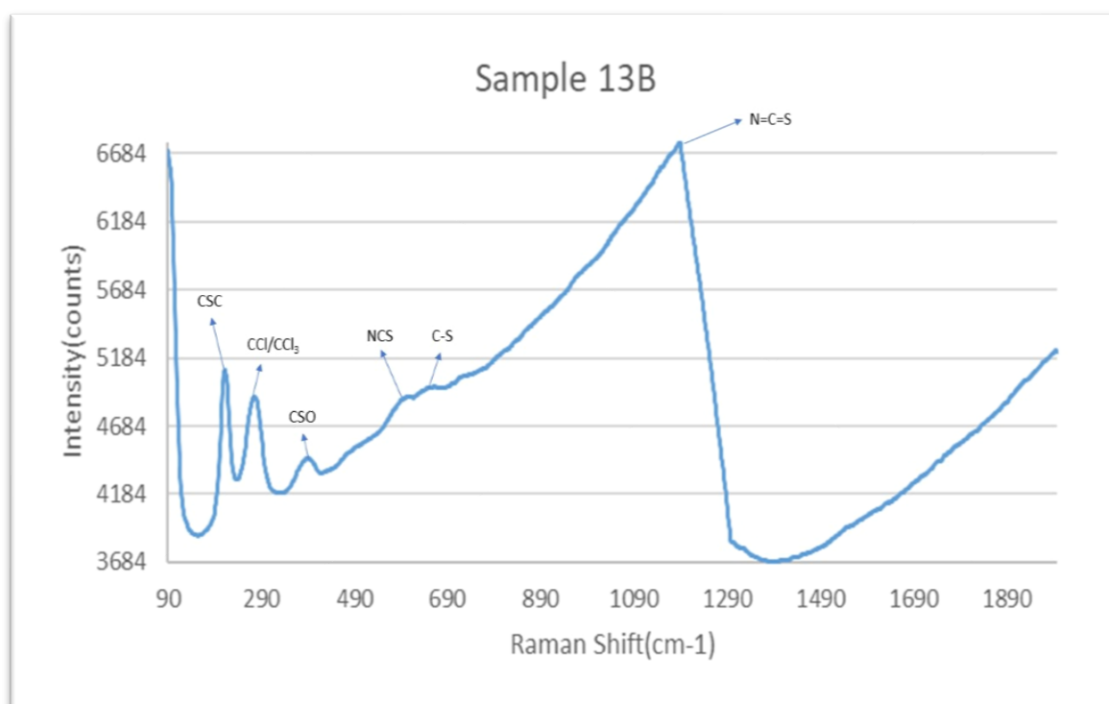
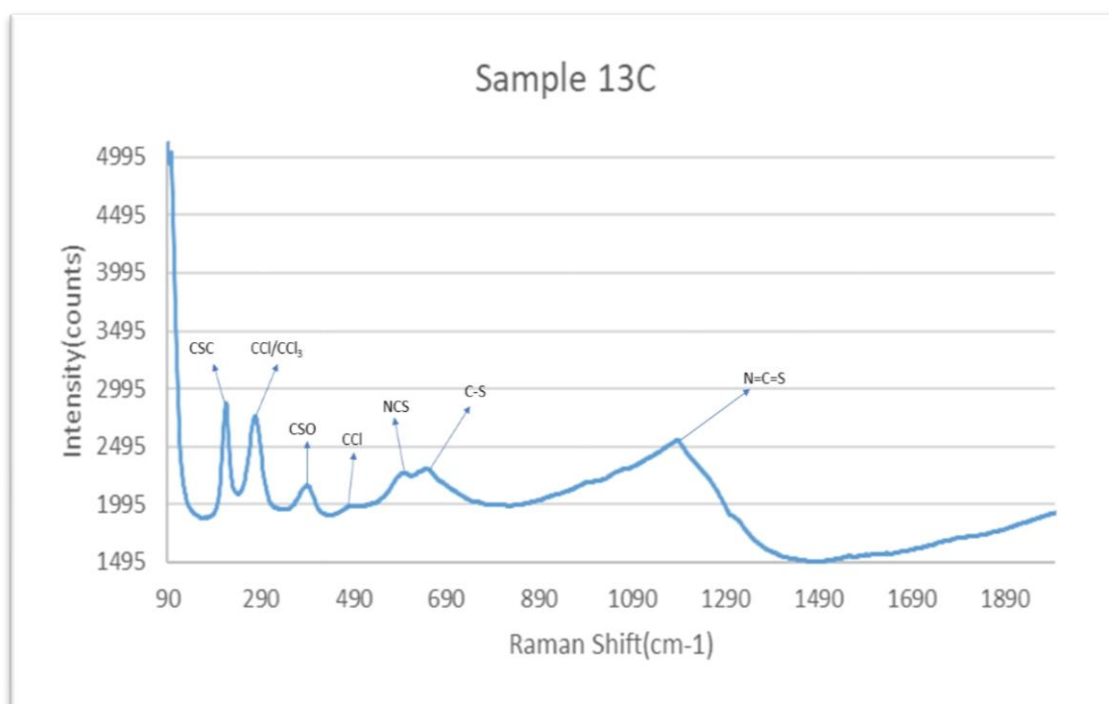
Figure 53. Raman analysis of samples from sample site 13.

Samples 13B and 13C have similar Raman spectra to the other sample sites (**Figure 53**). Sample 13A has a different spectrum but still contains commonly identified groups at $\sim 210\text{cm}^{-1}$, $\sim 280\text{cm}^{-1}$, $\sim 380\text{cm}^{-1}$ and $\sim 580\text{cm}^{-1}$. The different peak from sample site 13A is at $\sim 975\text{cm}^{-1}$ mono-substituted and para-substituted Benzene rings (CH).

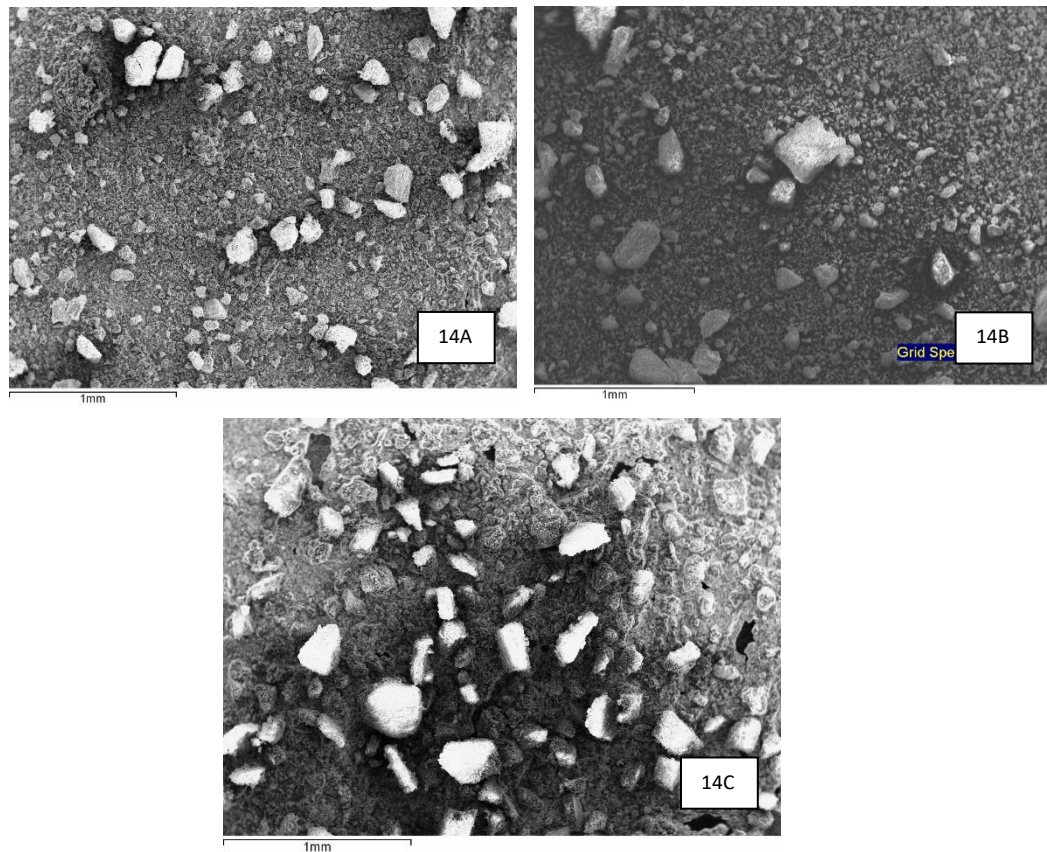
Figure 55. SEM analysis of sample site 14.

The SEM images are shown in **Figure 55** above. The elements detected in the samples for sample site 14: carbon, iron, zinc, chlorine, sodium, silicon, sulfur, calcium, titanium, cerium, aluminium and barium. Sample 14A additionally contained manganese and molybdenum. Sample 14B additionally contained potassium, manganese and neodymium. Sample 14C also contained rubidium.

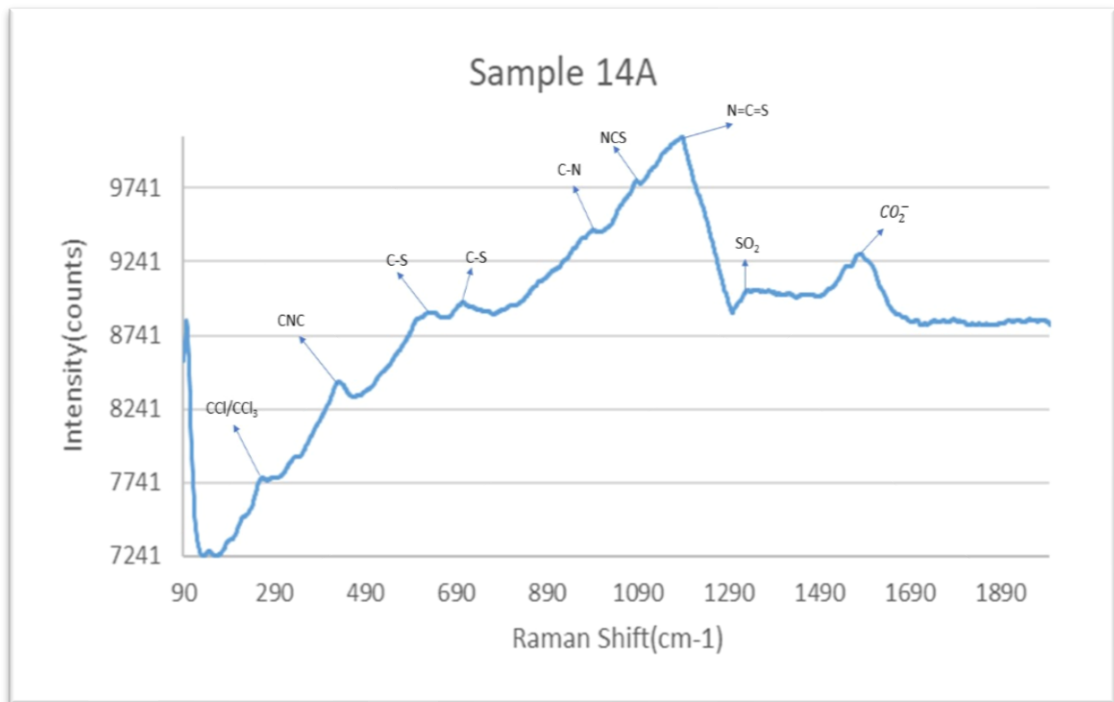
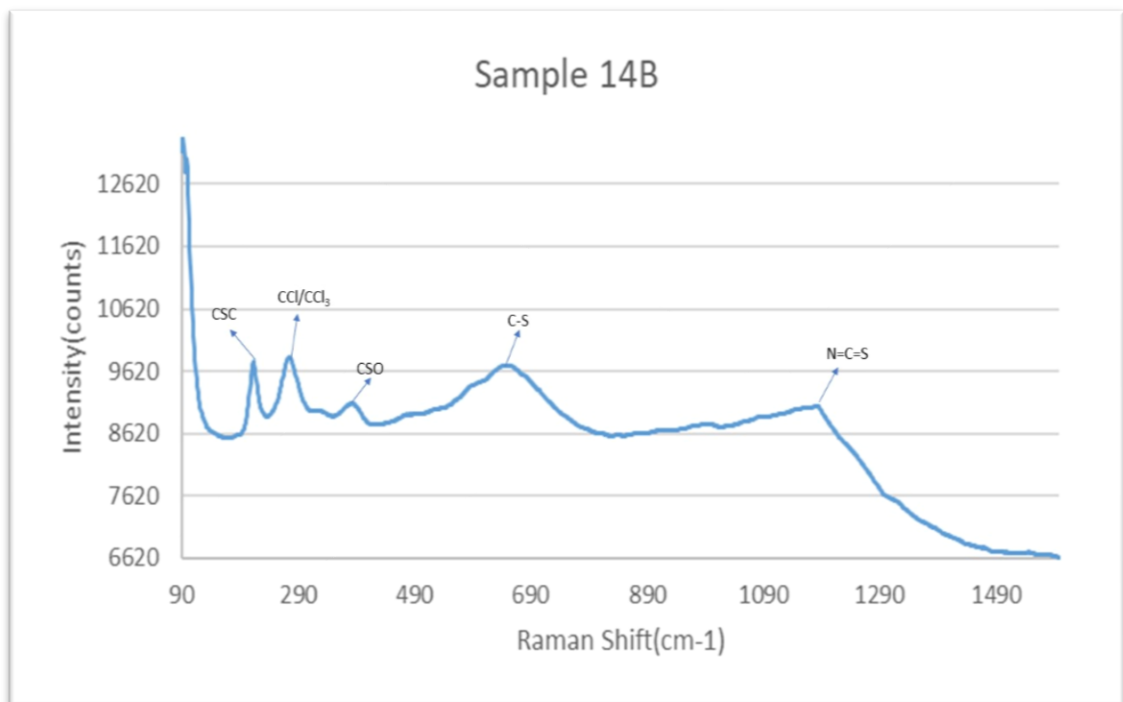
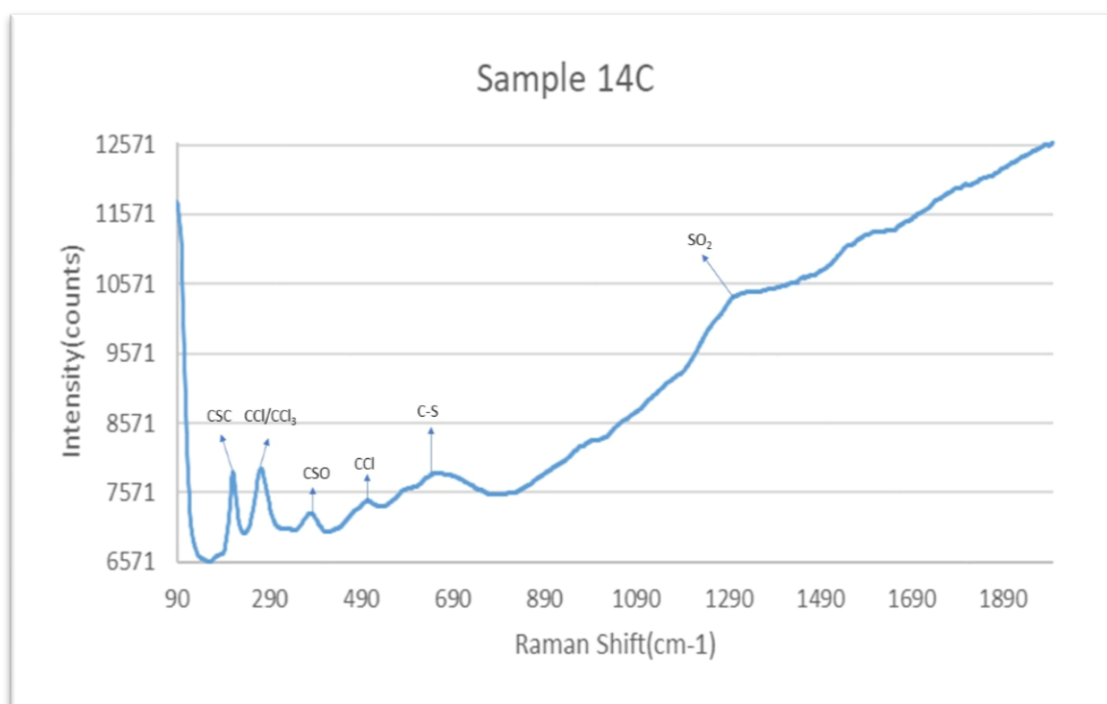
Figure 56. Raman analysis of samples form sample site 14.

Figure 56 shows the Raman spectra for sample site 14. Sample 14B and sample 14C show similar spectrum to other samples from the other sample sites. Sample 14A has a lot of fluorescence interference but some functional groups can be identified and associated with functional groups seen before. Sample 14A has peaks at 289, 432, 628, 704, 992, 1086, 1188, 1330 and 1551 cm^{-1} representing the respective compounds: Carbon chlorides (CCl/CCl_3), secondary aliphatic amines (CNC), aliphatic sulfides and disulfides (C-S), mono and disulphonyl chlorides (C-S), saturated primary and secondary nitro compounds (C-N), alkyl isothiocyanates (NCS), isothiocyanates ($\text{N}=\text{C}=\text{S}$), methyl sulphones (SO_2) and lastly aromatic acid slats (CO_2^-), respectively.

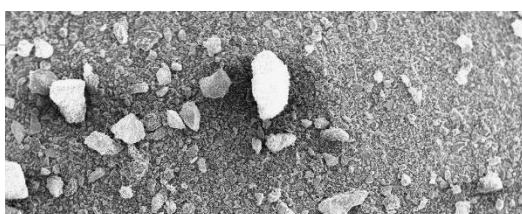
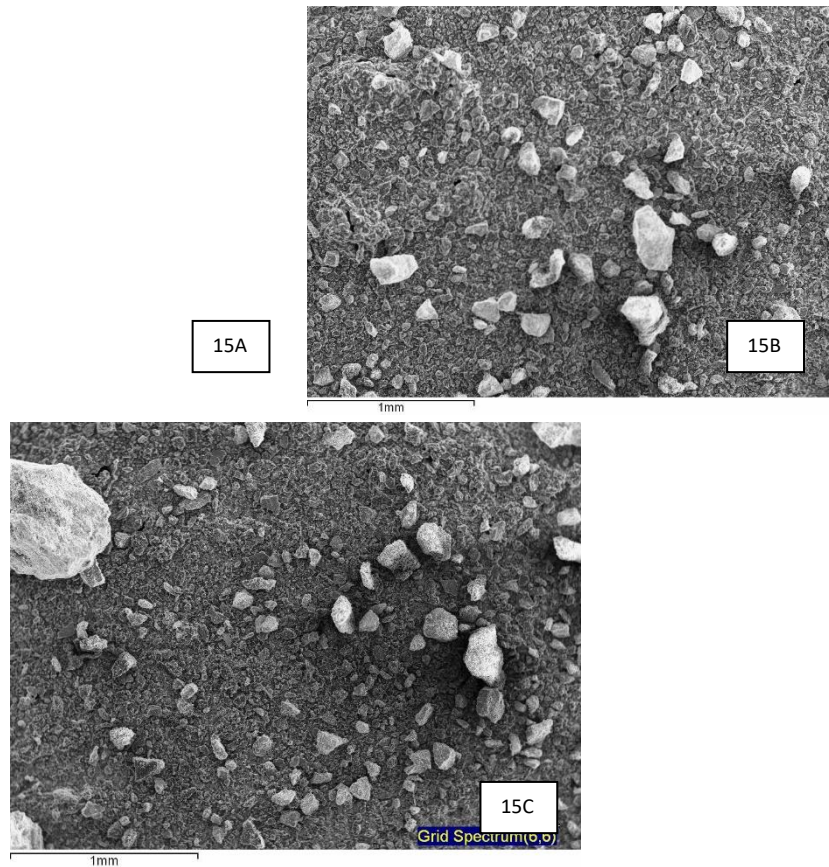
Figure 58. SEM analysis of samples from sample site 15.

The SEM images are shown above in **Figure 58**, the following elements were found in all the samples from sample site 15: carbon, titanium, iron, sodium, silicon, sulfur, zinc, chlorine, aluminium. Sample 15A also contains manganese, barium, potassium, calcium, magnesium and tungsten. Sample 15B additionally contains calcium, potassium and uranium. Sample 15C also contains magnesium.

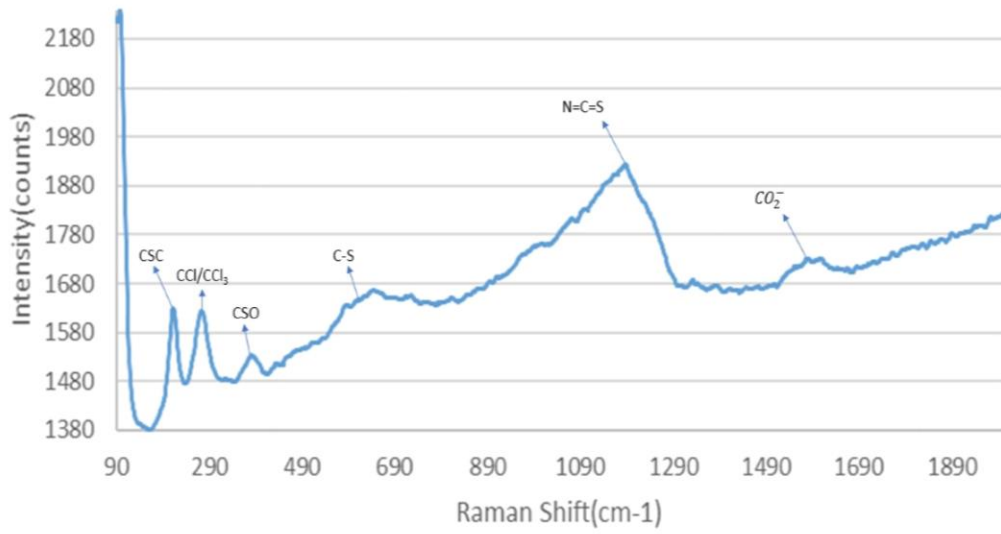
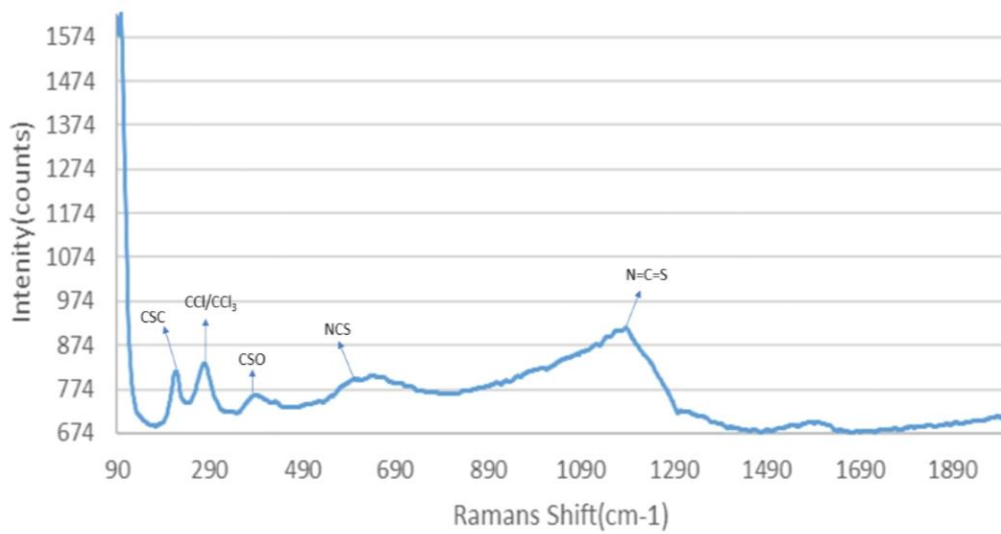
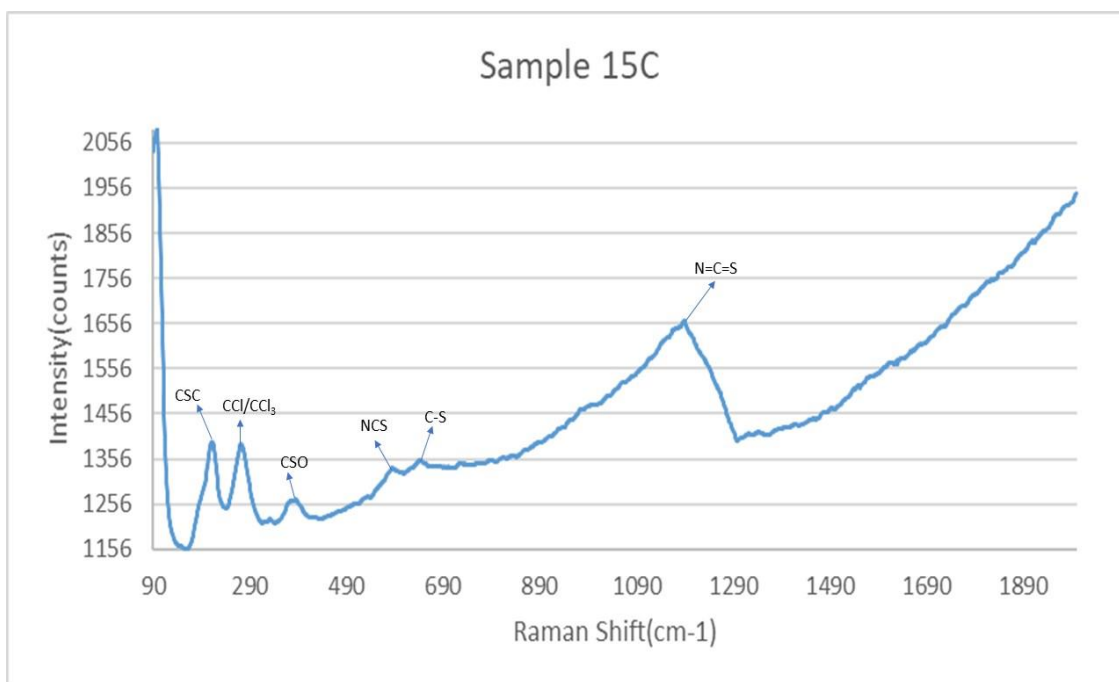
Figure 59. Raman analysis of samples from sample site 15.

Sample site 15 contains commonly identified compounds that are present in the other sample site, there are no drastic changes. Sample 15B has the least fluorescence interference compared to the other two samples from sample site 15 as seen in **Figure 59** above.

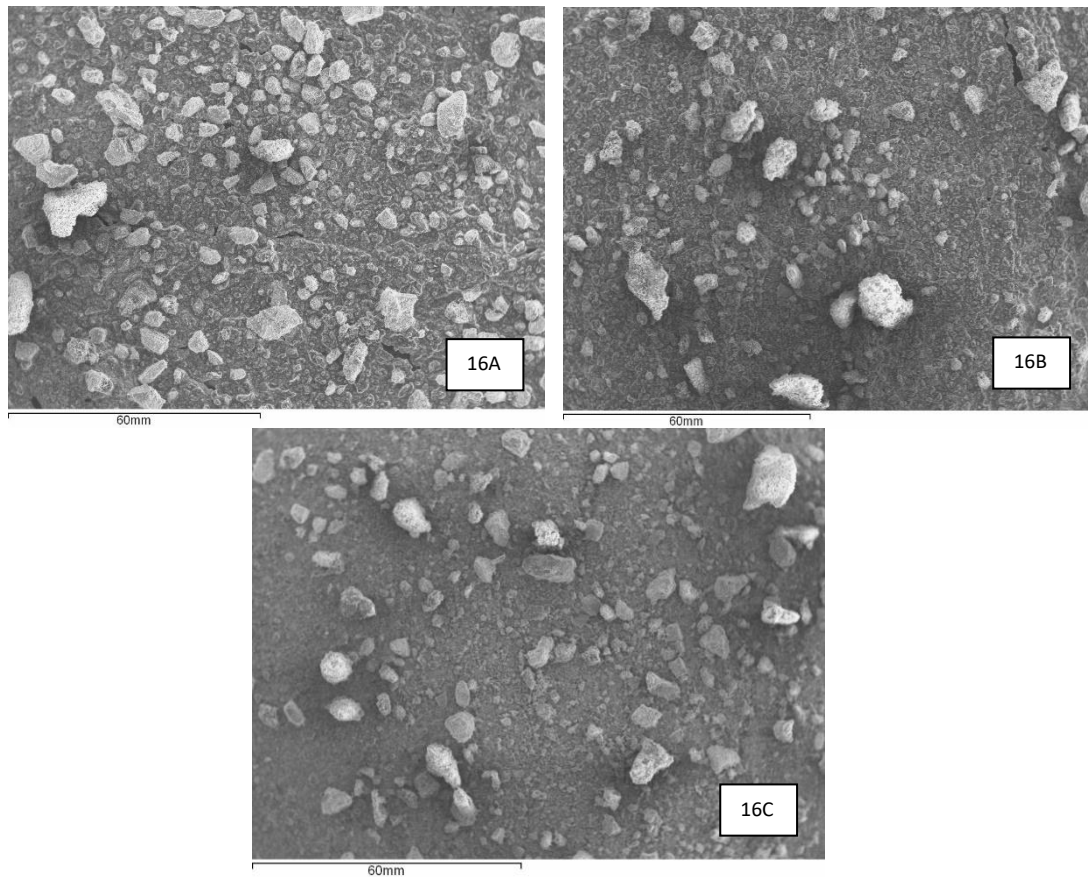
Figure 61. SEM analysis of samples from sample site 16.

The SEM images are as shown in **Figure 61**, the elements detected in all the samples from sample site 16 are; carbon, chlorine, iron, fluorine, zinc, silicon, sulfur, calcium, titanium, cadmium, aluminium. Sample 16A also contained sodium and sample 16B also contained potassium. Sample 16C additionally contained potassium, magnesium, sodium and phosphorus.

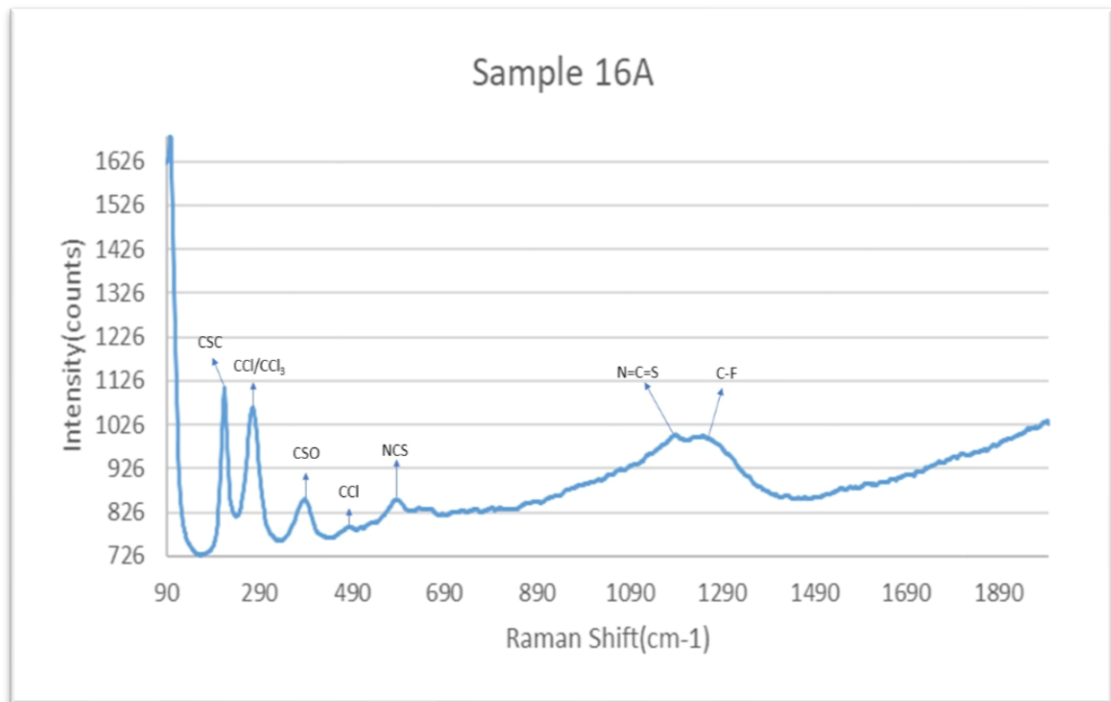
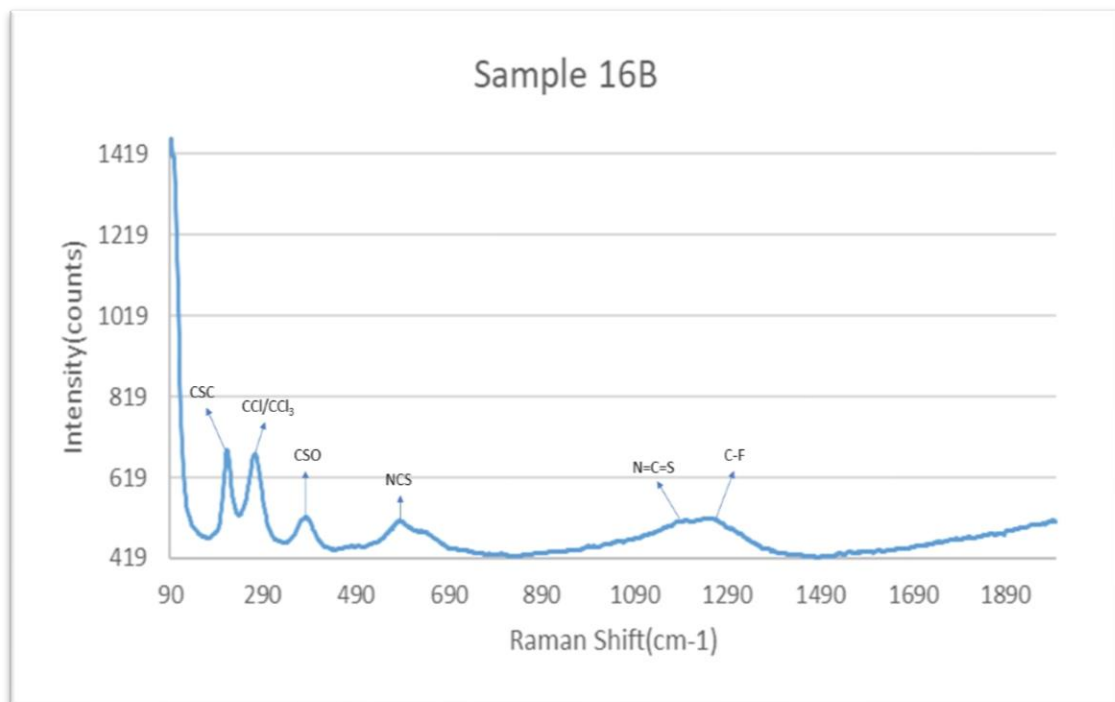
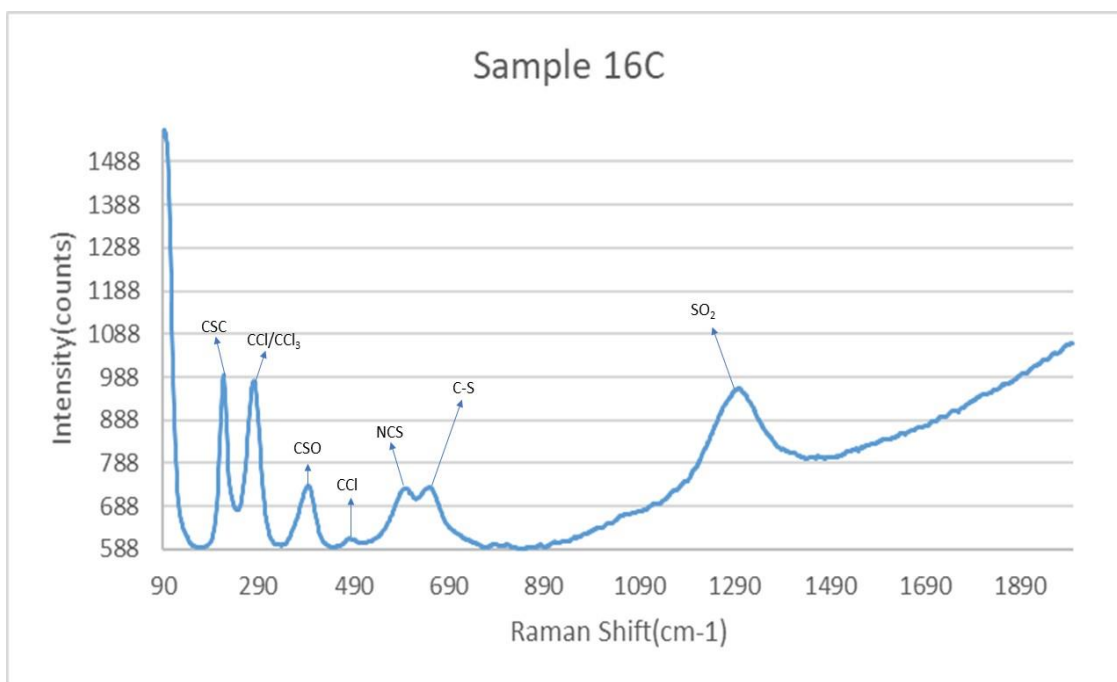
Figure 62. Raman analysis of samples from sample site 16.

Raman spectrum shown in **Figure 62**, have got low fluorescence interference, sample 16C is like spectra seen from other samples sites. Samples 16A and 16B contain a new identified compound, with the peak having a Raman Shift of $\sim 1250\text{cm}^{-1}$ representing carbon fluoride (C-F) compounds. This is because all samples were analysed to have had fluorine in them but, sample 16C has higher fluorescence interference which allows the methyl sulphones (SO_2) to eclipse that possible peak.

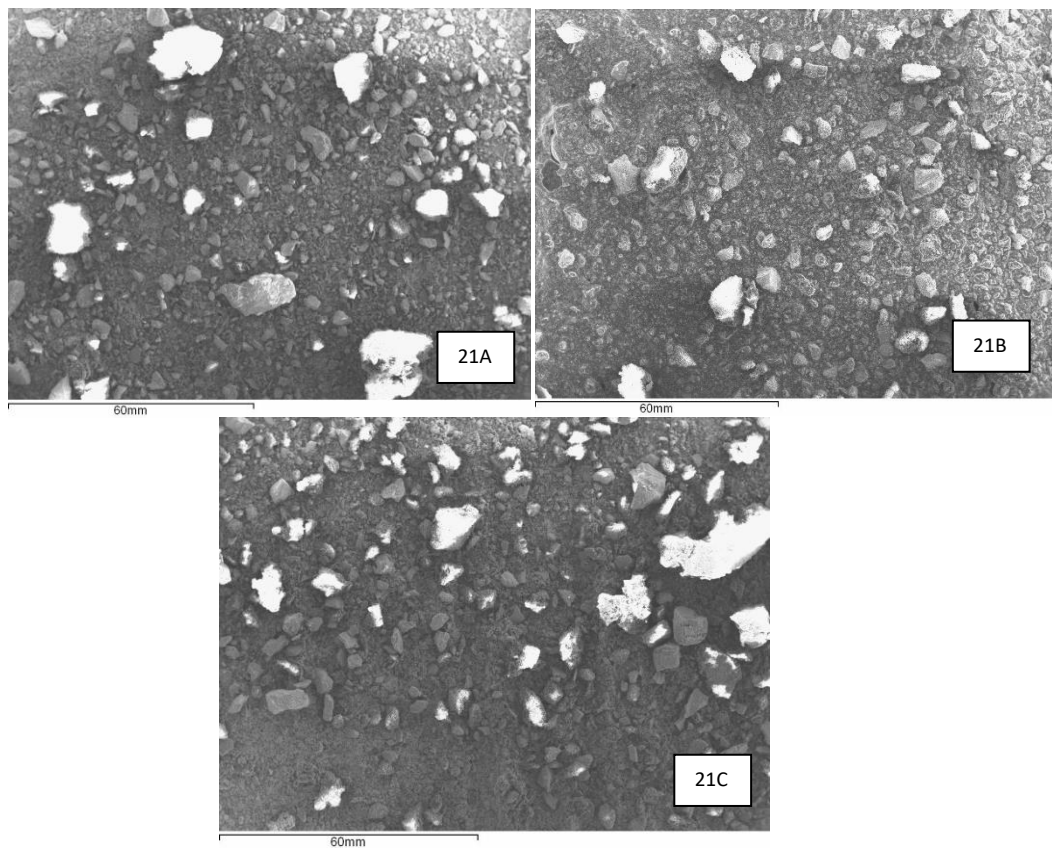
Figure 64. SEM analysis of samples form sample site 21.

The SEM images are show in **Figure 64**, the detected elements in all the samples for sample site 21 are; carbon, chlorine, iron, fluorine, manganese, silicon, cadmium, calcium, titanium, sodium, zinc, sulfur, magnesium, phosphorus and aluminium. Sample 21A also contained germanium.

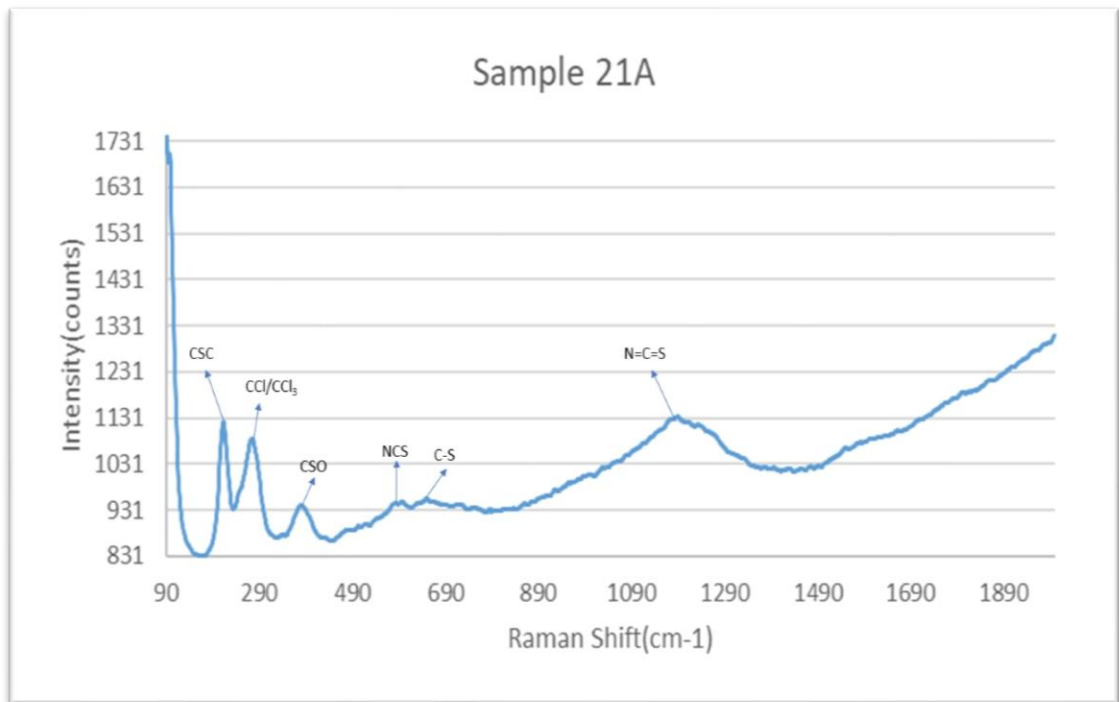
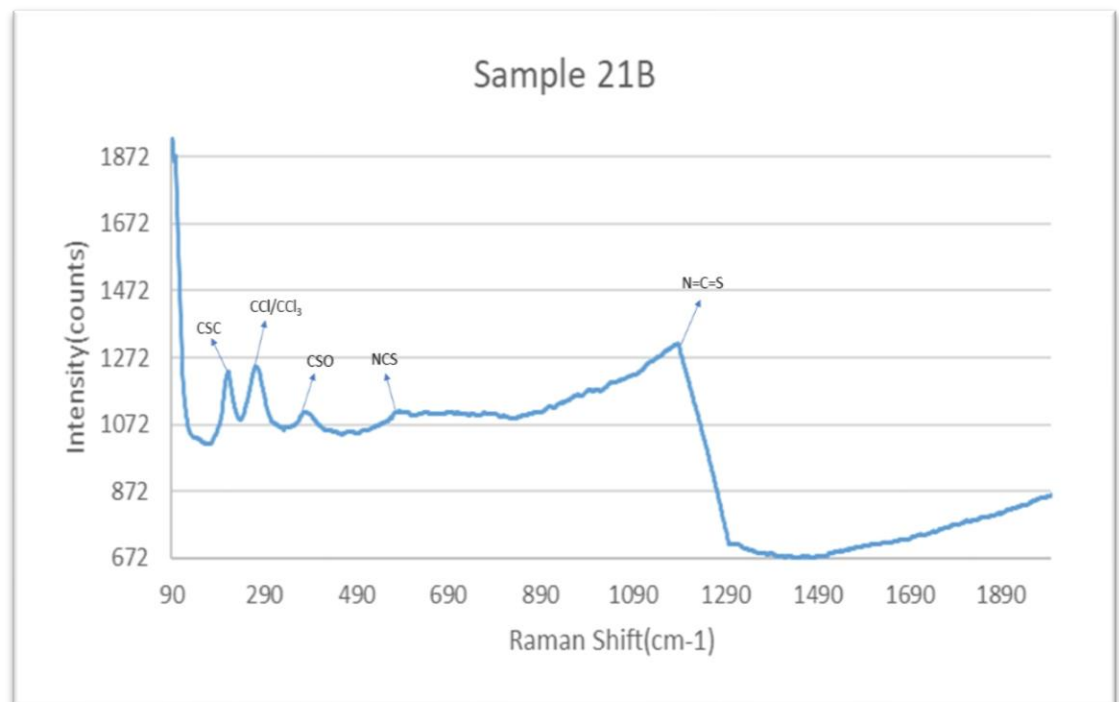
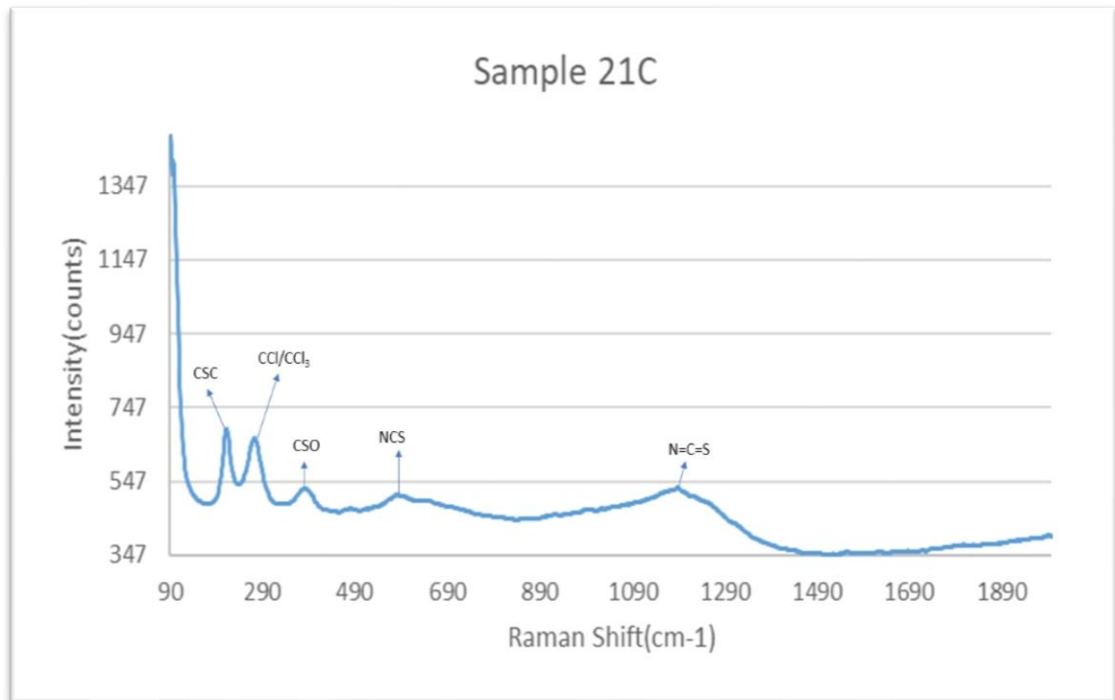
Figure 65. Raman analysis of samples from sample site 21.

The Raman spectrum in **Figure 65**, of samples from sample site 21 are similar that of other sample sites from before which have already identified the compounds relating to the peaks. There is however, a lot of noise in samples 21A and 21B.

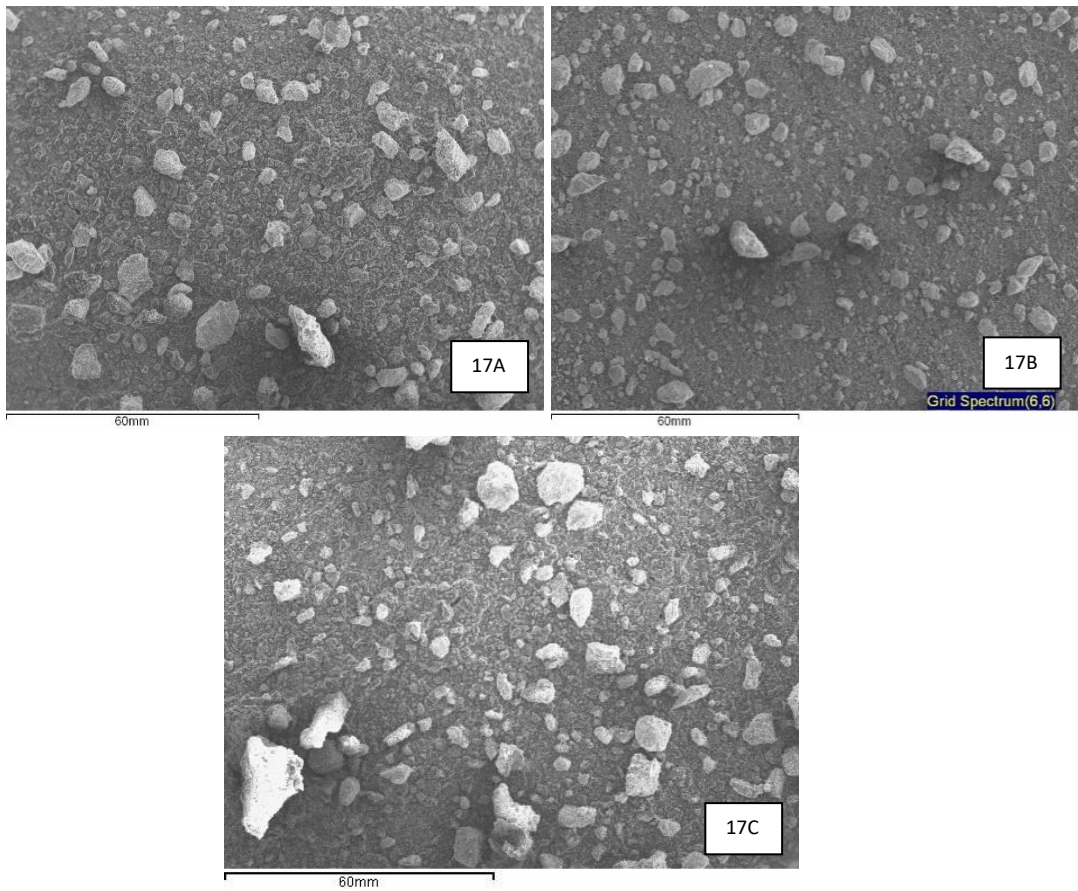
Figure 67. SEM analysis of samples from sample site 17.

The SEM images can be seen in **Figure 67**, the elements detected in all the samples from sample site 17 are; iron, titanium, chlorine, manganese, fluorine, carbon, cadmium, aluminium, silicon, calcium and sulfur. Sample 17A also contains calcium and magnesium. Sample 17C additionally contains calcium, sodium, magnesium and potassium.

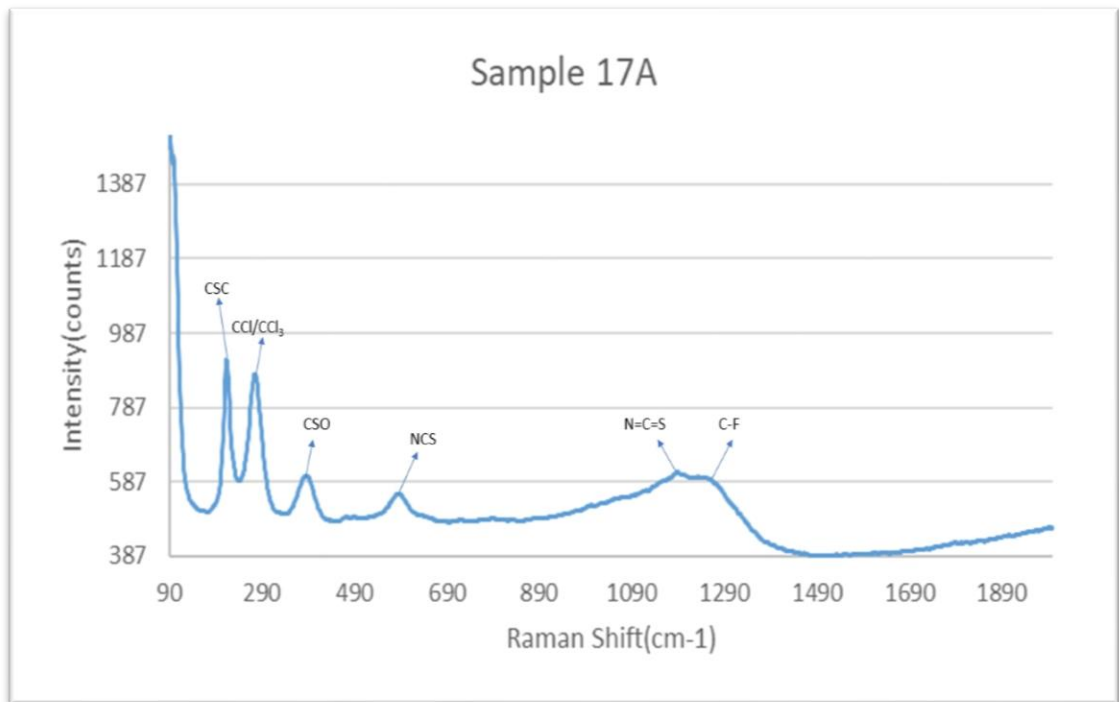
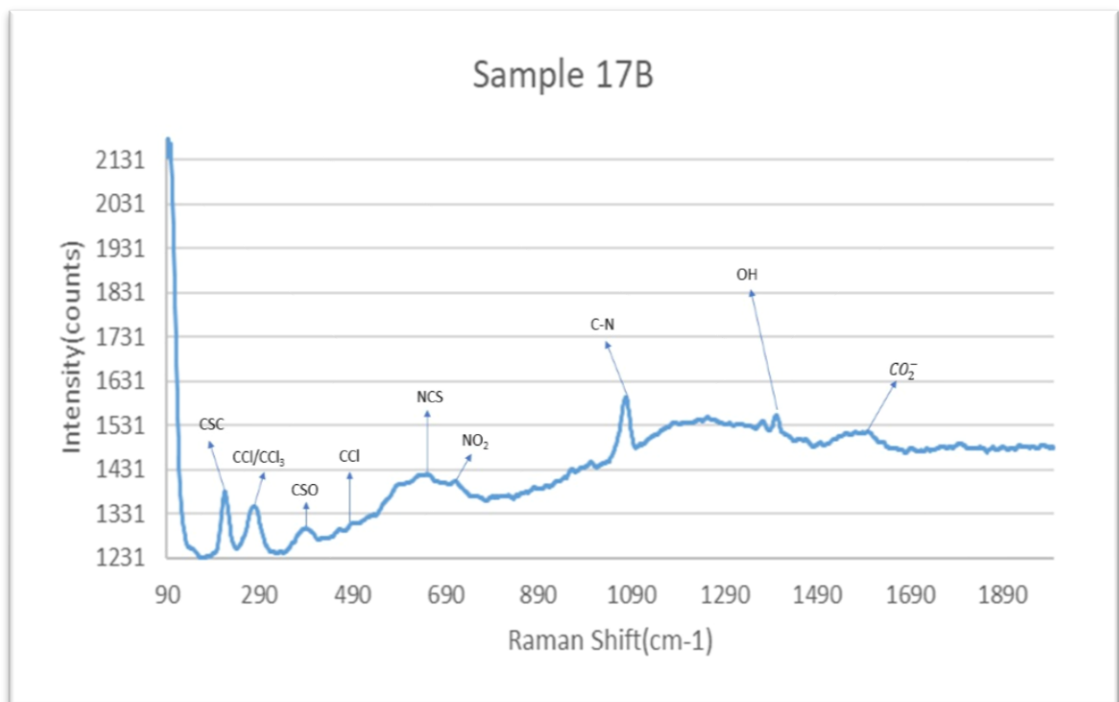
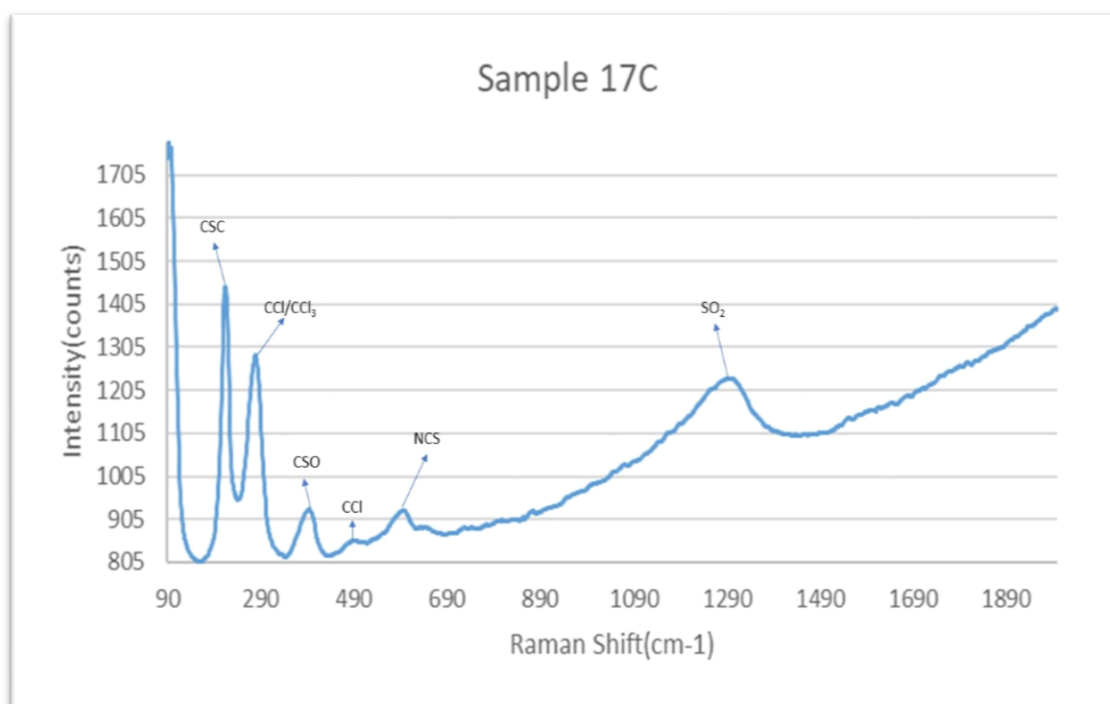
Figure 68. Raman analysis of samples from sample site 17.

All the spectra for the samples from sample site 17 are all different as illustrated in **Figure 68**. Sample 17A has an extra peak at $\sim 1250\text{cm}^{-1}$ carbon fluoride compounds (C-F) next to the commonly identified peak at $\sim 1188\text{cm}^{-1}$ isothiocyanates (N=C=S). Sample 17B has a lot of commonly identified peaks, the different peaks are at $\sim 1078\text{cm}^{-1}$ sulphonyl fluorides (C-N) and $\sim 1530\text{cm}^{-1}$ aromatic acid salts (CO_2^-). Sample 17C is made up of common peaks that have already been previously identified.

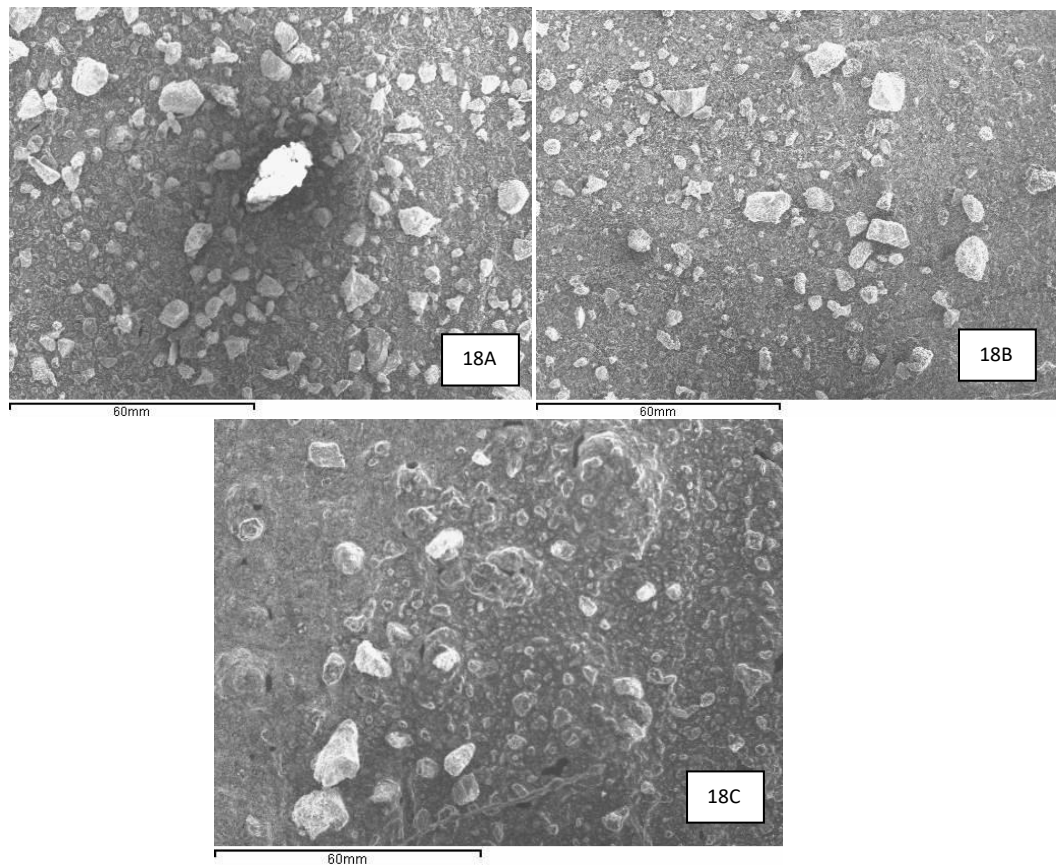
Figure 70. SEM analysis of samples from sample site 18.

The SEM images can be seen in **Figure 70**. All the samples for sample site 18, contain the elements: chlorine, iron, carbon, fluorine, sodium, silicon, cadmium, manganese, magnesium, zinc, calcium, aluminium, titanium and sulfur. Samples 15A and 15C additionally contain potassium.

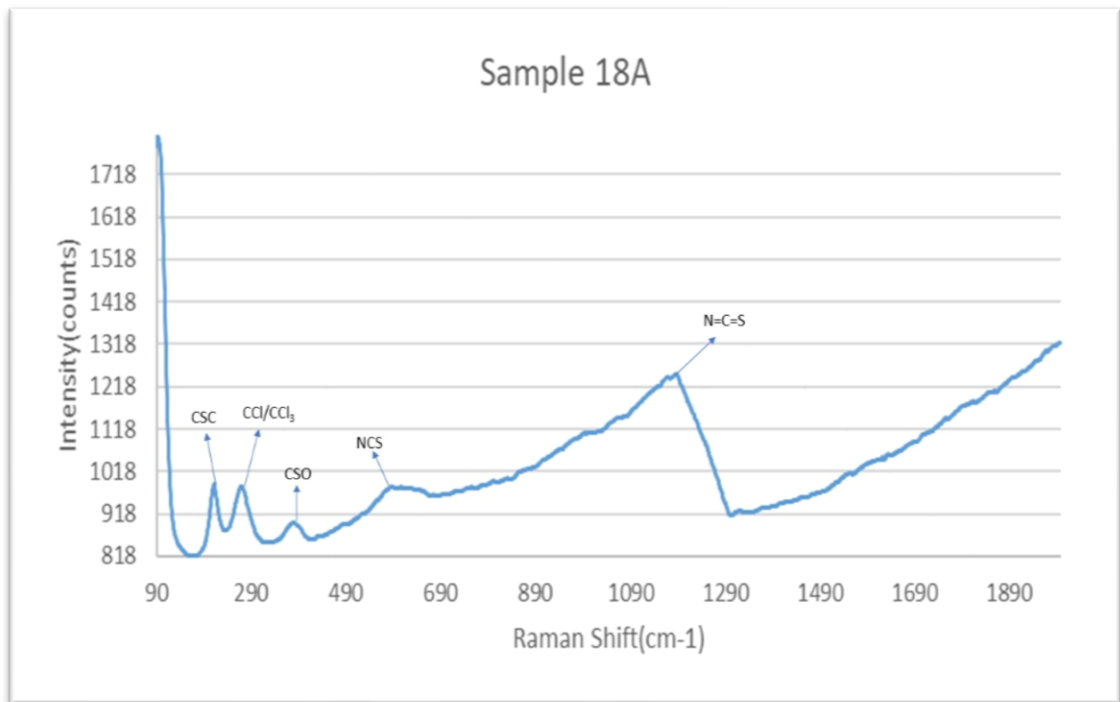
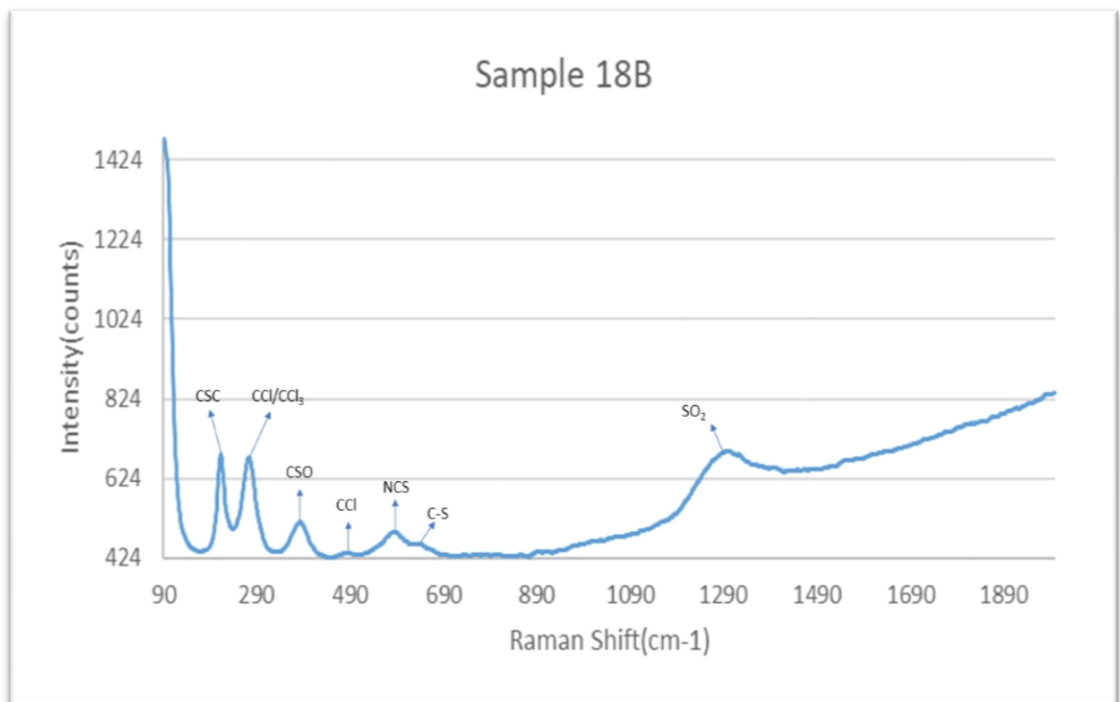
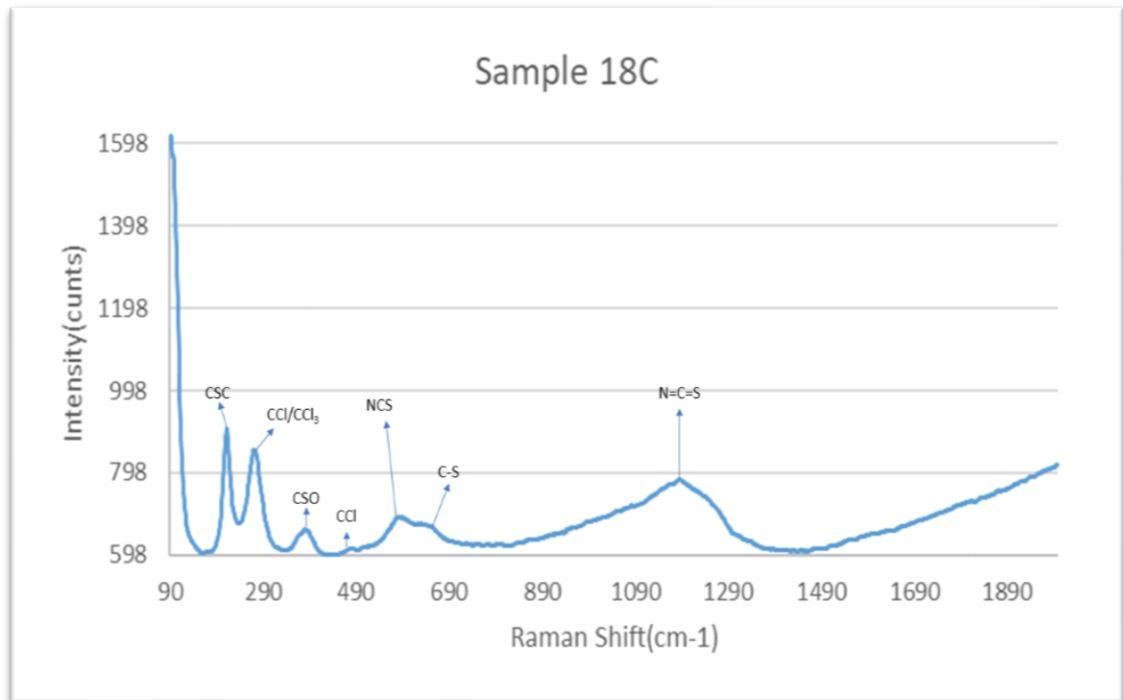
Figure 71. Raman analysis of samples from sample site 18.

The Raman analysis of sample site 18 has already been identified previously in other sample sites. Sample 18A has the worst fluorescence interference out of the samples for sample site 18, the evidence can be seen in **Figure 71**.
