THE INVESTIGATION OF
THE CAUSE AND
SEVERITY OF
CORROSION AT THE
PORT OF DOVER

Thesis Submitted For The Degree Of Research Masters In
Chemistry At The University Of Kent

Abstract

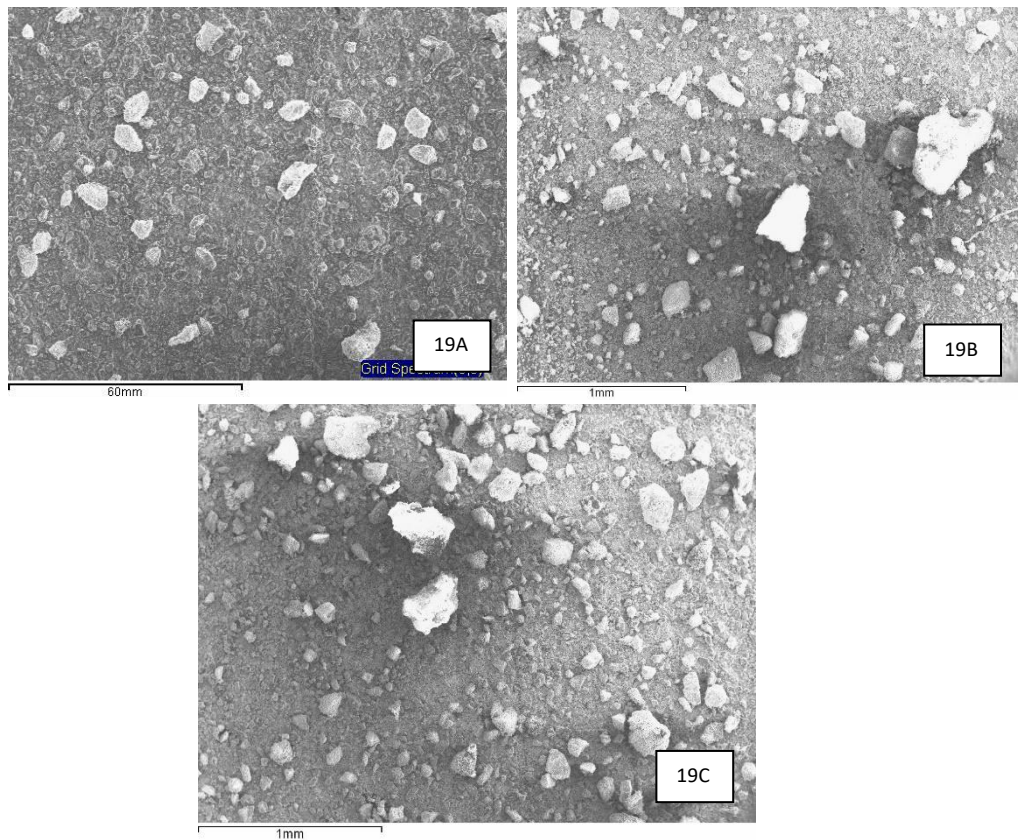
Figure 73. SEM analysis of samples from sample site 19.

The SEM images for site 19 can be seen in **Figure 73**. The elements detected in all the are: chlorine, carbon, iron, sodium, zinc, silicon, manganese, titanium, sulfur, calcium and aluminium. Sample 19A also contains fluorine, cadmium and phosphorus. Sample 19B additionally contains phosphorus, magnesium and barium.

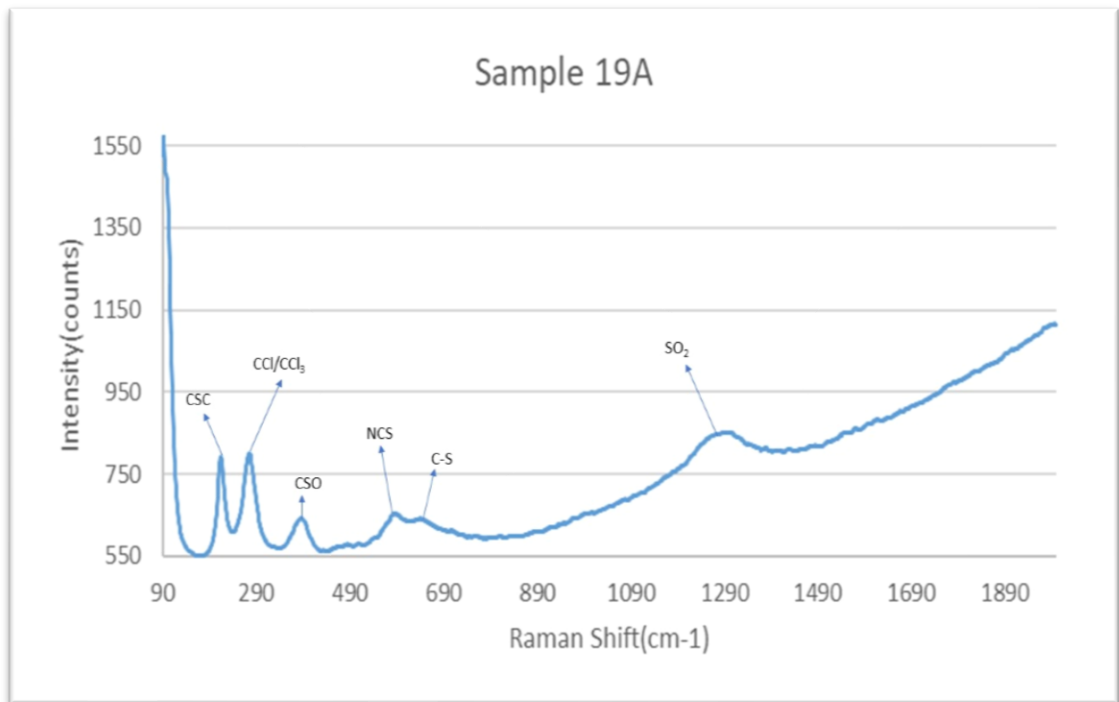
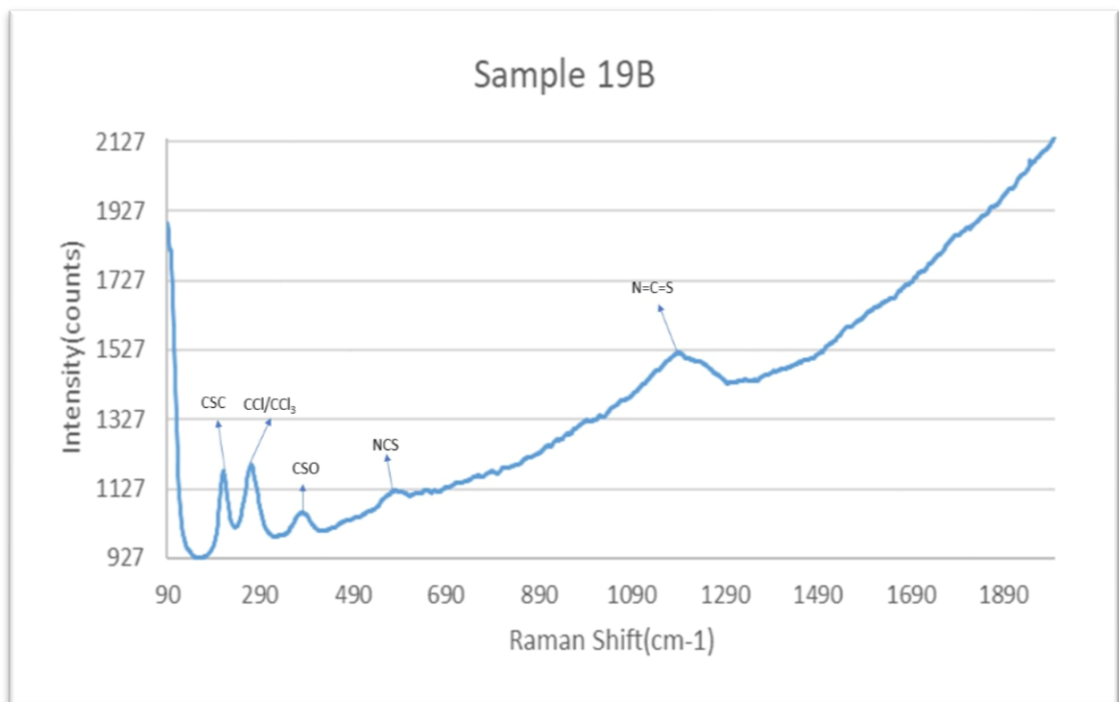
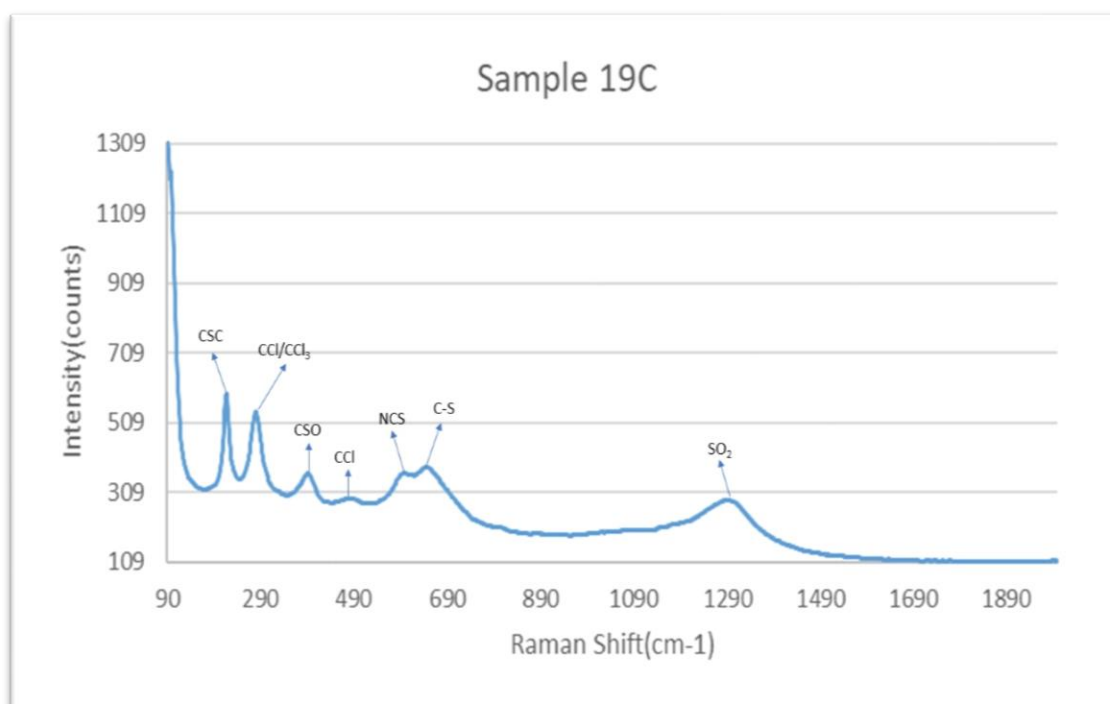
Figure 74. Raman analysis of samples from sample site 19.

The Raman spectra for site 19 are seen in **Figure 74**. The samples contain peaks that have already been identified in previous samples. Sample 19C having very little fluorescent interference and 19A having a little but, sample 19B has a lot of interference.

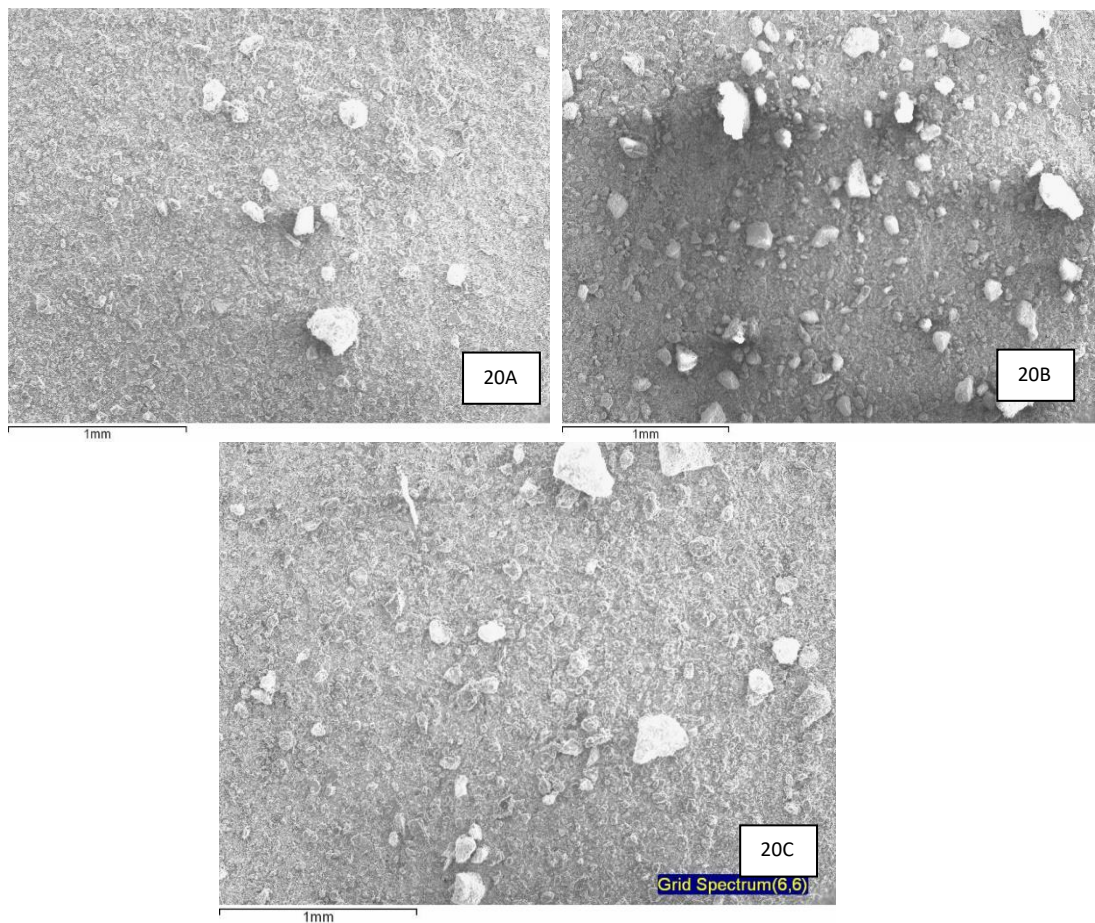
Figure 76. SEM analysis of samples from sample site 20.

The SEM images from site 20 can be seen in **Figure 76**. The samples from sample site 20, all contained the following elements: iron, carbon, silicon, sodium, chlorine, zinc, aluminium, manganese, titanium, calcium and sulfur. Sample 20A also contained magnesium and barium. Sample 20B additionally contained copper, bromine and rubidium. Sample 20C also contained bromine, magnesium, cerium and copper.

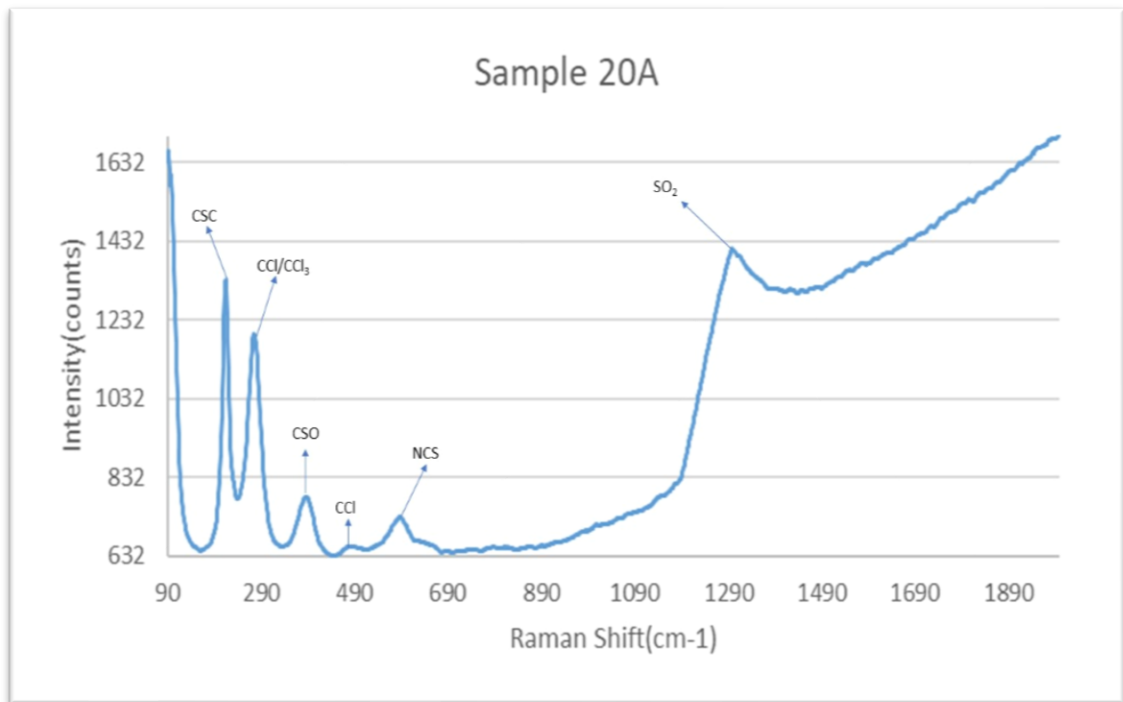
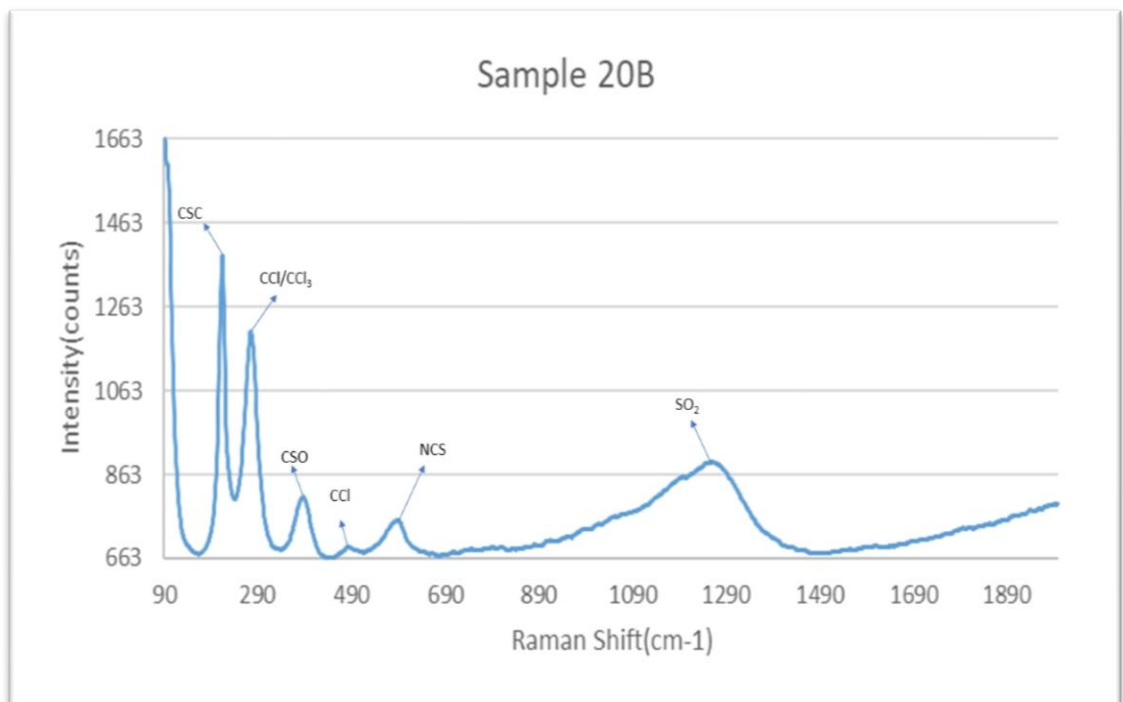
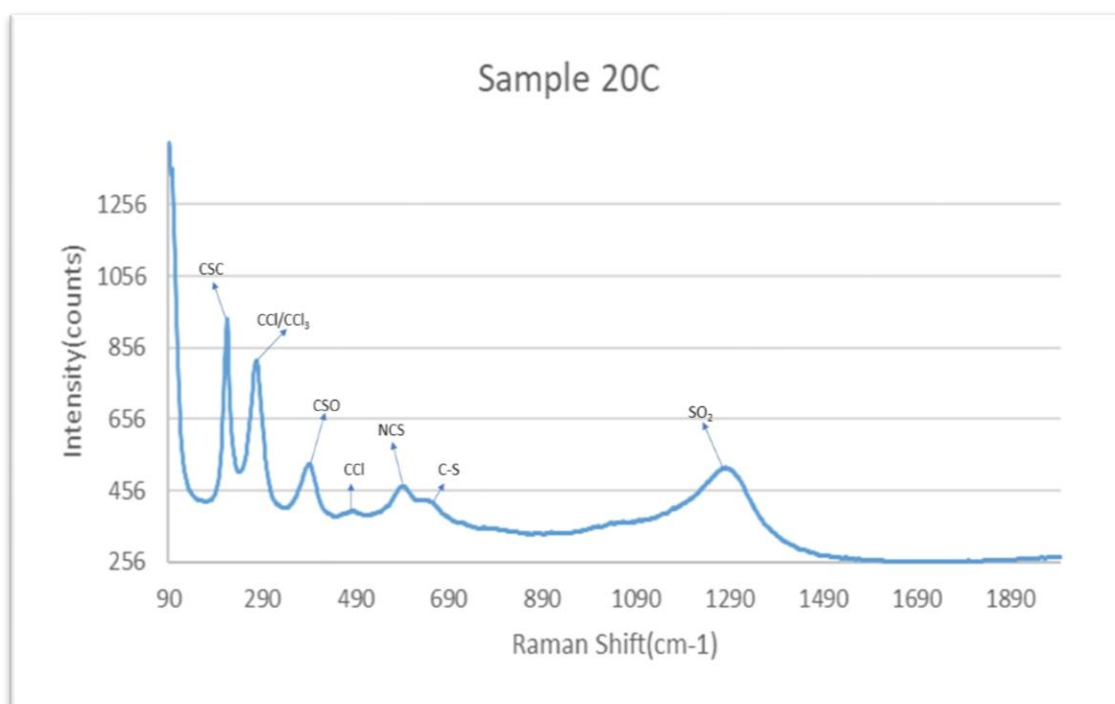
Figure 77. Raman analysis of samples from sample site 20.

All the Raman spectra for sample site 20 shown in **Figure 77**, have already been identified in previous samples. Samples 20B and 20C have very little fluorescence interference when compared to sample 20A.

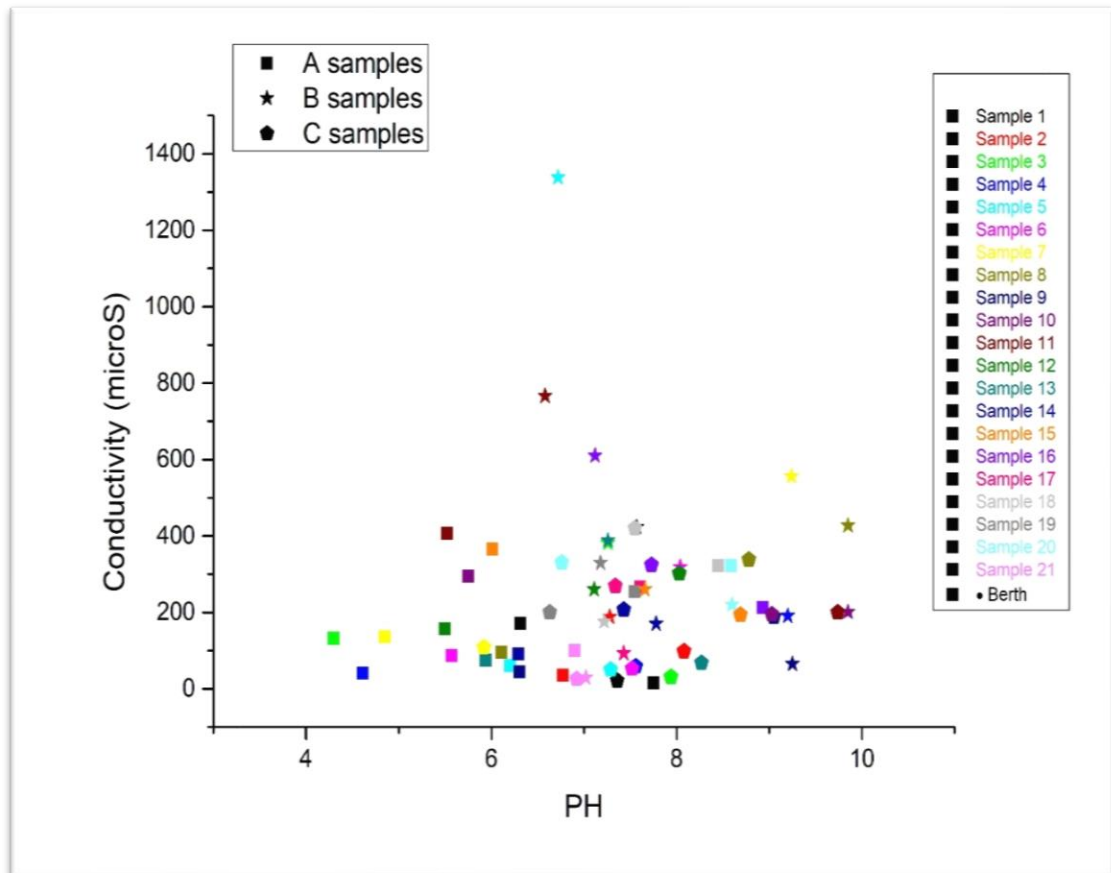
Figure 78. The pH against conductivity for all samples.

As can be seen in **Figure 78**, sample area 1 was quite acidic in general, with samples from the second sample area also having high acidity. The difference is the conductivity with respect to the two areas. The more alkaline samples with high conductivity readings are found in areas of the new part of the elevated bridge. The main differences between the samples from areas 1,2 and samples from the new part of the bridge (sample areas 6,7 and 8 as seen in **Figure 14**) is that: area 1 and 2 are in very high-density traffic zones, area 1 is a car park next to a major road, area 2 is the security gate next to the busiest road of the port and next to the workshop. The new part of the bridge is close to this very busy road, but it is right at the end, so it does not get aa much traffic as the old part of the bridge. This is due to the traffic siphoning off into their respective lanes for the ferry's and port services.

The rate of degradation across the board can be related to the basic pH associated with the environment or the steel alloy. In the results the basic pH samples have a closer average in terms of conductivity. The acidic samples are more varied in terms of conductivity. This is happening to the bridge that is closer to the sea, area 2 is an exception as sample 5 was sheltered from the sea and sample 9 has a slightly acidic sample A with a high conductivity. The rest of the samples have a basic pH and good conductivity. This area is also in one of the most heavily trafficked areas of the port. The new part of the bridge is highly basic and has some acidic areas, but the conductivity is steady and not very high as seen in **Figure 78**.

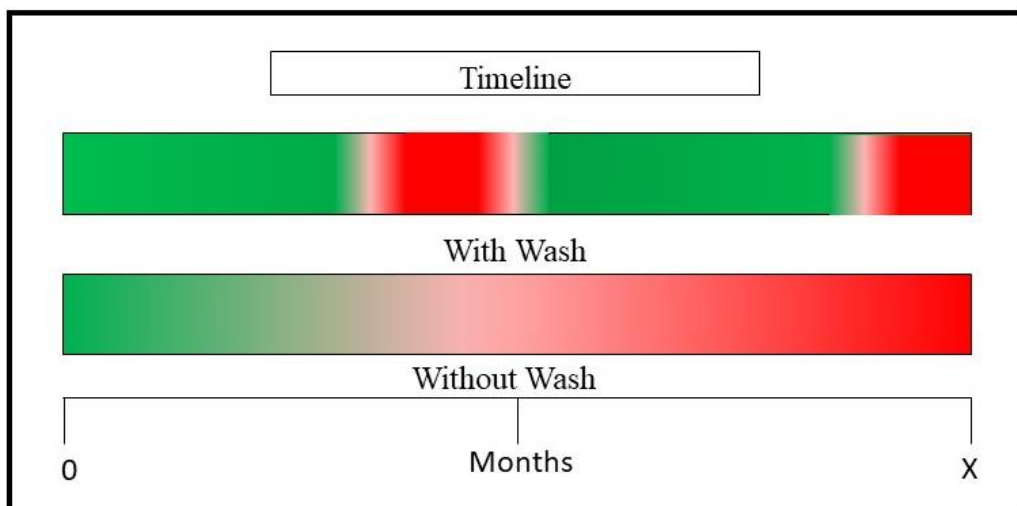
Figure 79. Example timeline of the elevated bridge being washed and without being washed.

Figure 79 is an example of a timeline in which particulate matter forms allowing for more deposition. The key for this figure is green for when there is no particulate matter and red for when there is. This figure is to illustrate the benefit of washing the bridge on a regular basis.

This paint coating is for the most corrosive of environments and is the most suitable for the Port of Dover. This does not however consider the carbon particulate matter. As a countermeasure for the particulate matter that is produced in the port, a maintenance system should be put in place to reduce buildup of the particulates and, hence, the formation of corrosion products. Cleaning the elevated bridge regularly will aid the prevention of corrosion. The timeline seen below in **Figure 79**, in the future work, illustrates the buildup of corrosion before and after a wash.
