Revisiting the 19th-Century Principles of Fire Protection at the Palace of Westminster, 1835-1942

Henrik Schoenefeldt

Following a devastating fire in October 1834, fire safety became a central concern during the reconstruction of the Palace of Westminster. Although it was not considered at the stage of the architectural competition, between 1836 and 1860 the architect Charles Barry oversaw the development of a scheme for fire protection. This paper presents a detailed examination of the evolution of this scheme. The first part shows that Barry's office pursued a passive approach that combined the use of fire-resistant materials with structural compartmentation. This approach had implications for the cost and design of the structural fabric and also affected David Boswell Reid's design for the ventilation system. A study of the final scheme, which is the subject of the second part, illustrates that Barry, aware of the limitations of the structural measures, including the risk of ducts breaching compartmentation, also considered operational aspects. These became an integral part of facilities management procedures that had been implemented under Barry's supervision. The third part

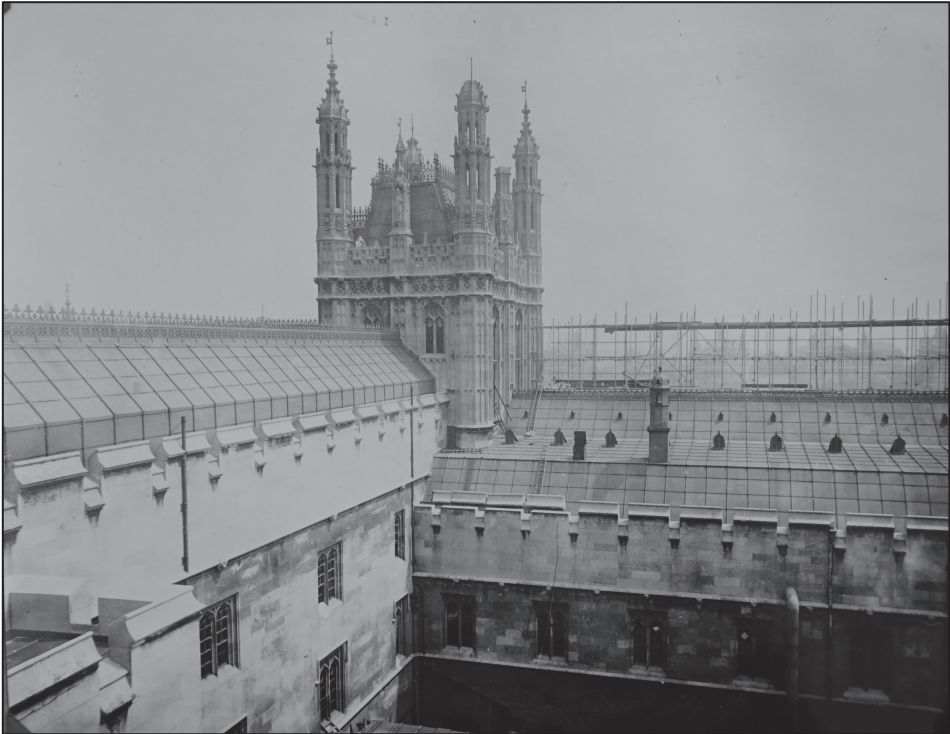
Figure 7: Photograph of original cast-iron roofs on the east and north side of Royal Court, taken c.1920s (Source: Historic England Archive, Swindon, AL 1016).

Another significant change, undertaken in the mid-1840s, was the adoption of fire-resistant materials for the roof construction, which was originally planned to be timber-framed. This idea was first discussed on 27 September 1841 during a sitting of the Select Committee of the House of Lords. Barry reported that the roofs could be made fire resistant if “the battens for the slates, and the entire roof, were of iron”,⁵¹ but initially did not consider it necessary as the roof spaces were already isolated through jack-arches.⁵² In the final design two different types of fire-resistant roof construction were adopted. In 1857, 16 years after his original statement, Barry wrote that the introduction of large smoke flues necessitated the roofs to be “constructed entirely of fireproof materials”.⁵³ The main roofs were covered with thick plates of cast-iron (Fig. 7), supported on wrought-iron trusses (Fig. 8).⁵⁴ The lower roofs, which were located inside the courtyards, were covered with large panels of natural slate, supported on iron beams.⁵⁵

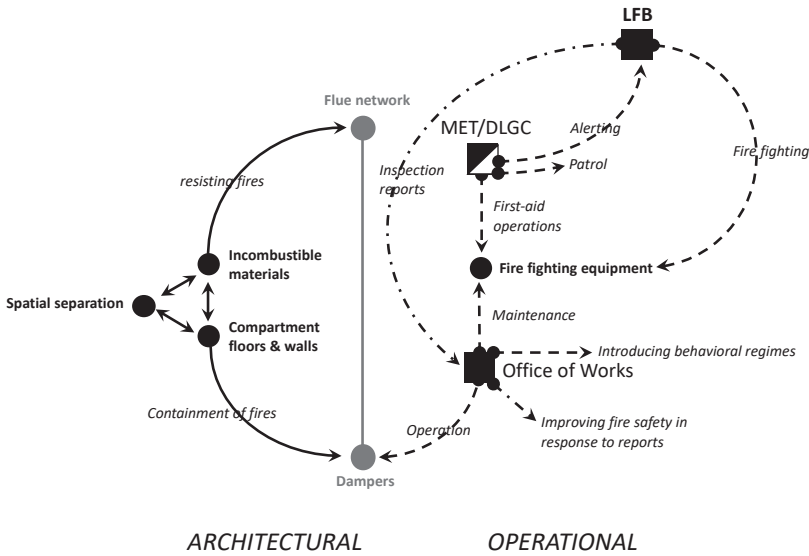
Figure 11: Architectural and operational functions within the socio-technical system (Source: Author's own diagram).

Barry's strategy has followed a largely passive approach to fire protection, exploiting the inherent safety provided through structural compartmentation, spatial separation, and the use of fire-resistant materials. From 1845, however, Barry's office became increasingly aware of the limitations of these passive measures, and his final scheme incorporated firefighting services and considered the role of facilities management, exposing its reliance on human interventions. Manual operations, such as the closing of hand-operated valves, represent historic examples of active measures, and they were part of a larger set of operational procedures that were concerned with the detection, containment and fighting of fires. The administrative files of the Office of Works, which cover the period from 1852 to 1942, reveal that the passive measures need to be understood as part of a socio-technical system, in which the structure, services and management procedures fulfilled complementary functions (Fig. 11).
