Hutiu, Gheorghe, Duma, Virgil-Florin, Demian, Dorin, Bradu, Adrian and Podoleanu, Adrian G.H. (2018) *Assessment of Ductile, Brittle, and Fatigue Fractures of Metals Using Optical Coherence Tomography.* Metals, 8 (2). pp. 3-18. ISSN 2075-4701.

## Assessment of Ductile, Brittle, and Fatigue Fractures of Metals Using Optical Coherence Tomography

**Keywords:** metallic materials; fracture; ductile; brittle; fatigue; Optical Coherence Tomography (OCT); Scanning Electron Microscopy (SEM); surface topography; forensic investigations

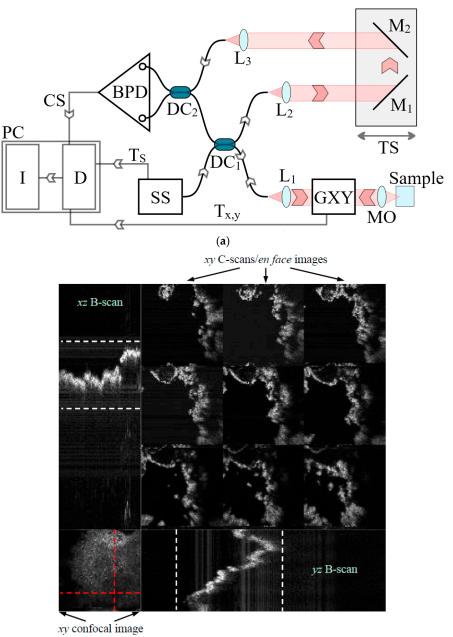
**Figure 1.** (a) Schematic diagram of the MS/SS-OCT system. SS, swept source; DC1, 20/80 single mode directional coupler; DC2, 50/50 single mode directional coupler; GXY, two-dimensional lateral scanning head (galvanometer-based); L1 to L3, achromatic lenses; microscope objective (MO): telecentric scanning lens; PD, photodetector; M1 and M2, flat mirrors; TS, translation stage; (b) OCT images provided by the instrument, with: a confocal image (lower part, left) to image the exact selected area on the *xy* surface of the sample; two B-scans (cross-sectional images), an *xz* and an *yz* one (where the *z* axis is the in-depth one, perpendicular on the surface of the sample), taken on the positions marked in red in the confocal image; nine *xy* C-scans/*en-face* images, taken each at a constant depth in the topography of the sample surface, between the dotted lines marked in the B-scans. All OCT images are presented simultaneously to the user.

A detailed schematic diagram of the SS-OCT imaging instrument is presented in Figure 4a, while in Figure 4b the raw images obtained are shown.

As optical source, a swept source laser (SS, Axsun Technologies, Billerica, MA, USA), with a central wavelength at 1060 nm, sweeping range 106 nm (quoted at 10 dB), and a 100 kHz line rate is used. This allows an axial resolution measured in air of around 10 µm. The interferometer configuration uses two single-mode directional couplers, DC1 and DC2. DC1 has a ratio of 20/80, whilst DC2 is a balanced splitter, 50/50. DC2 feeds a balance detection receiver (Thorlabs, Newton, NJ, USA, model PDB460C). 20% of the SS power is conveyed toward the object arm via lens L1 (focal length 15 mm), which collimates the beam toward a pair of orthogonal galvanometer scanners GXY (Cambridge Technology, Bedford, MA, USA, model 6115), which are driven with a scan frequency of 66.7 Hz for the fast axis and 0.044 Hz for the slow axis. The scanning steps have been determined by the area of the investigated surface and by the required resolution; for example for an area of  $1.5 \times 1.5$  mm<sup>2</sup> and a lateral resolution of 10 µm, 1500 lines have to be considered for the slow scan—when using B-scans/cross-sections to achieve OCT images. The scanners are followed by an interface optics made from a telecentric scanning lens, MO, which finally determines the lateral resolution of the *en-face* images. Two situations were considered. In the first case, MO was chosen in such a way that the lateral resolution across the *en-face* image was around 10  $\mu$ m, while for the second case a shorter focal length lens was chosen that determined a lateral resolution of around 4  $\mu$ m across the image. The power on the sample in both situations is around 2.2 mW. At the other output of DC1, 80% of the SS power is directed toward the reference arm of the interferometer, equipped with two flat mirrors, M1 and M2, placed on a translation stage, TS, to adjust the optical path difference (OPD). Collimating lenses L1, L2 and L3 are identical. The signal from the balanced receiver is digitized by D (Alazartech, Quebec, Canada, model ATS9350, 500 MB/s). Trigger signals from the SS ( $T_S$ ) and from the galvanometer scanners ( $T_x$  and  $T_y$ ) are used to synchronize the acquisition allowing for the production of the volumetric datasets. The acquired channeled spectra CS (OPD) were manipulated via a program implemented in LabVIEW

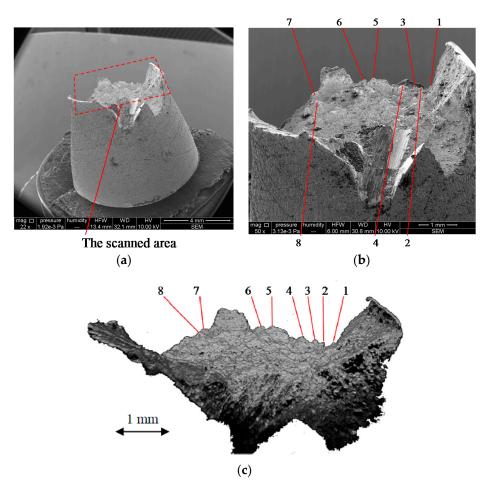
**Figure 3.** Images of a fracture in OL 37 steel: (a) frontal SEM overview of the entire sample, with an area selected for SEM and OCT imaging; (b) SEM image of the marked area; (c) OCT image of the same area, with a 10  $\mu$ m transversal resolution, with the same grains as in (b) numbered on the surface.

Figures 3–5 show the fracture surfaces of low carbon steel samples OL 37 and OL 44. These types of steel have been chosen because they are subjected to ductile (or shearing) fracturing at the testing temperature of 20 °C, which is produced inside the crystal grains in sliding planes with maximum atom density. The fracture crack propagates along the maximum tangential stress of the load applied; such a crack moves under a 45° angle from the tensile stress applied.

Figures 3a, 4a and 5a show the overall images of the OL 37 and OL 44 ductile fractured samples. It can be noticed that all samples have cup-type shapes that are characteristic of ductile fractures. Figures 3b and 4b show the fracture images of the OL 37 and OL 44 steel, generated using SEM. It can be remarked that all grains broke in a transgranular manner. As the grains have different orientations against the applied load, it can, however, be noticed that only a few grains were broken under the characteristic 45° angle from the tensile stress applied; this remark is valid for the surface grains that we have investigated; as OCT cannot penetrate metallic (reflective) materials, no volume investigations can be made. Figure 3c, Figure 4c, and Figure 5b show images of the broken surfaces of OL 37 and OL 44, generated using OCT. In order to demonstrate that the OCT images are similar to those generated using SEM, several surface grains have been numbered on the corresponding images of both investigations.

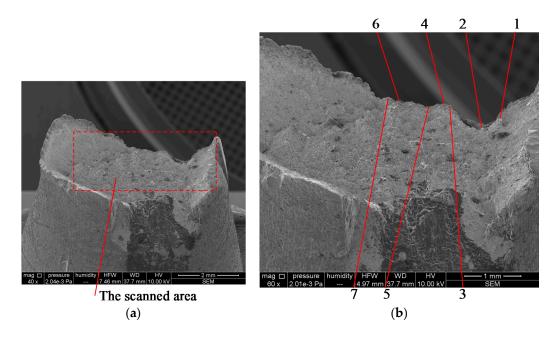
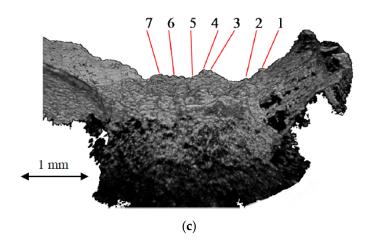
**Figure 4.** Images of a fracture in OL 44 steel: (a) frontal SEM overview of the entire sample, with an area selected for SEM and OCT imaging; (b) SEM image of the marked area; (c) OCT image of the same area (with a 10  $\mu$ m transversal resolution), with the same grains as in (b) numbered on the surface—also presented in [36].

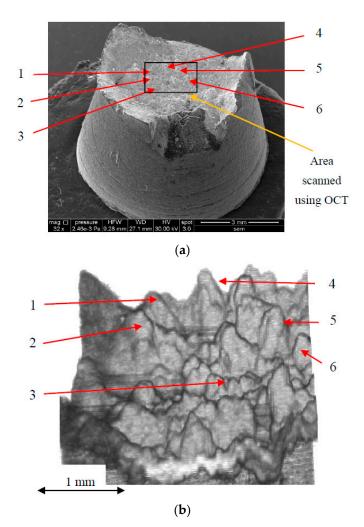
**Figure 5.** Images of a fracture in OL 44 steel: (a) frontal SEM overview of the entire sample, with a marked area for the OCT investigation; (b) OCT image  $(1.5 \times 1.5 \text{ mm}^2)$  obtained with the novel MS/SS-OCT system—with an improved, 4  $\mu$ m transversal resolution—with the same grains as in (a) numbered on the surface after a 5× magnification of the area of interest.

As in Figures 3 and 4, the OCT investigations have been performed with the OCT instrument working in a low 10  $\mu$ m resolution mode, we have explored in Figure 5 the same sample as in Figure 4 (i.e., a low carbon steel OL 44), but this time with an MS/SS-OCT in an improved 4  $\mu$ m resolution mode. It can be seen that the latter system gives much clearer images of the broken surfaces; thus, Figure 5b shows much better images of the broken ductile grains; in contrast, the assessment of the ductile fracture type using the 10  $\mu$ m transversal resolution OCT system in Figures 3 and 4 is more difficult to perform due to the small dimensions of the grains on the metallic surfaces.

A quantitative assessment can also be performed on the topography obtained, regarding the dimensions of the grains on the SEM and OCT images. As the OCT instrument is capable of producing volumetric reconstructions of the sample under investigation, via software manipulation, such as ImageJ [37], the volumetric image can be rotated and tilted in order to make such assessments in a more precise way. Thus, from Figure 4b, the width and height of grain 1, for example, can be evaluated using SEM as equal to 0.22 mm and 0.18 mm, respectively. From Figure 4c, these dimensions can be evaluated using OCT as equal to 0.18 mm and 0.20 mm, respectively. A similar assessment can be done from Figure 5b,c. From the former, the width and height of grain 5, for example, can be evaluated using OCT as equal to 0.24 mm and 0.31 mm, respectively. A good agreement can be seen regarding the above values, although those measured from OCT images are the exact ones, because SEM images cannot be rotated and tilted in order to obtain a lateral view of the grains. Also, when using SEM only some grains can be measured; when using OCT this can be done for any grain.

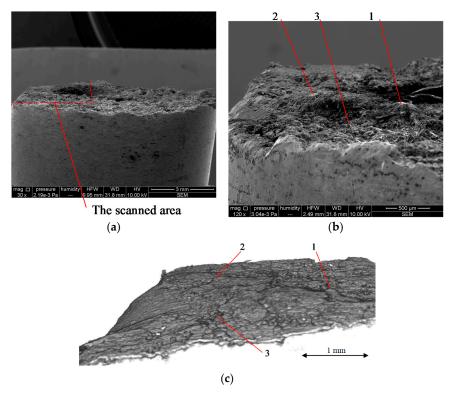
**Figure 6.** Images of a fracture in a lamellar cast iron EN-GJL 250: (**a**) frontal SEM overview of the entire sample, with a marked area for the OCT investigation; (**b**) SEM image of the selected area shown in (**a**); (**c**) OCT image of the same area with a 10  $\mu$ m transversal resolution, with the same grains as in (**b**) numbered on the surface.

Figure 6 shows the image of the fractured surface of lamellar cast iron EN-GJL 250—for a 10 mm diameter sample.

Figure 6a,b show the overview of the cast iron sample generated using SEM. It can be noticed that the sample broke without elongation, which is a characteristic feature of a brittle fracture. The area where the OCT analysis was performed has been marked on both images (on the lateral part of the probe, in order to obtain the same image with both methods) and several grains have been numbered in order to evaluate OCT versus SEM. Note that specifically grains were selected, that were also seen on the SEM images with a broken tip and with the remaining surface perpendicular on the direction of the applied force. Further note that we used SEM analysis in the present study, and not optical metallographic microscopy, therefore no polishing/etching of the cast iron sample was made.

Figure 6c shows the image of this selected surface of the fracture generated using OCT. The grains generated using both methods (i.e., SEM and OCT) can be identified on the corresponding images, Figure 6b,c, respectively. Both images show that grains 1, 2, and 3 broke in a transgranular manner (with their surface perpendicular on the direction of the applied force), which also proves that the fracture was brittle. In general brittle fractures are achieved by cleavage; they consist of a breakdown of atomic bonds between atoms placed on two adjacent planes that are perpendicular to the direction in which the normal tensile load was applied. However, cleavage fracture is not visible on the magnification scale used.

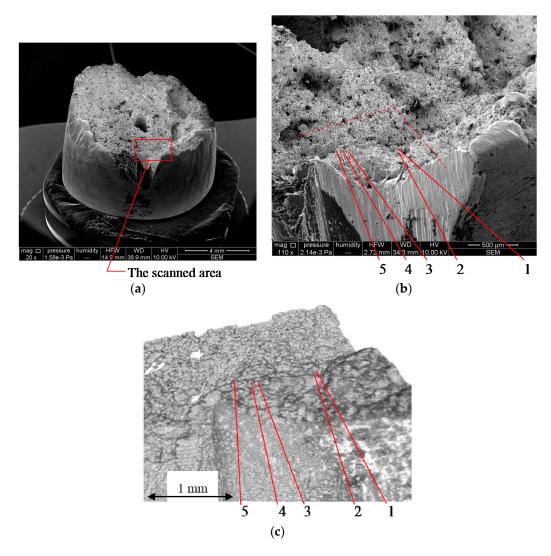
**Figure 7.** Images of a fracture in a Sn-Sb-Cu antifriction alloy: (a) frontal SEM overview of the entire sample, with a marked area for the OCT investigation; (b) SEM image of the selected area; (c) OCT image of the same area with a 10  $\mu$ m transversal resolution, with the same grains as in (b) numbered on the surface.

Figure 7 shows the fractured surface of a Sn-Sb-Cu antifriction alloy—also for a sample with a 10 mm diameter. Figure 7a,b show an overview of the sample—generated using SEM. Figure 7a shows that, as in the previous case, the sample broke without elongation, which is a characteristic feature of a brittle fracture. The area where the OCT analysis was performed has been marked on both images and some grains have been numbered in order to evaluate the OCT volumetric image versus the SEM one. Figure 7c shows the image of the fracture surface generated using OCT; the grains imaged using SEM in Figure 7b can be identified in Figure 7c, as well. On both images, one can remark that, as in the previous case, the grains broke in a transgranular manner, perpendicular with regard to the direction of the applied force, which also proves that this fracture was brittle.

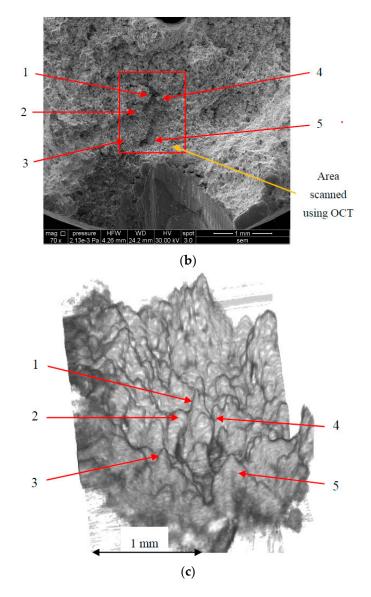
**Figure 8.** Images of a fracture in a Sn-Sb-Cu antifriction alloy: (**a**,**b**) frontal SEM overview of the entire sample, the latter with a zoom to mark the area for OCT imaging; (**c**) OCT image  $(1 \times 1.5 \text{ mm}^2)$  of the selected area, obtained with the MS/SS-OCT system—with the improved 4 µm transversal resolution.

Figure 8 shows the image of the same fractured surface of the Sn–Sb–Cu antifriction alloy as in Figure 7—but with the MS/SS-OCT system with the improved 4 µm resolution. Figure 8a shows the overview of the same sample as in Figure 7, but with another area than in Figure 7b selected further on in Figure 8b for OCT. On the whole, the same conclusions as in Figure 7a, b have been obtained in Figure 8a,b, respectively: the sample broke without elongation and the grains broke in a transgranular manner, perpendicular to the direction of the applied force. Both are characteristic features of brittle fractures. The advantage of using this OCT system with an improved 4 µm resolution can be concluded from this case as well, as the broken grains are seen much clearer in Figure 8c; this figure looks similar to Figure 5c, but in the former one can see that all grains have been broken perpendicular to the applied force, while in the latter one can distinguish grains 3 and 6 broken at  $45^{\circ}$  with regard to the direction of the applied force. A clear advantage of OCT with regard to SEM can also be concluded from this comparison: the volumetric OCT image can be rotated and tilted in all directions (while the SEM image cannot be manipulated), therefore other grains can be noticed on the OCT image, and the surface angles of their peaks can be determined. The granular fracture surface is plane and perpendicular to the direction in which the tensile stress was applied. However, due to the fact that in polycrystalline materials cleavage planes in each grain are not always perpendicular to the direction of force (grain axes are differently oriented), at microscopic scale fracture surfaces are not perfectly plane, except for the grain surface.

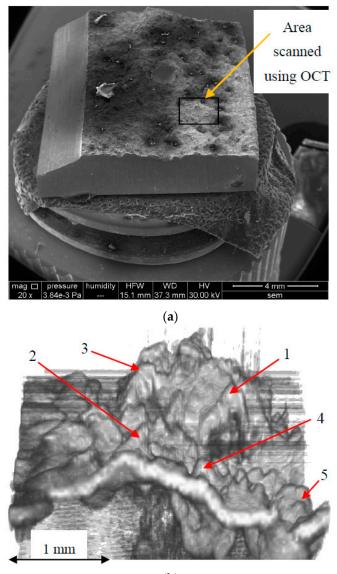
**Figure 9.** Images of a fracture in an OLC 45 steel: (a) SEM overview of the entire sample, with the marked area for OCT imaging; (b) OCT image of the selected area, obtained with the MS/SS-OCT system with the improved 4  $\mu$ m transversal resolution, with several grains numbered on the surface.

Figure 9a shows the SEM overview of an OLC 45 steel sample that underwent an impact test using a pendulum, with an impact energy of 8 J. This test carried on at -20 °C triggers a brittle fracture of the steel sample. The  $1.5 \times 1.5 \text{ mm}^2$  area selected and analyzed further on using OCT is outlined on this image; Figure 9b shows the image of the fracture surfaces generated using the improved 4  $\mu$ m resolution of the MS/SS-OCT system. One can see that the grains broke in a brittle manner; for example, grains 3, 4, and 5 broke perpendicular to the direction in which the normal tensile stress/load was applied—through the grains (fiery aspect), while grains 1 and 2 broke at the boundaries of the crystal grains (fiber aspect). These characteristic details can only be seen using the 4  $\mu$ m resolution MS/SS-OCT system, therefore the 10  $\mu$ m resolution OCT system was not used in this case anymore.

Another capability (and thus, advantage) of OCT can be seen from such an image: using ImageJ, the program used to generate volumetric OCT images from stacks of *en-face* OCT images in MS/SS-OCT (or of B-scans/cross-sections in SS-OCT), one can perform other quantitative evaluations of the surface topography, obtaining for example the number of grains per surface unit. An issue in such an evaluation is that, by rotating volumetric images, different grains can be seen, while others may become hidden; therefore, an optimal view has to be determined using ImageJ. Thus, in Figure 9b, 30 grains can be obtained on the  $1 \times 1.5$  mm<sup>2</sup> surface investigated with OCT.

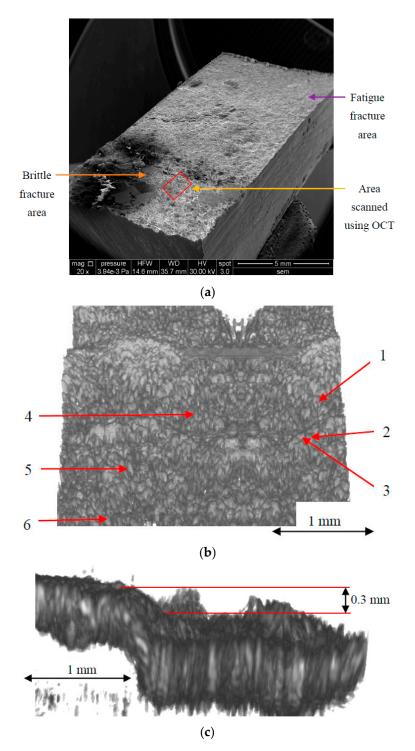
**Figure 10.** Images of a fracture in a T10NiCr180 stainless steel sample: (**a**) SEM overview of the entire sample, with the selected area for OCT imaging; (**b**) OCT image of the selected area, obtained with the improved MS/SS-OCT system—with a 10  $\mu$ m lateral resolution; (**c**) OCT image of the step from the fatigue area to the one of the brittle fracture.

Figure 10a shows the image of the fractured surface of a T10NiCr180 stainless steel sample. This sample was subjected to the testing conditions specified in Section 2.2, resulting in fatigue fracture, which occurs when metallic materials are subjected to variable loads and high amplitudes.

Figure 10a shows the fracture surface generated using SEM, while Figure 10b shows the image of the selected area generated using OCT. In the latter one can see that all the grains broke brittle. For example, grains 1, 2, and 3 broke perpendicular to the direction in which the normal tensile stress was applied, and grains 4, 5, and 6 broke at the crystal grains' boundaries. If there is no breakage due to fatigue because of the chemical composition and microstructure, this steel normally breaks in a ductile manner. In this specific case, the OCT analysis of this surface confirmed that the breakage of the steel was brittle.

A dimensional evaluation can also be done using OCT in Figure 10, regarding the transition/step from the fatigue to the brittle area. To our knowledge, such an evaluation cannot be performed using SEM. Using the lateral OCT view in Figure 10c, we have evaluated this step to 0.3 mm, result that is in good accordance with the physical reality.
